## Item 12

**SUBJECT:** Consideration of Local Coastal Program amendment to facilitate future construction of a replacement fire station (County Fire Station Number 59) and extension of CSA-11 to serve the fire station and Pescadero Middle/High School located at 350-360 Butano Cut Off. Both projects are located in the Pescadero area of the unincorporated San Mateo County.

County File Number: PLN 2021-00056 (County of San Mateo)

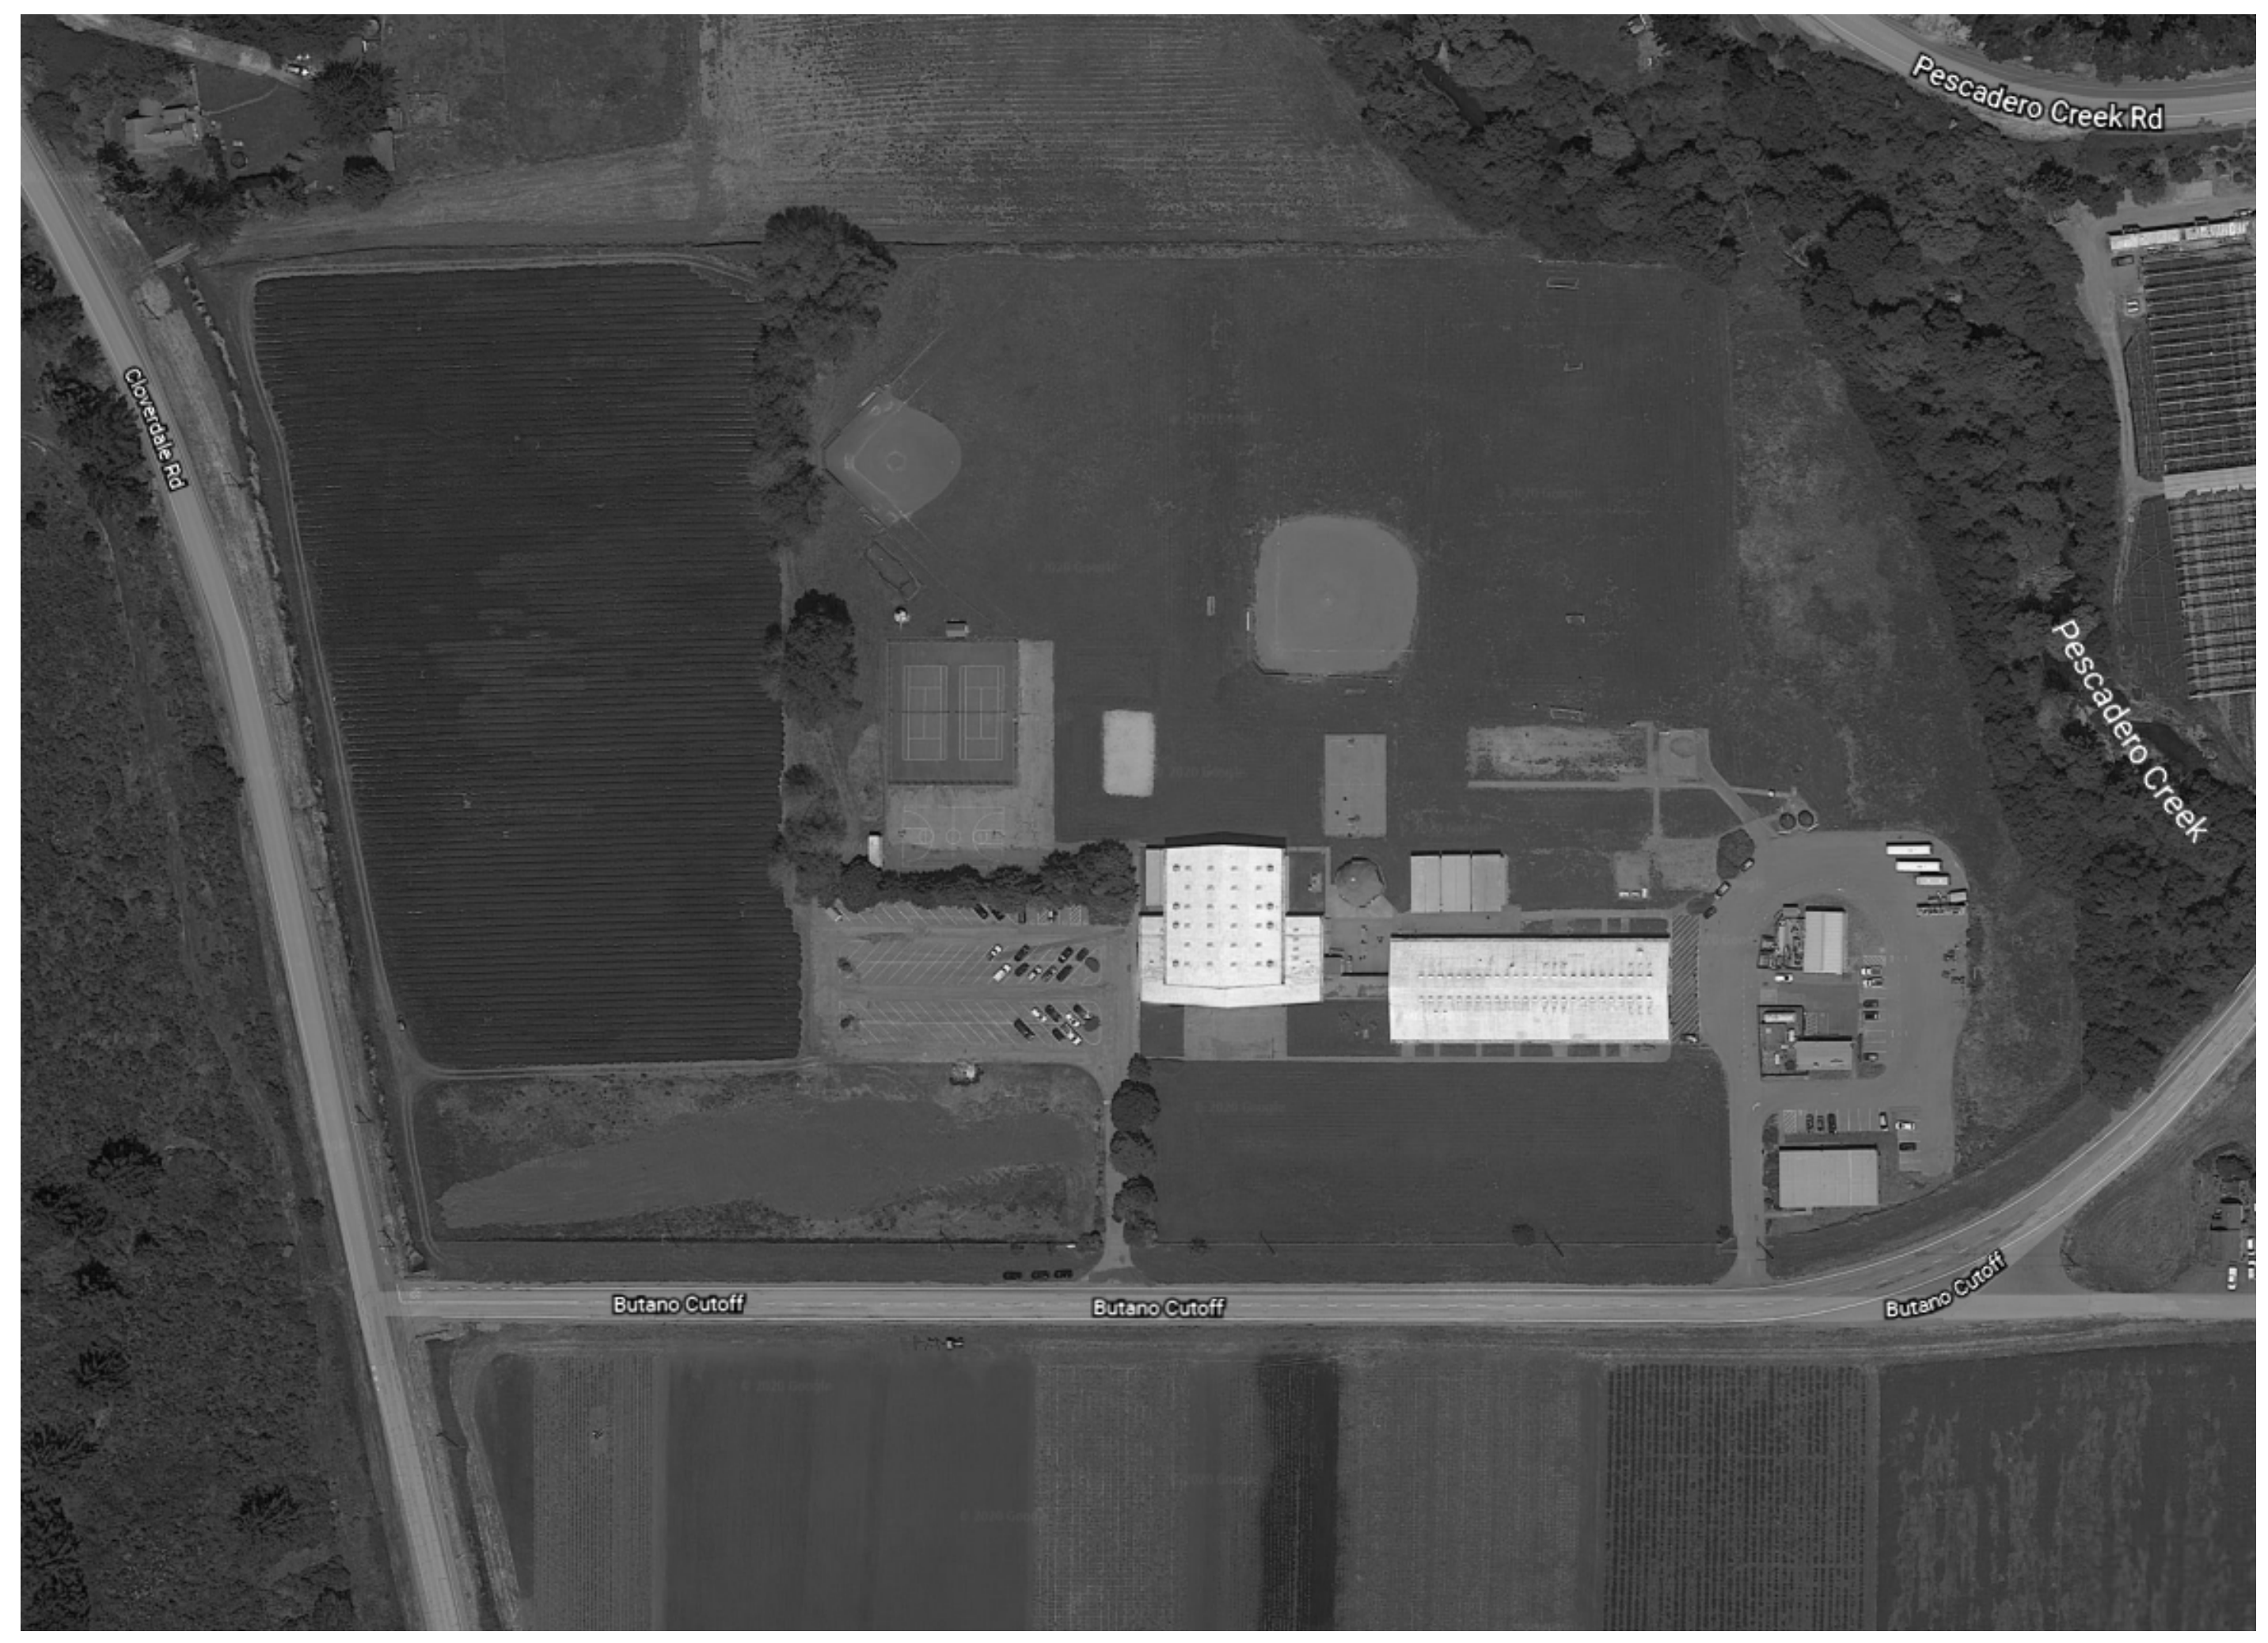
SCHEMATIC SITE PLAN

Existing La Honda High School Site

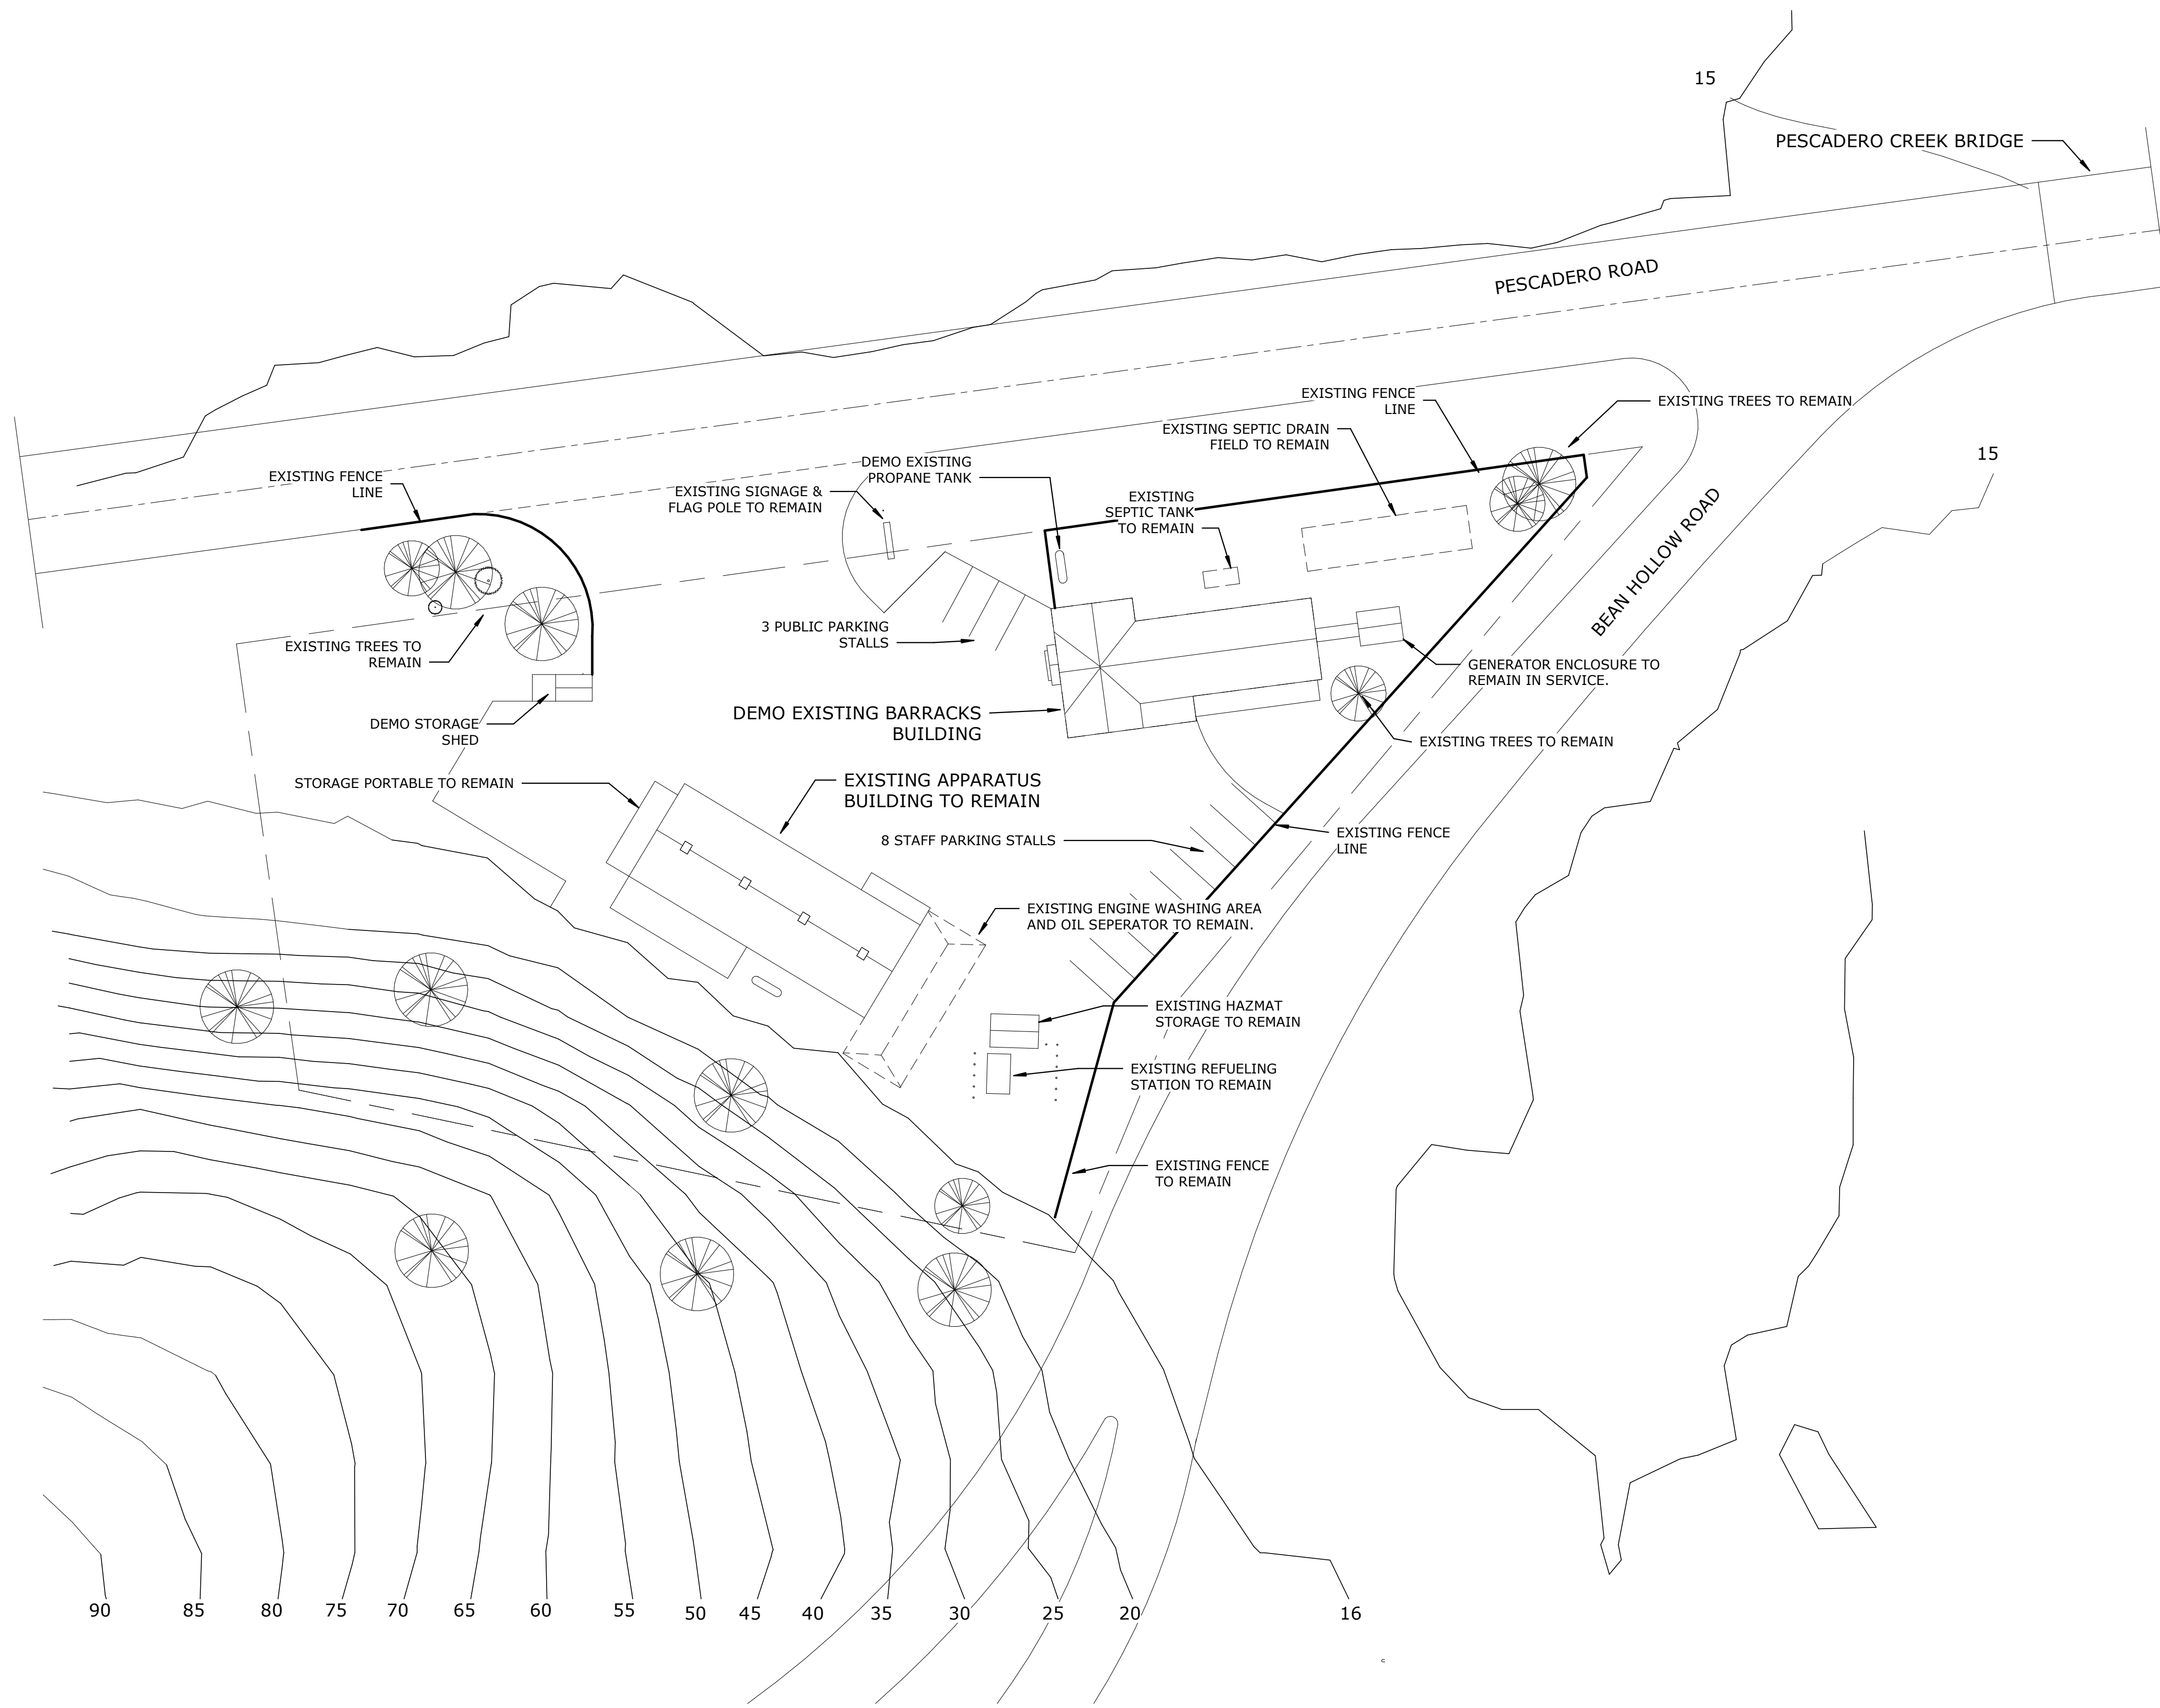
**EXISTING SITE PLAN - PARTIAL DEMO PLAN**

CUT:	
PAVEMENT SECTIONS	1,000 CU-YD
BIORETENTION BASINS	100 CU-YD
STRUCTURAL FOUNDATIONS	350 CU-YD
ROUGH GRADING	620 CU-YD
SANITARY SEWER DRAINFIELD	1,100 CU-YD
	3,170 CU-YD
FILL:	
ROUGH GRADING	570 CU-YD
	570 CU-YD
BALANCE:	
CUT	3,170 CU-YD
FILL	570 CU-YD
	2,600 CU-YD (CUT)

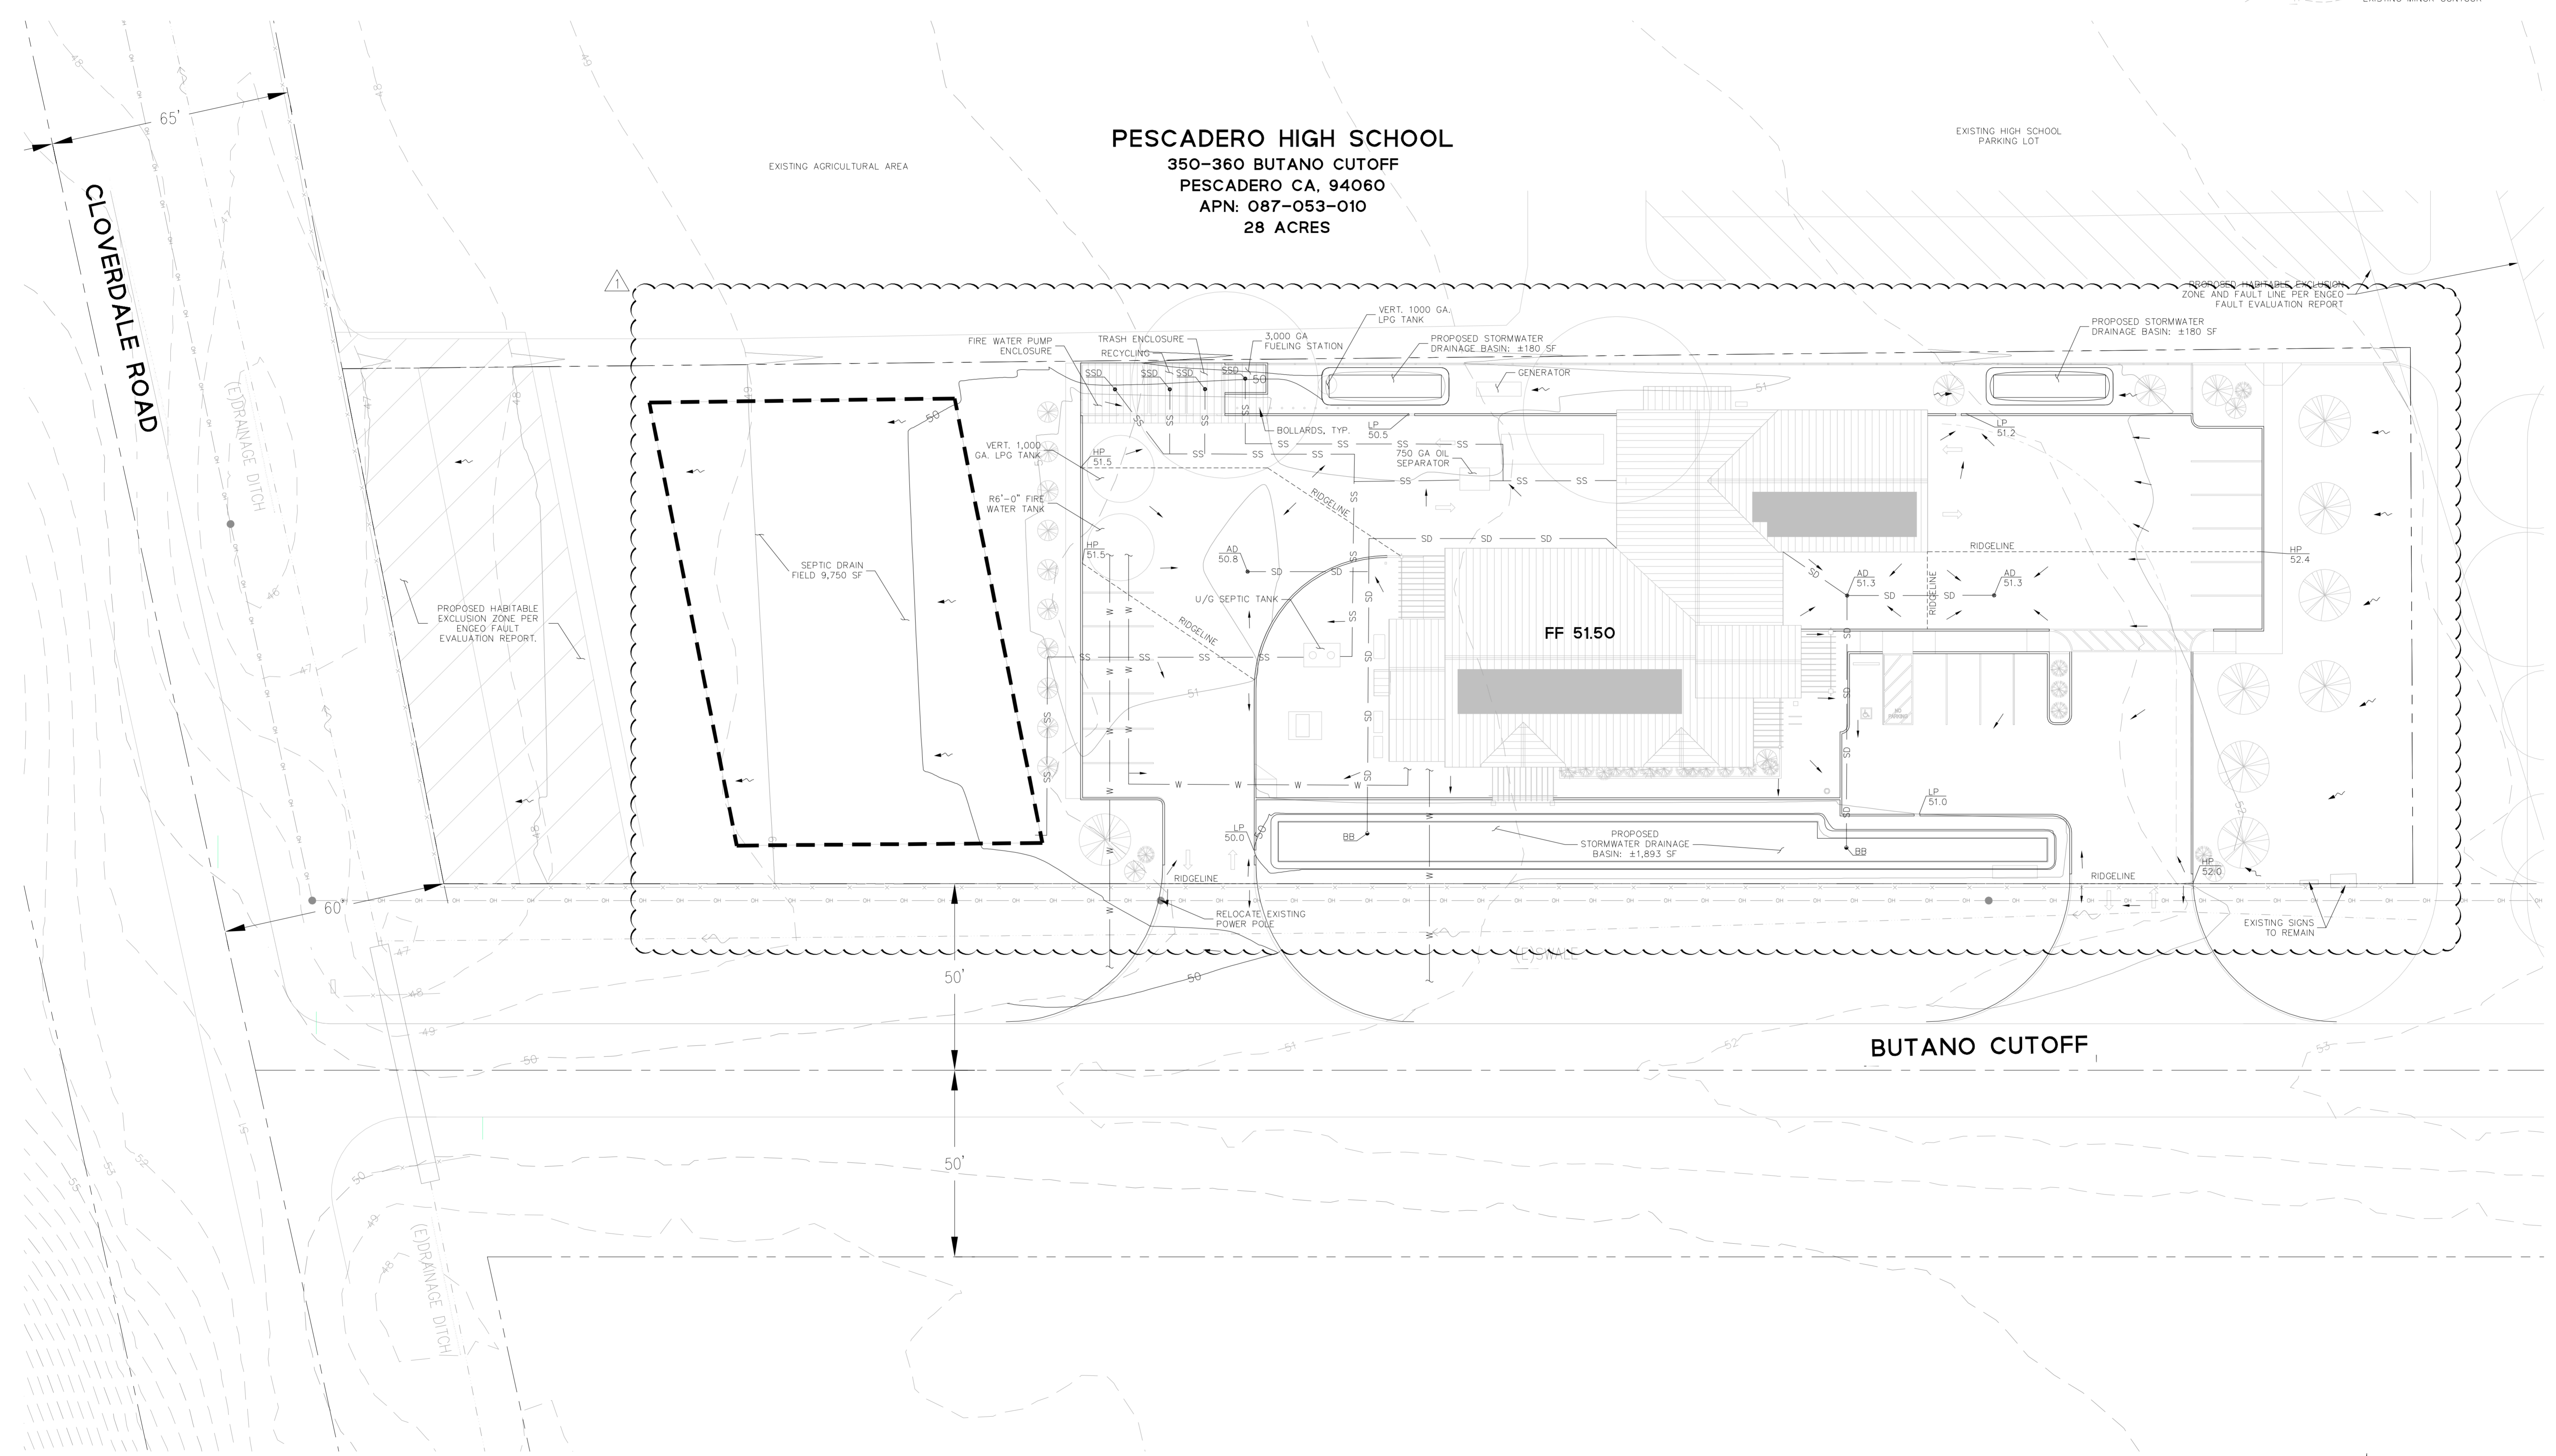
PRELIMINARY GRADING,  
DRAINAGE, AND UTILITY  
PLAN

- STORMWATER HAS BEEN SCHEMATICALLY SHOWN TO ADHERE TO THE SAN MATEO COUNTY DRAINAGE REQUIREMENTS. THIS PROJECT WILL BE SUBJECT TO THE BASIC DRAINAGE REVIEW FOR THE COUNTY PLANNING OR BUILDING PERMIT. THE CURRENT SITE SHOWS 33,781 SF OF IMPERVIOUS AREA, AND THE PROJECT WILL UTILIZE BIORETENTION RAIN GARDENS WITH INFILTRATION TO ADHERE TO TREATMENT REQUIREMENTS, AND THE PEAK FLOW AND VOLUME CONTROL DESIGN CRITERIA. THE SITE HAS BEEN SHOWN TO INFILTRATE AT A RATE OF 7.44 IN/HR.
- THE SANITARY SEWER DRAIN FIELD HAS BEEN SCHEMATICALLY SHOWN TO ACCOMMODATE 1,000 GAL/DAY, 77 GAL/DAY FOR 13 HABITANTS. THE DRAIN FIELD WILL A BE SHALLOW SEPTIC DRAIN FIELD.
- A CSA-11 WATER MAIN EXTENSION IS PLANNED TO PROVIDE SERVICE TO THE SITE AT BUTANO ROAD.
- POWER POLE LOCATIONS ARE APPROXIMATE. A GROUND TOPOGRAPHIC SURVEY IS REQUIRED TO VERIFY EXACT LOCATIONS.

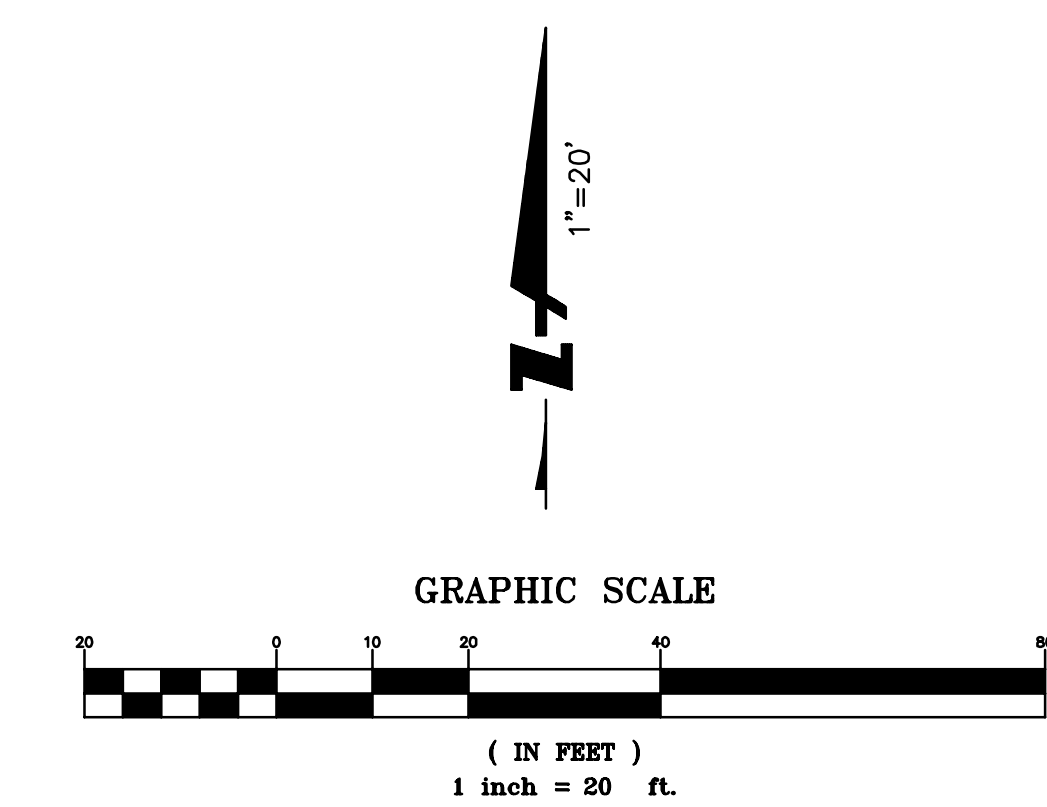
EXISTING CONDITIONS

1. THE BOUNDARY SHOWN IS DRAWN FROM RECORD INFORMATION. A FIELD SURVEY SHALL BE COMPLETED TO VERIFY THE SITE BOUNDARY.
2. 1 FT CONTOURS ARE SHOWN BASED ON USGS DATA.
3. EXISTING UTILITY INFORMATION IS SHOWN BASED ON VISIBLE FACILITIES ON AERIAL IMAGERY.

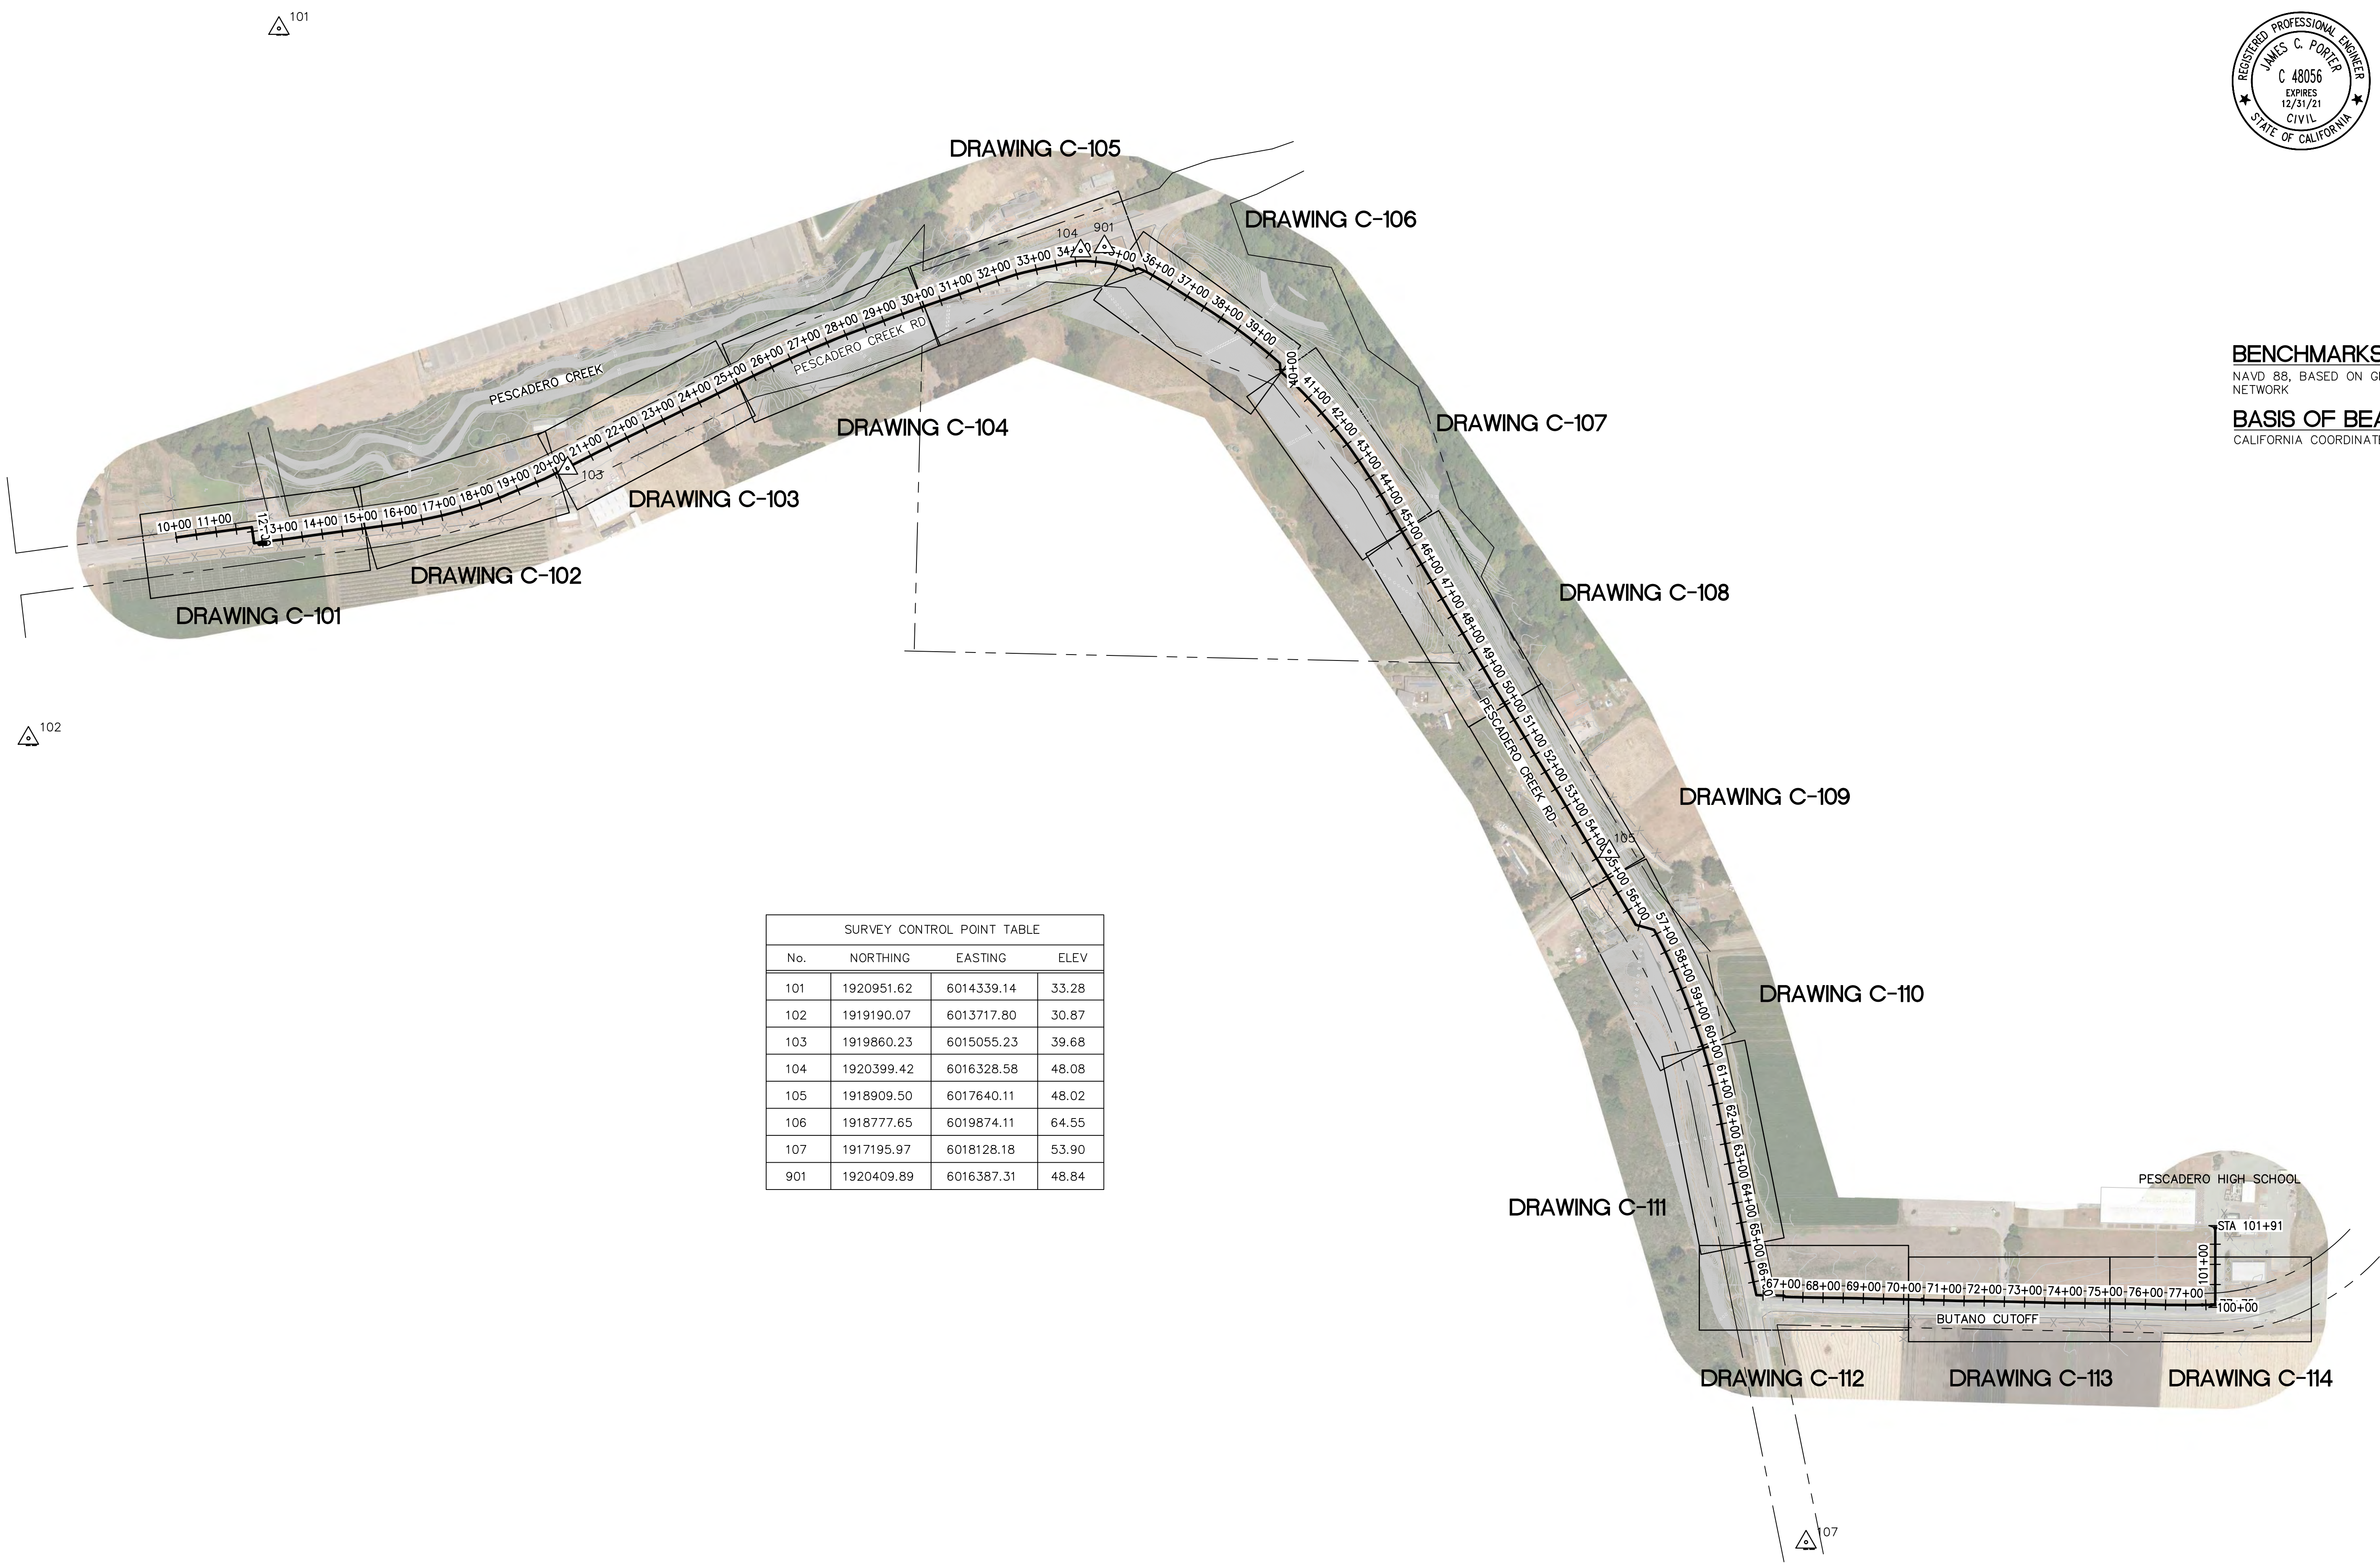
**BENCHMARKS:**  
 NAVD 88, BASED ON GPS OBSERVATIONS USING THE CSDS VSN NETWORK

**BASIS OF BEARINGS:**  
 CALIFORNIA COORDINATE SYSTEM NAD83, ZONE 3

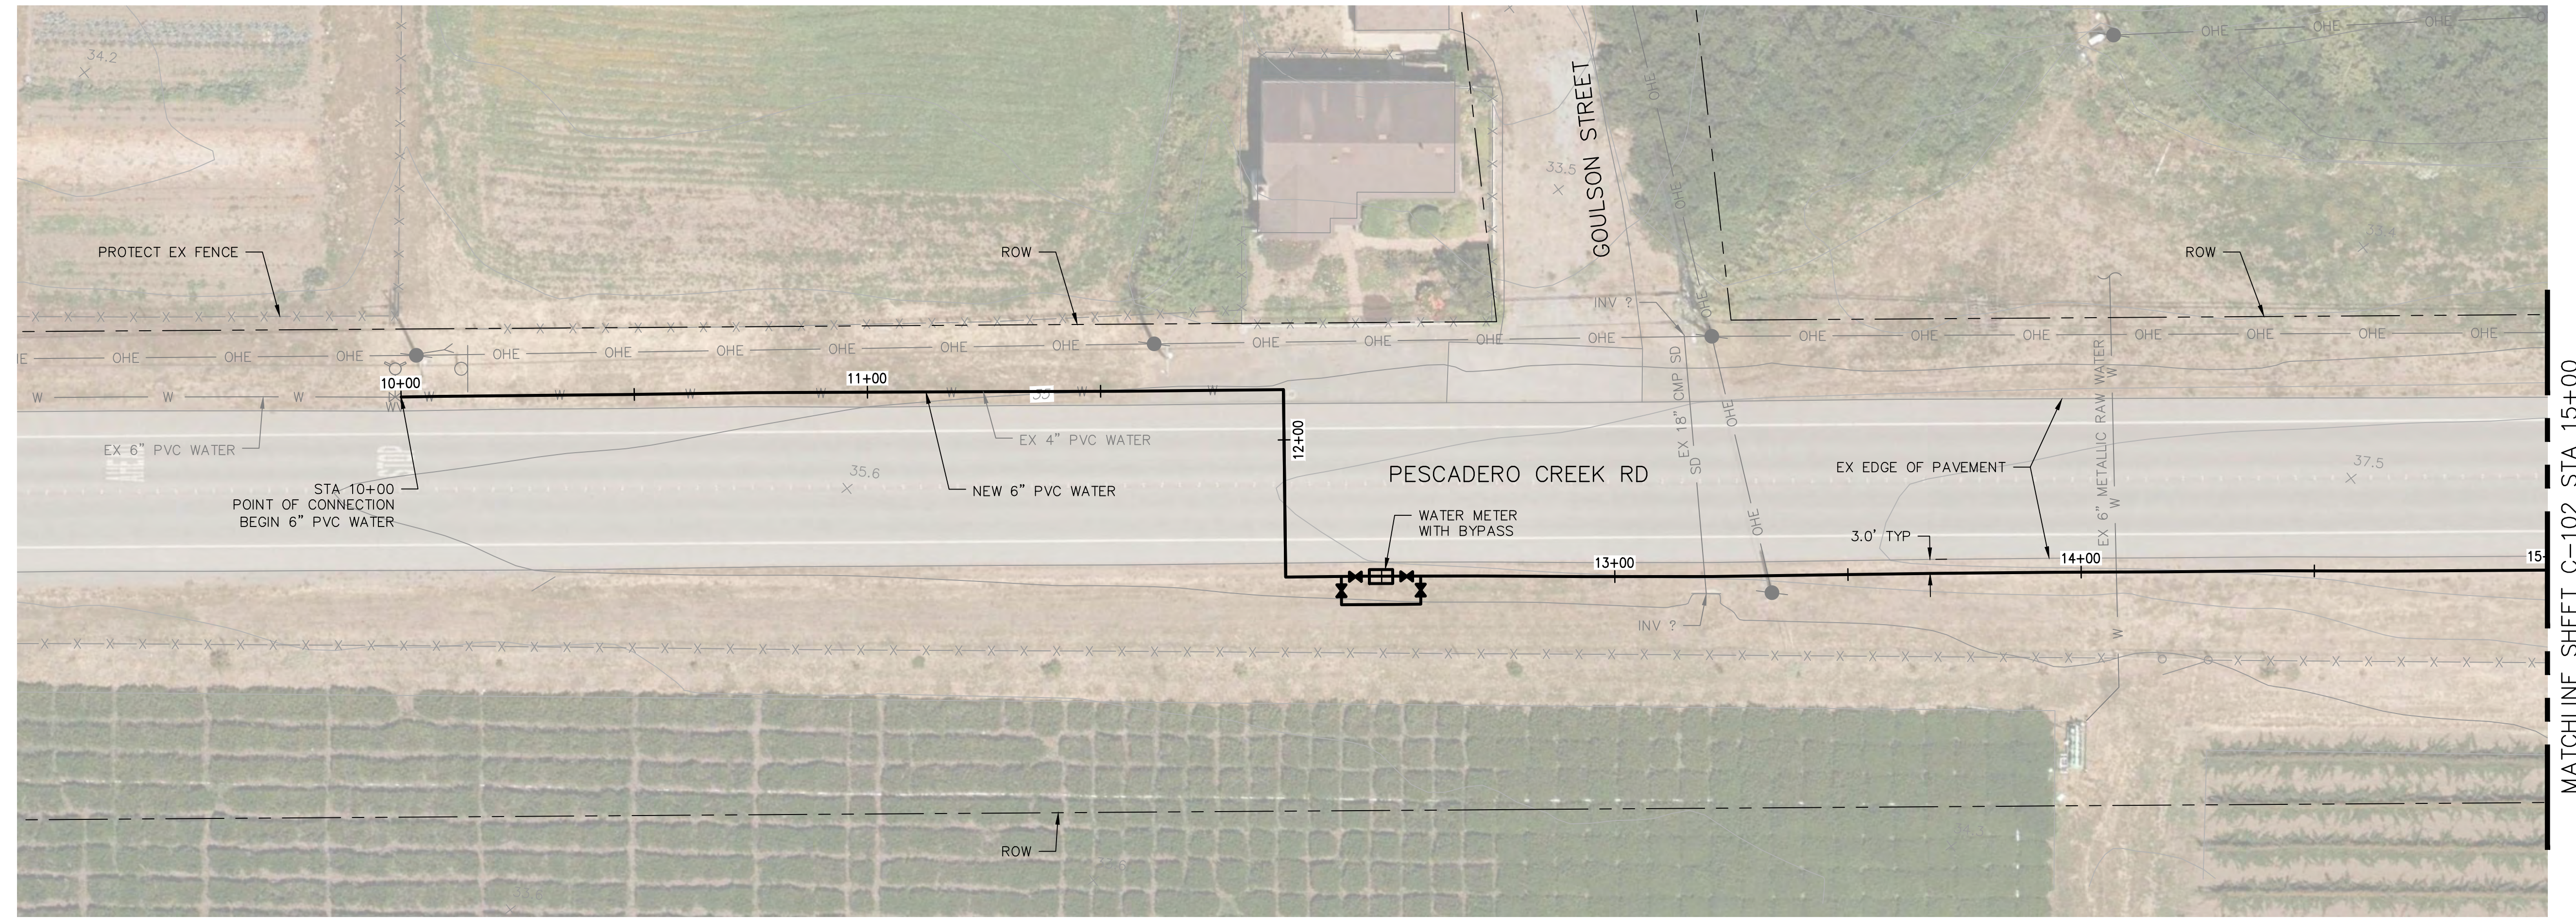
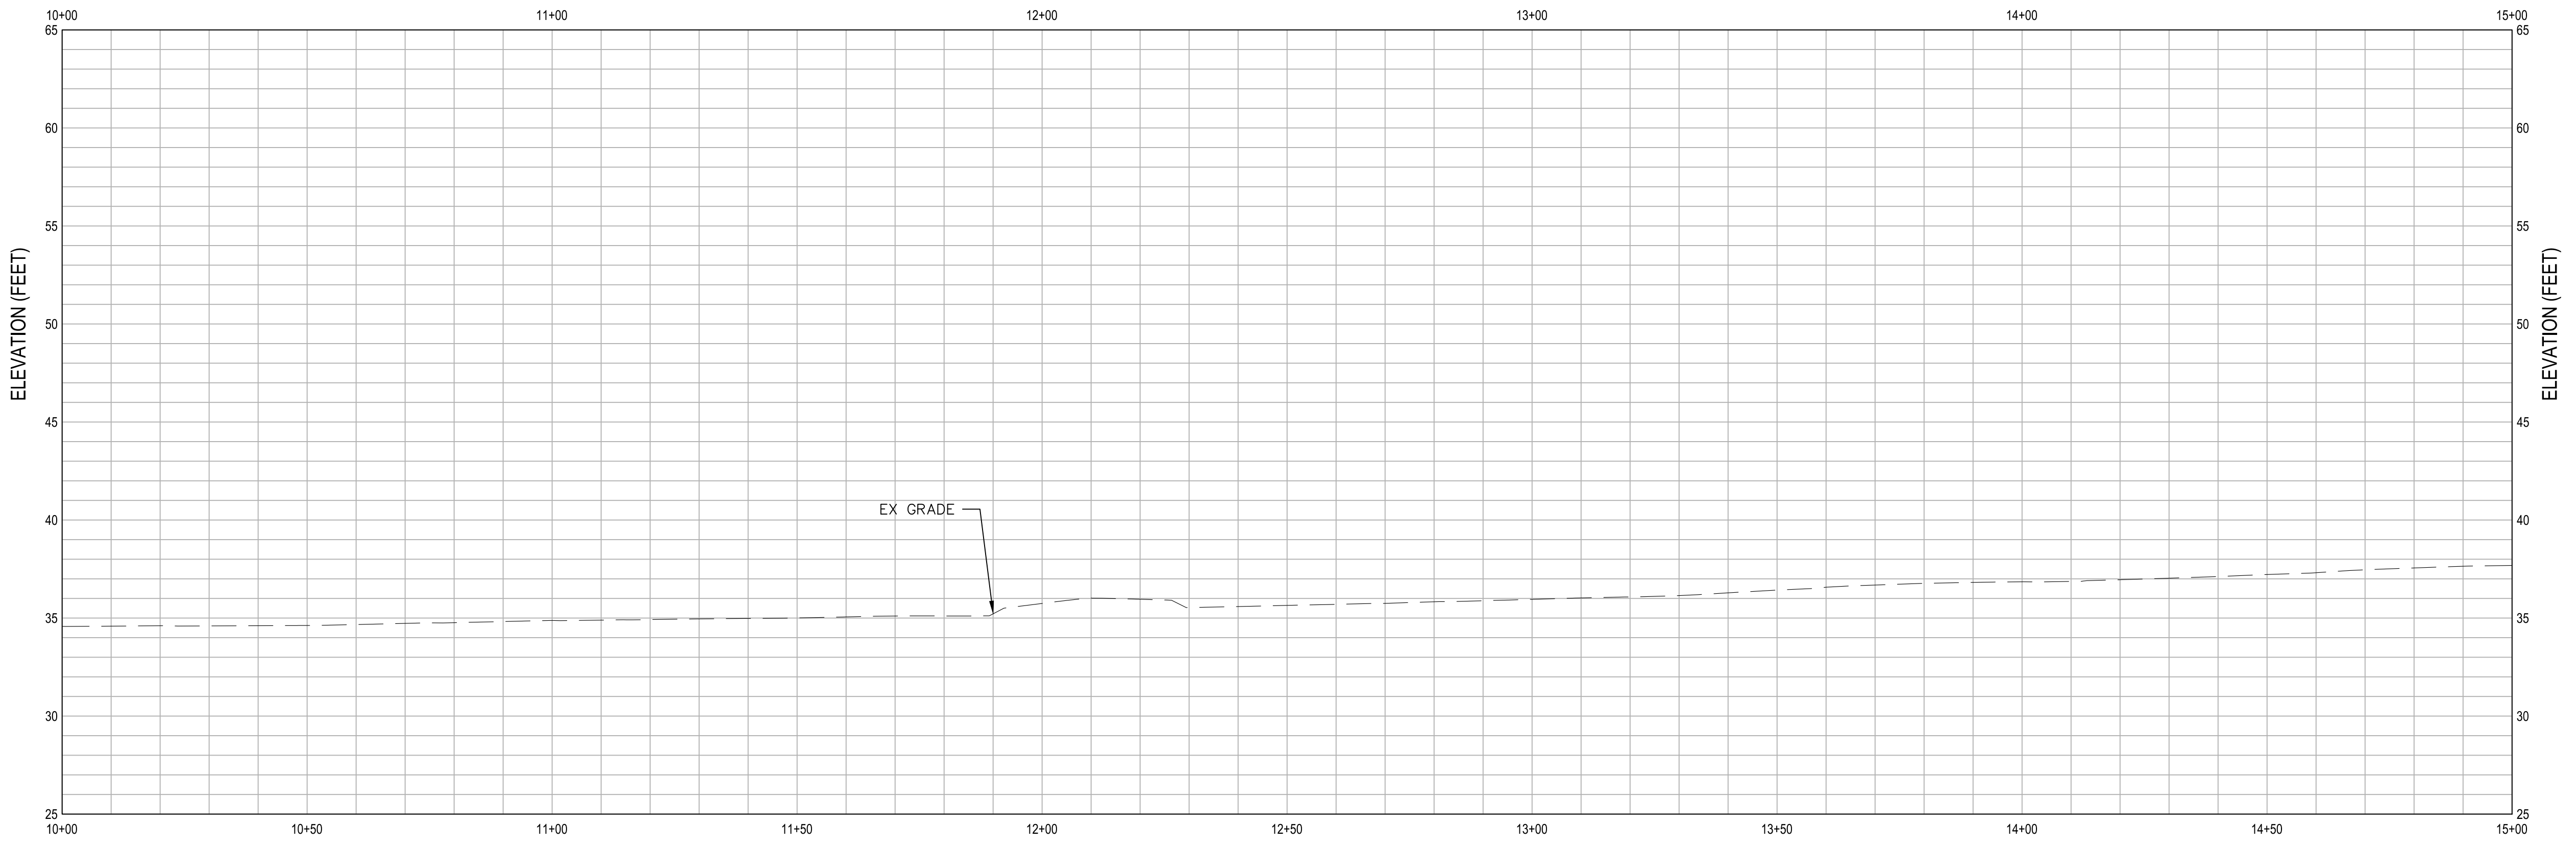
PLAN  
 SCALE 1"=20'

PROFILE  
 SCALE 1"=20' HZ, 1"=5' VT
