## Item 12

**SUBJECT:** Consideration of Local Coastal Program amendment to facilitate future construction of a replacement fire station (County Fire Station Number 59) and extension of CSA-11 to serve the fire station and Pescadero Middle/High School located at 350-360 Butano Cut Off. Both projects are located in the Pescadero area of the unincorporated San Mateo County.

County File Number: PLN 2021-00056 (County of San Mateo)

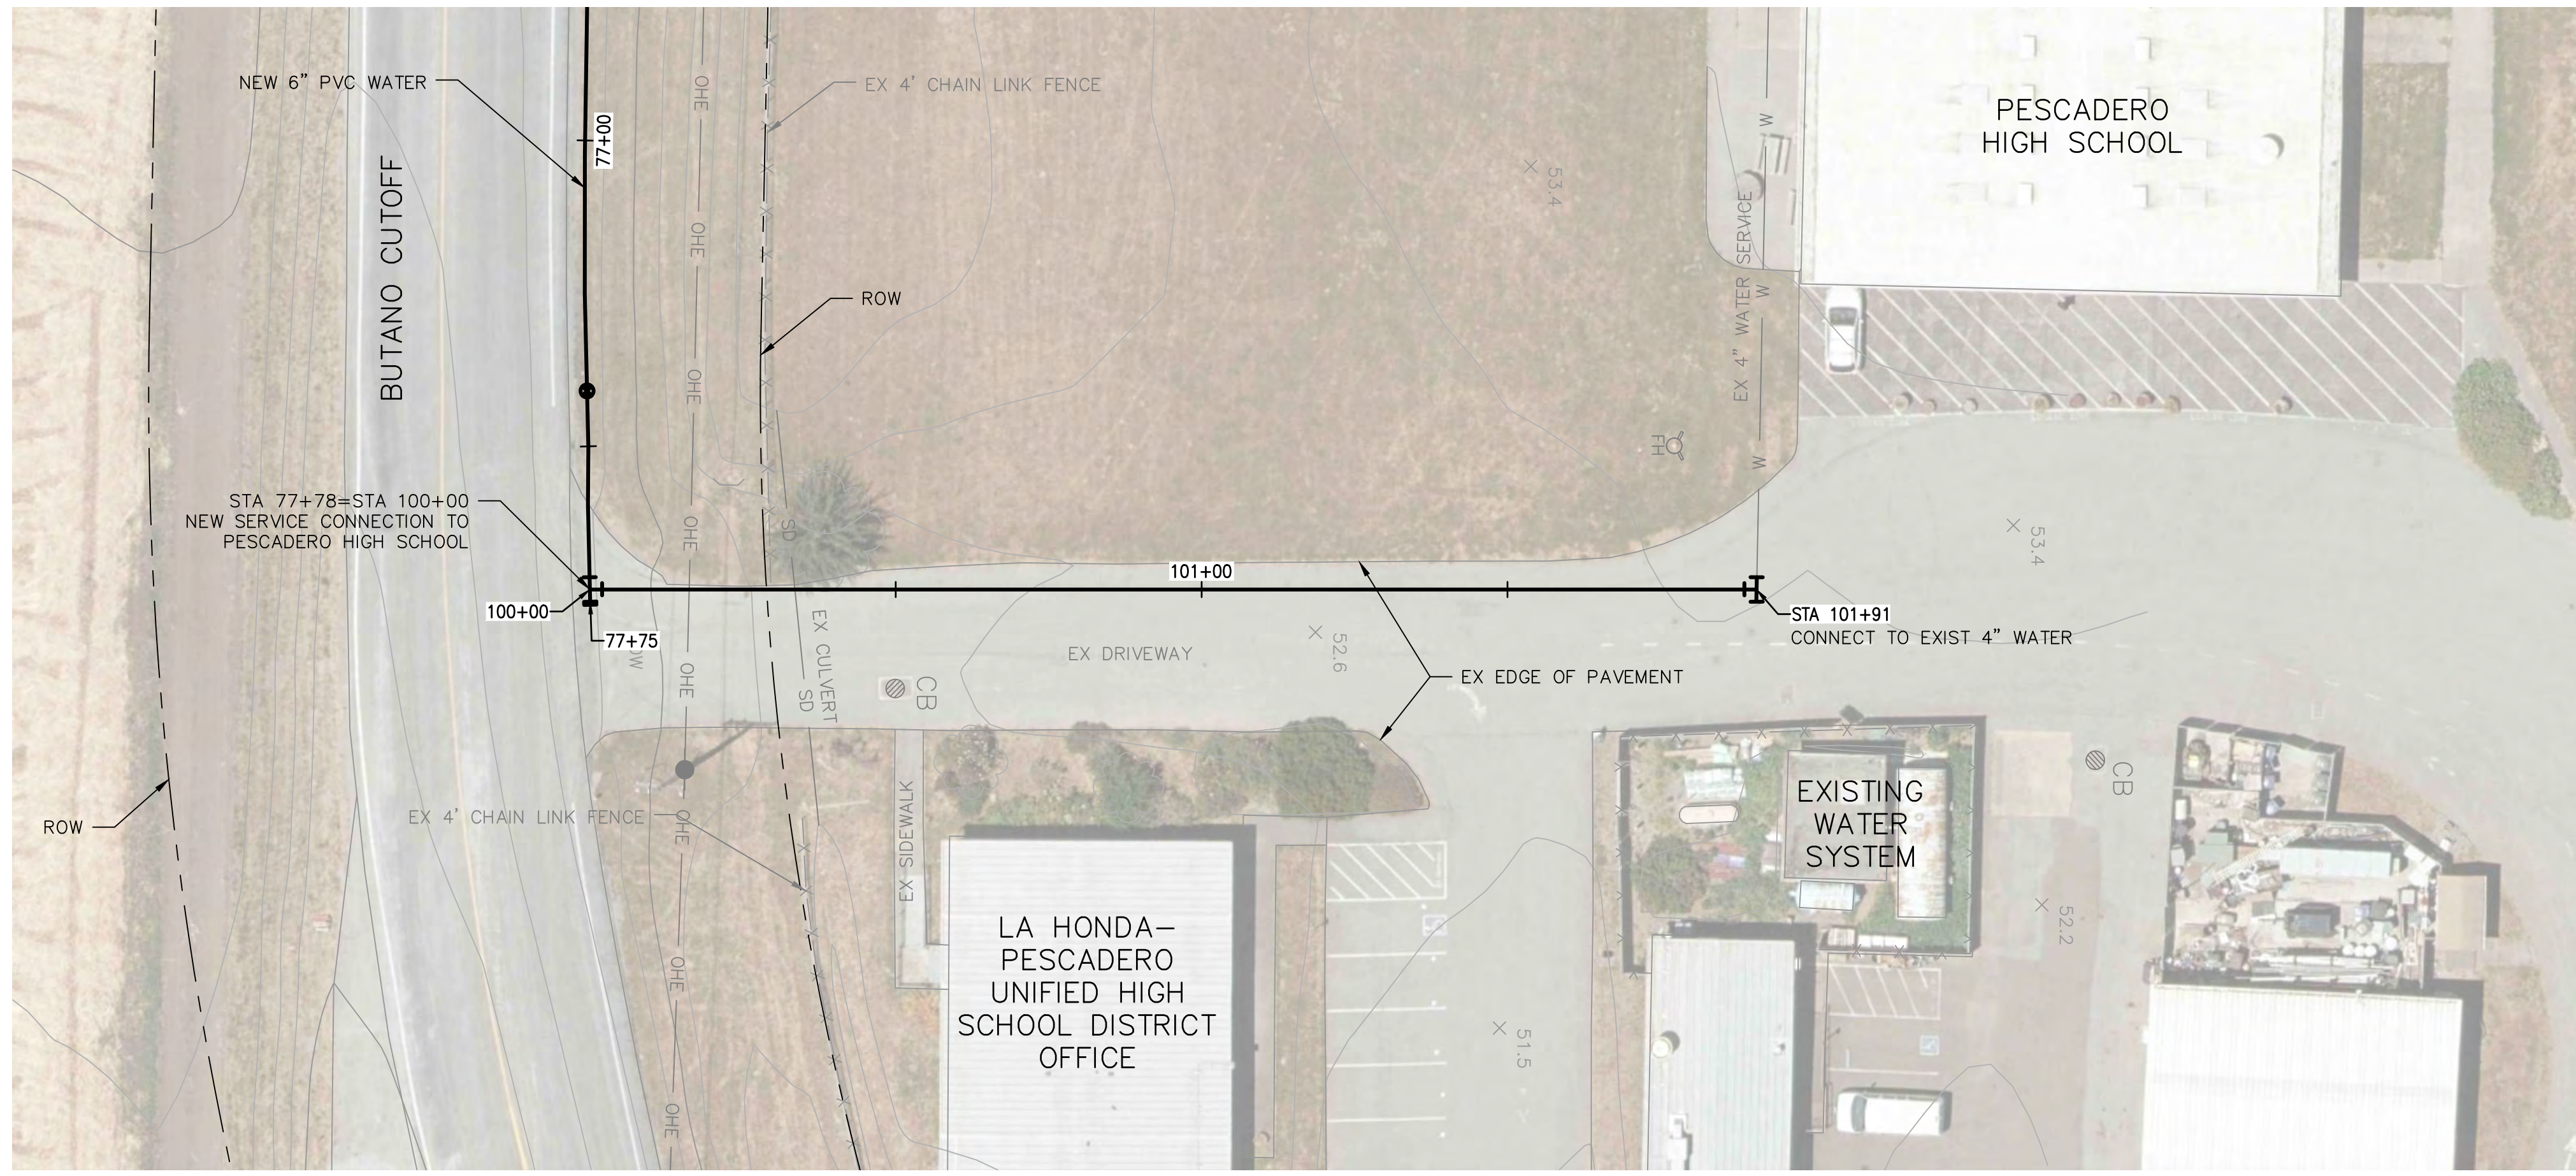
PLAN  
SCALE 1"=20'

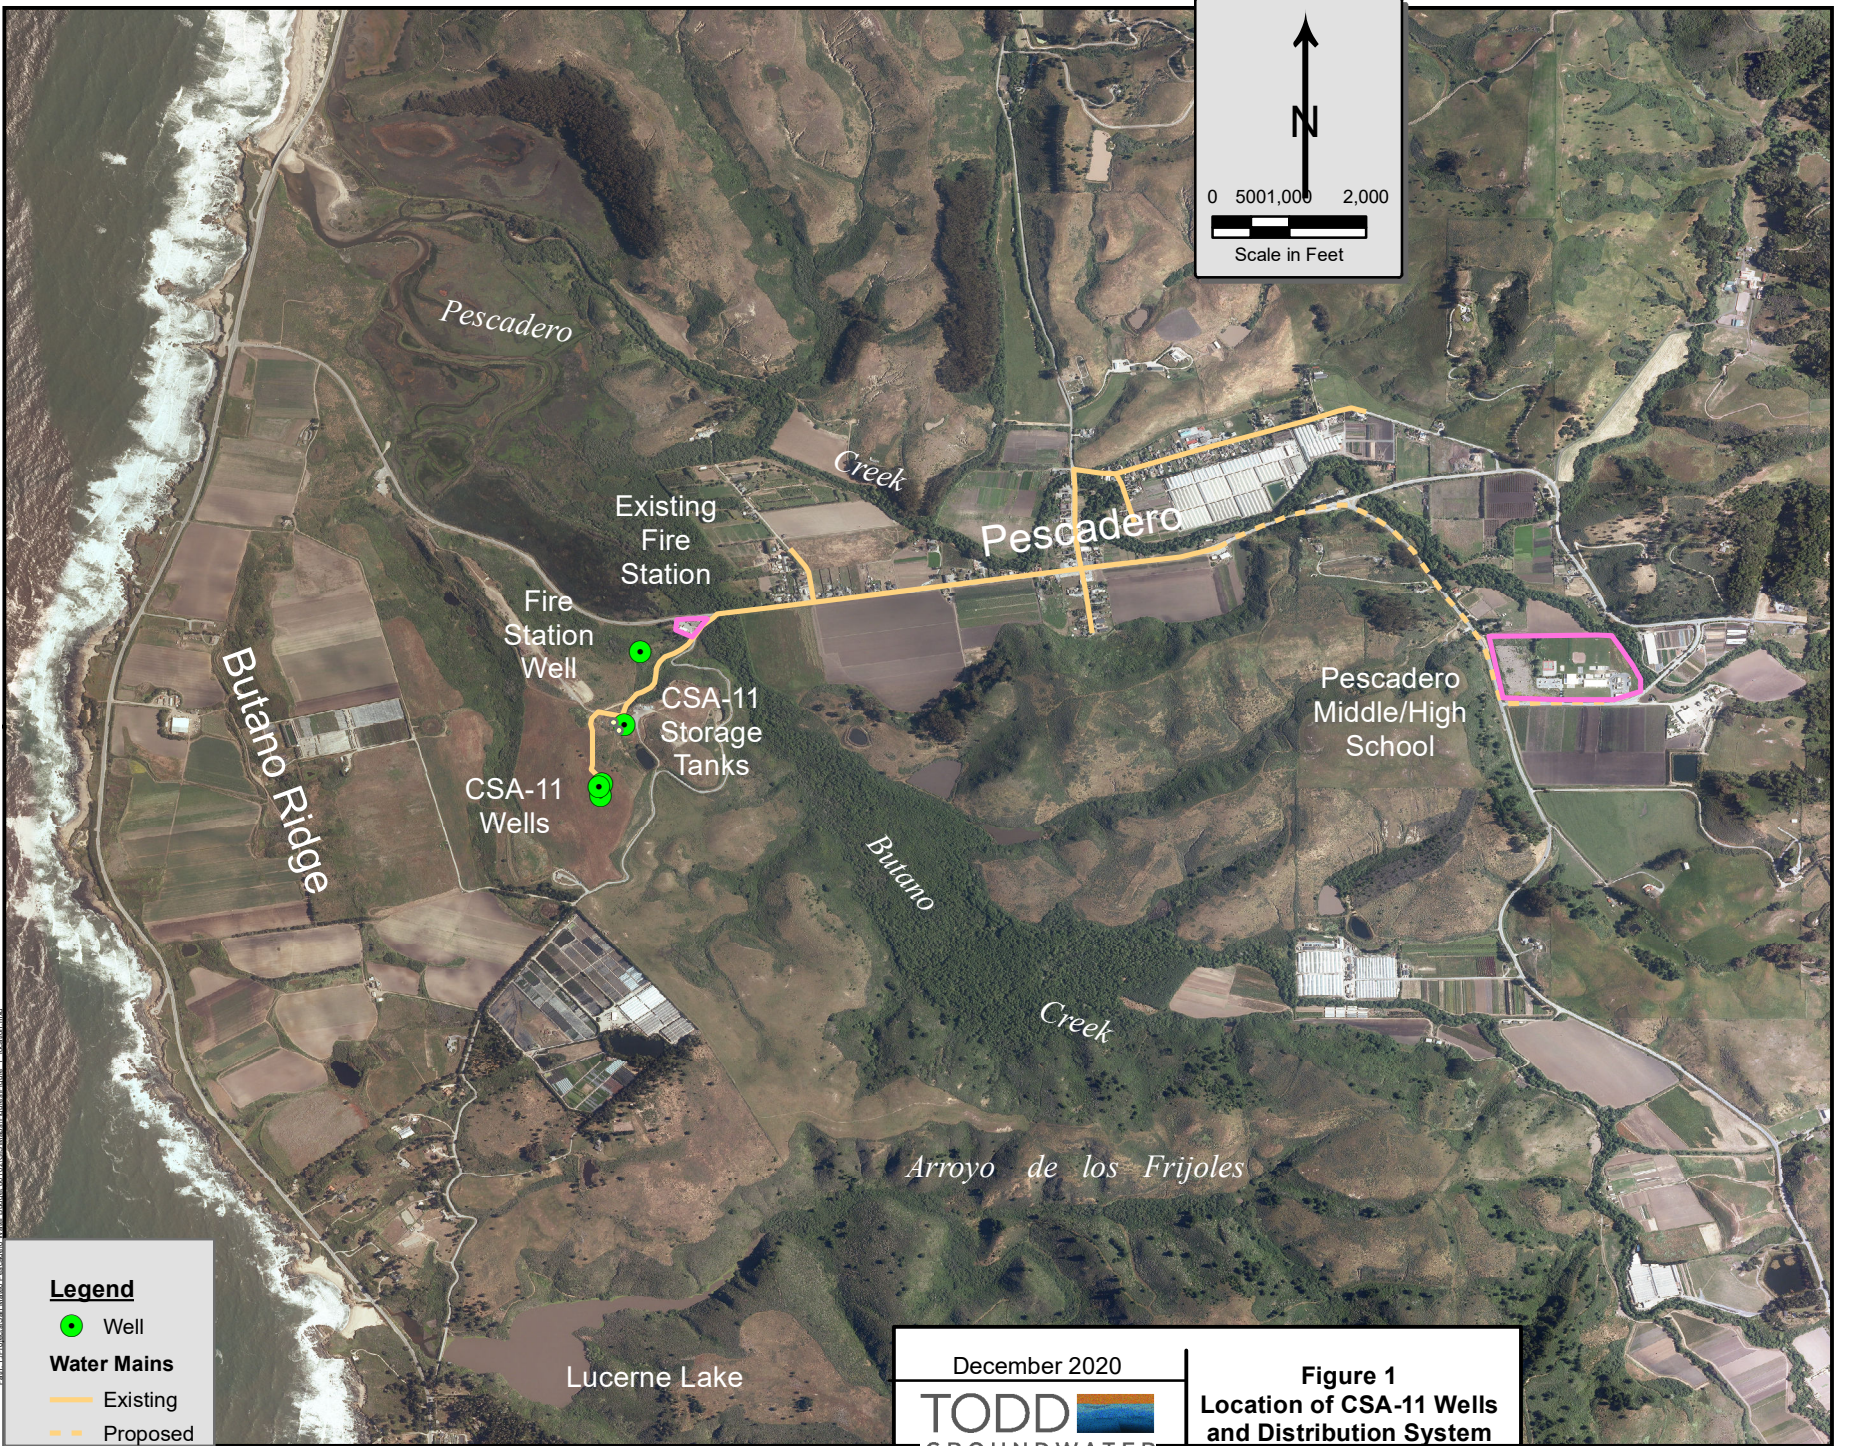
December 2020	
<b>Figure 1</b>	
<b>Location of CSA-11 Wells and Distribution System</b>

San Mateo County Service Area 11 (CSA-11) provides municipal water service to the community of Pescadero and has had capacity issues for many years. Pescadero is a small town (population 643 in 2010) on the San Mateo County (County) coast, 14 miles south of Half Moon Bay (**Figure 1**). Since 1992, the municipal water supply has been from wells located on Butano Ridge, a fault-bounded hill between the town and the Pacific Ocean. Water levels in the two original supply wells (Well No. 1 and Well No. 2) steadily declined from 1992 to the present. In 2018, a third well screened at greater depth (Well No. 3) was constructed, which will extend the useful life of the well field but not change the local water balance of the groundwater system.

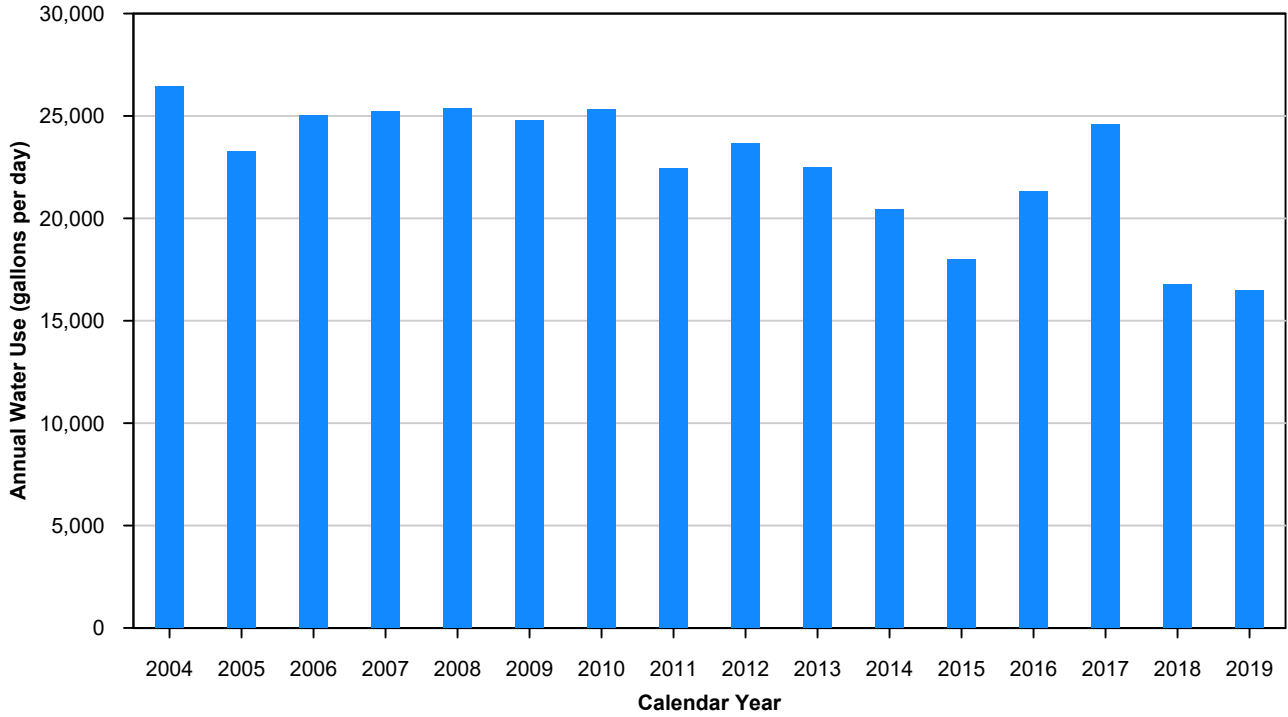
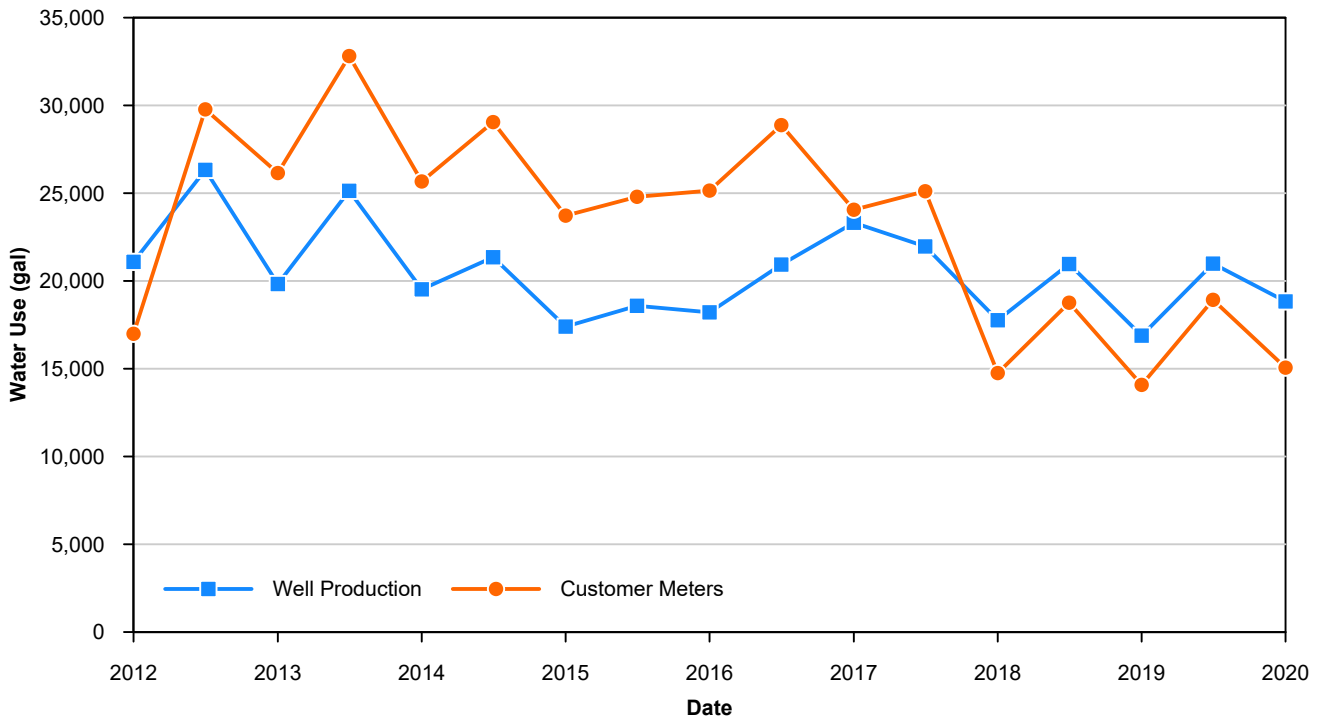
**Figure 2**  
**Well Production and**  
**Metered Customer Use**

Water production and delivery are both metered in CSA-11. Production is metered at each well for Well Nos. 1 through 3. Water use is also metered at the turnout to each customer. Meters are currently read on a bimonthly schedule. **Figure 2** shows A. metered water use for 2004-2019 and B. semiannual well production and metered customer consumption for 2012-2019. As shown in the lower graph, well production was consistently less than the sum of the customer meter readings until 2016, when the meter on Well No. 1 was replaced. Since then, the two data sets have matched more closely. The sum of the customer meters has generally been about 20 percent lower than the metered well production since then. Water meters tend to under-record as they age, which could be causing some of the recent

discrepancy. Leaks or unmetered uses in the distribution system could also contribute to the discrepancy. In any case, the obvious effect of changing the well meter in 2016 underscores the fact that even metered water use data are subject to uncertainty.

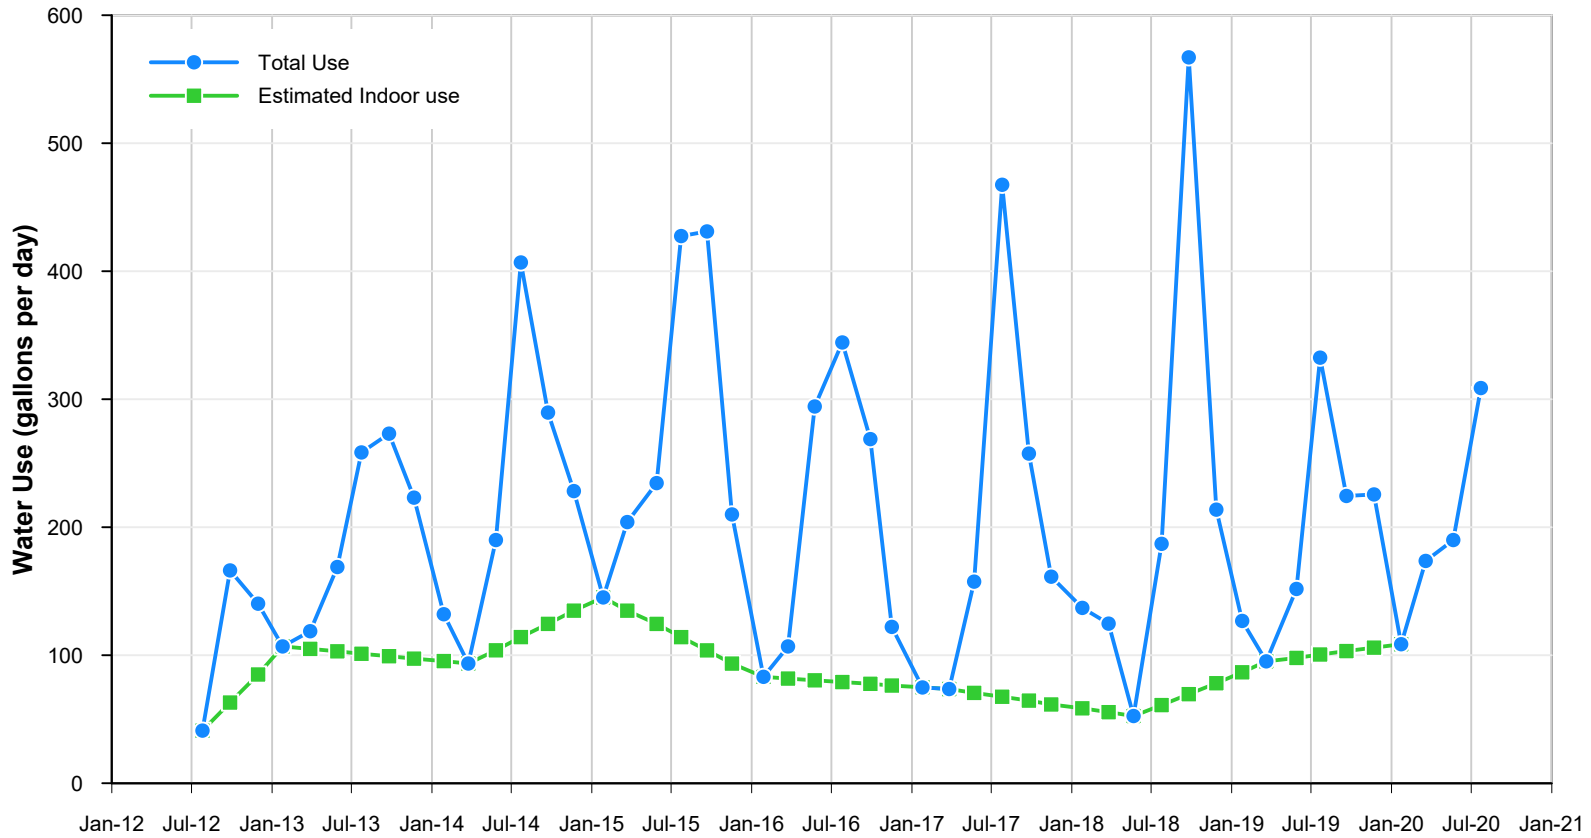
Figure 3  
Customer Account with  
Suspected Irrigation Use

Of the 101 active customer accounts, 36 had average usage exceeding 180 gallons per day (gpd). Usage at those accounts was reviewed individually, and 11 of them were found to have an irrigation pattern. The presence of irrigated landscaping was confirmed at most of those accounts during a site visit on September 18, 2020. The amount of irrigation use was estimated using the curve separation technique, which assumes that water use during the minimum-use month of the year is all indoor use and that additional use in other months is for irrigation. By interpolating between these seasonal low points over the entire hydrograph period, indoor use (below the green line in **Figure 3**) was separated from irrigation use (above the line). By this method, average annual irrigation use during 2015-2019 by the 11 accounts with an irrigation pattern amounted to 1,516 gpd, or 8 percent of total water use by all accounts.

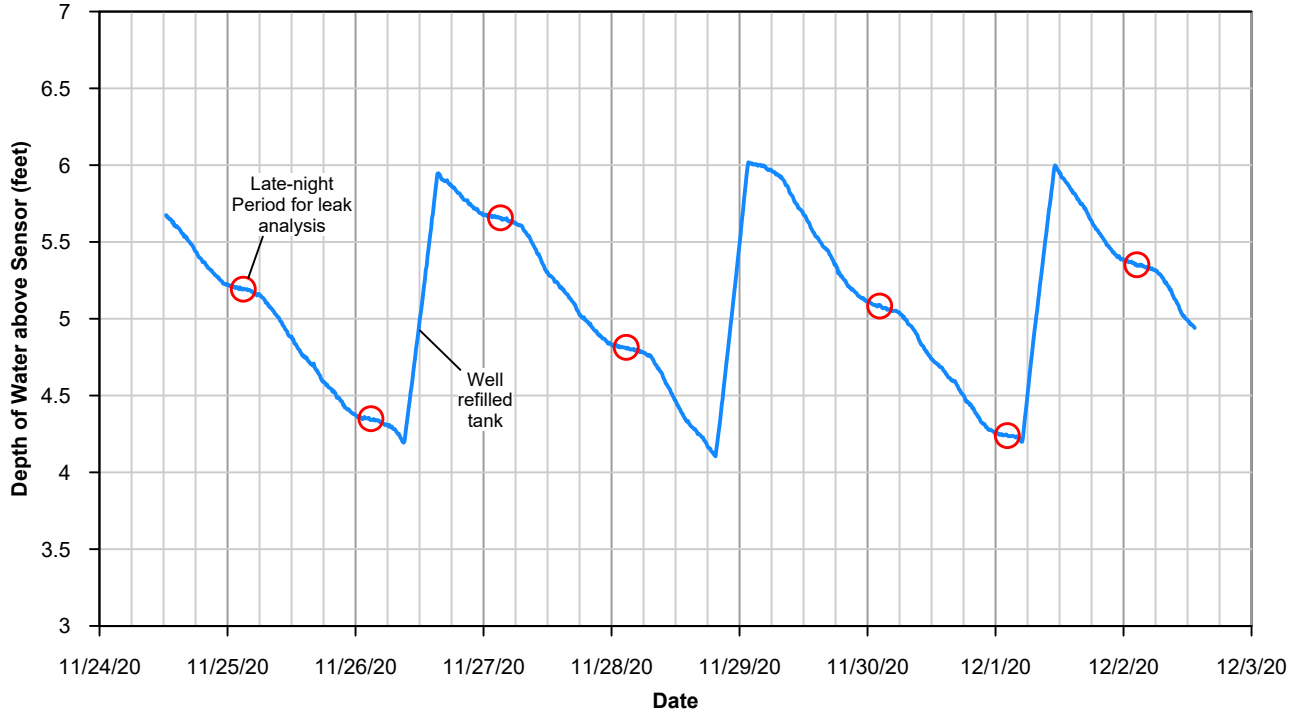
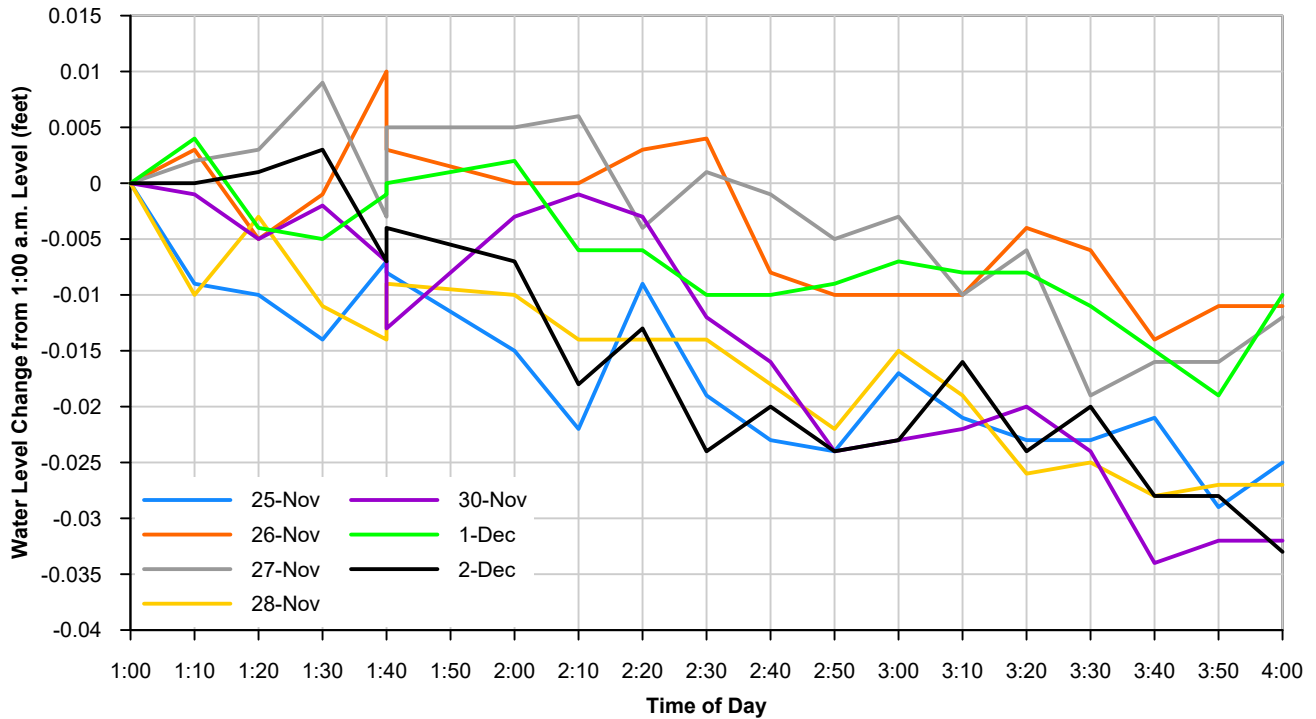
Customer meters and inflow from the storage tanks to the distribution system were both investigated for signs of leakage from the water distribution system. The customer meters are equipped each with a highly sensitive spinner dial capable of detecting small flows, typically down to approximately 0.1 gallon per minute (Pietrosanto and others, 2020). Slow rotation of the spinner dial indicates a possible leak. During the September 18, 2020 site visit, thirty meters were read around the middle of the day. The spinner dial on all of them came to a complete stop while being observed, even ones that initially had some movement. Therefore, none of those accounts appeared to have a plumbing leak downstream of the meter.

### A. Water Level in Storage Tanks

### B. Storage Tank Late-Night Water-Level Decline

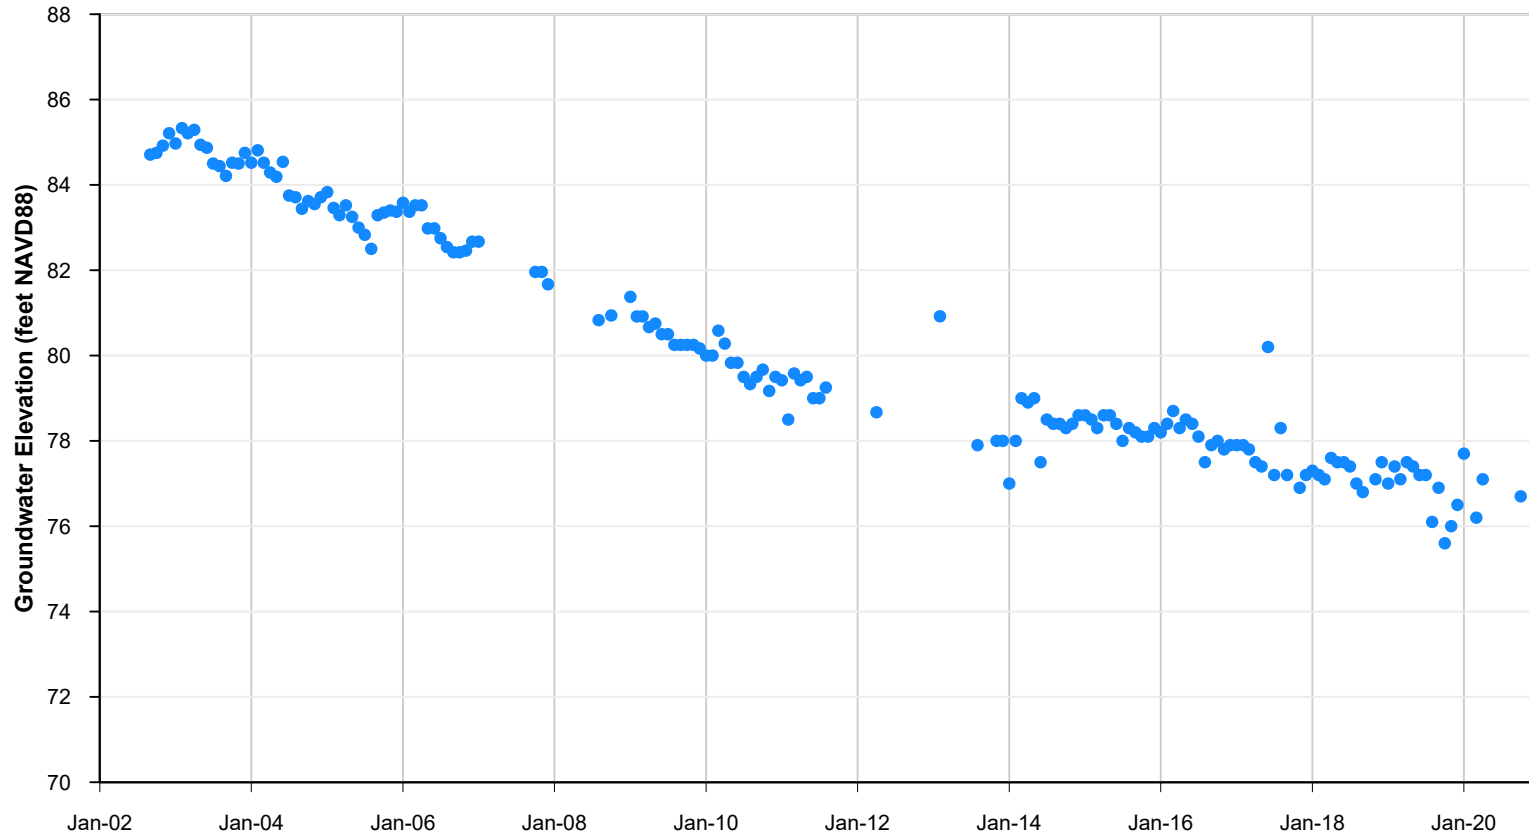
**Figure 6**  
**Well No.1**  
**Water Levels**  
**2002-2020**

Water levels at CSA-11 Well No. 1 continue to decline, as they have since 1992 when the first CSA-11 well began operating. Measured water levels since 2002 are shown in **Figure 6**. The hydrograph includes three intervals of relatively steady rates of decline: -0.74 feet per year (ft/yr) during 2002-2011, -0.10 ft/yr during 2012-2014, and -0.5 ft/yr during 2015-2019. The smaller rate of decline during 2012-2014 drought could have been caused by drought-related water conservation efforts and decreased pumping.

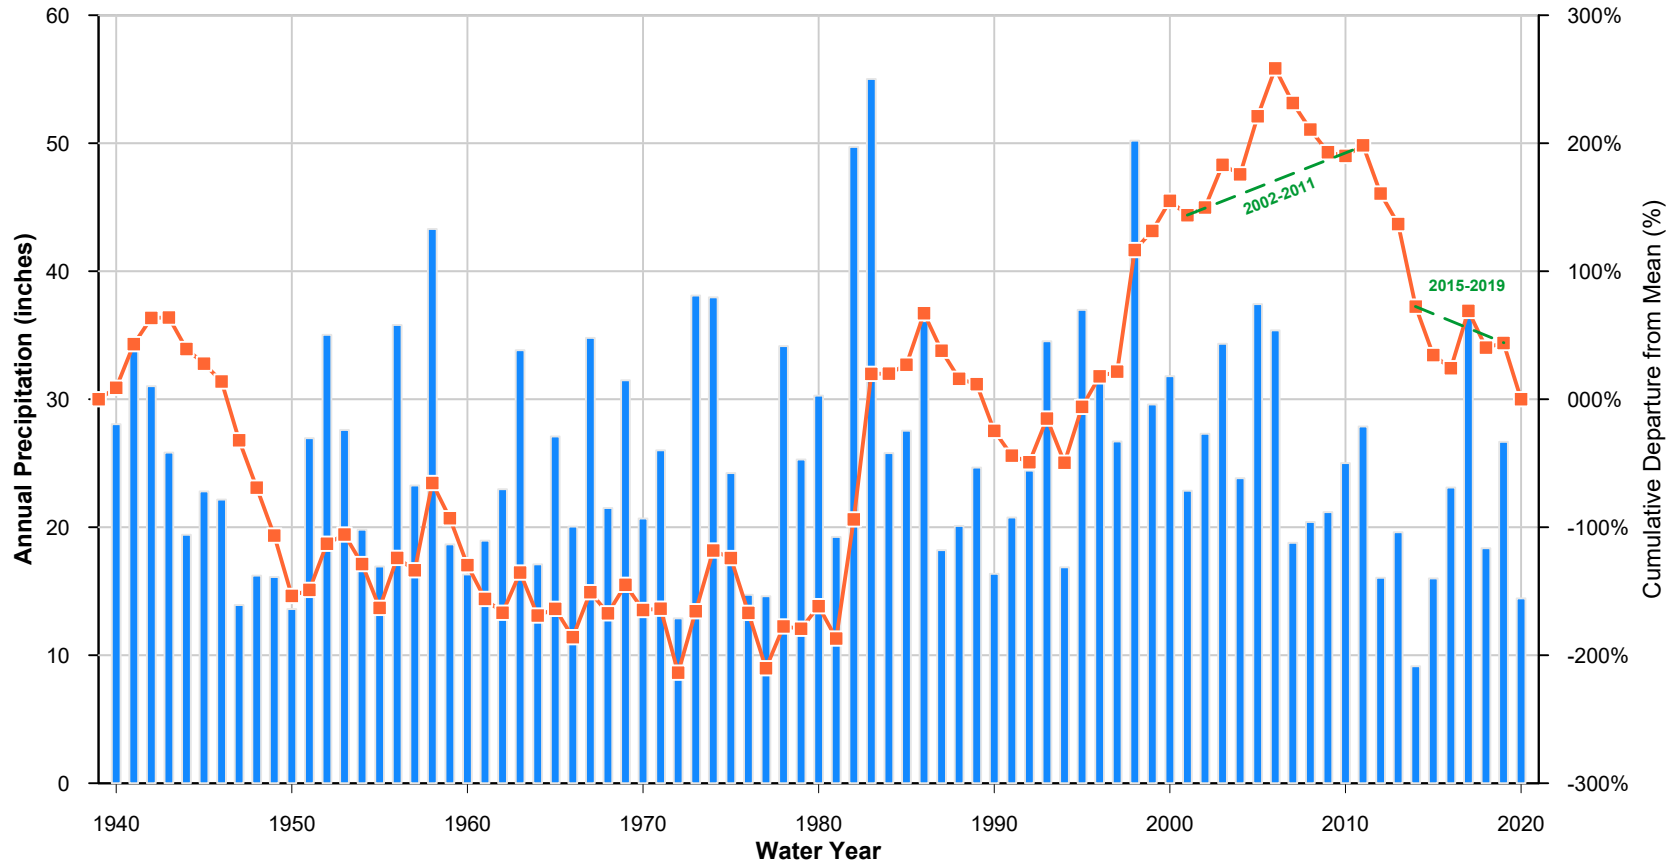
**Figure 7**  
**Cumulative Departure of Annual Precipitation**

It is less likely that the change in rate of decline was caused by changes in recharge. Recharge on Butano Ridge is from rainfall and irrigation return flow. The latter does not vary much from year to year, whereas rainfall recharge is highly variable. The cumulative departure of annual precipitation in Half Moon Bay during 1940-2020—which is shown in **Figure 7**—indicates that 2015-2019 was slightly drier overall than 2002-2011: 94 percent versus 105 percent of the long-term average. The 2012-2014 period was much drier than the other two periods (58 percent of long-term average precipitation). Based on rainfall, recharge was probably lowest during 2012-2014 and greatest during 2002-2011. If water levels reflected current recharge, one would expect the rate of water-level decline to be greatest during 2012-2014 and lowest during 2002-2011, but that was opposite of the observed pattern. The reason is probably that water levels do not respond rapidly to variations in recharge at the ground surface. Annual variations in recharge are attenuated by flow through the thick unsaturated zone (approximately 200 feet in the area of the CSA-11 wells) and through fractures between the water table and the well screen depth. As a result, recharge arrives at the screened interval at a relatively steady rate, consistent with the steady rate of decline in measured water levels.

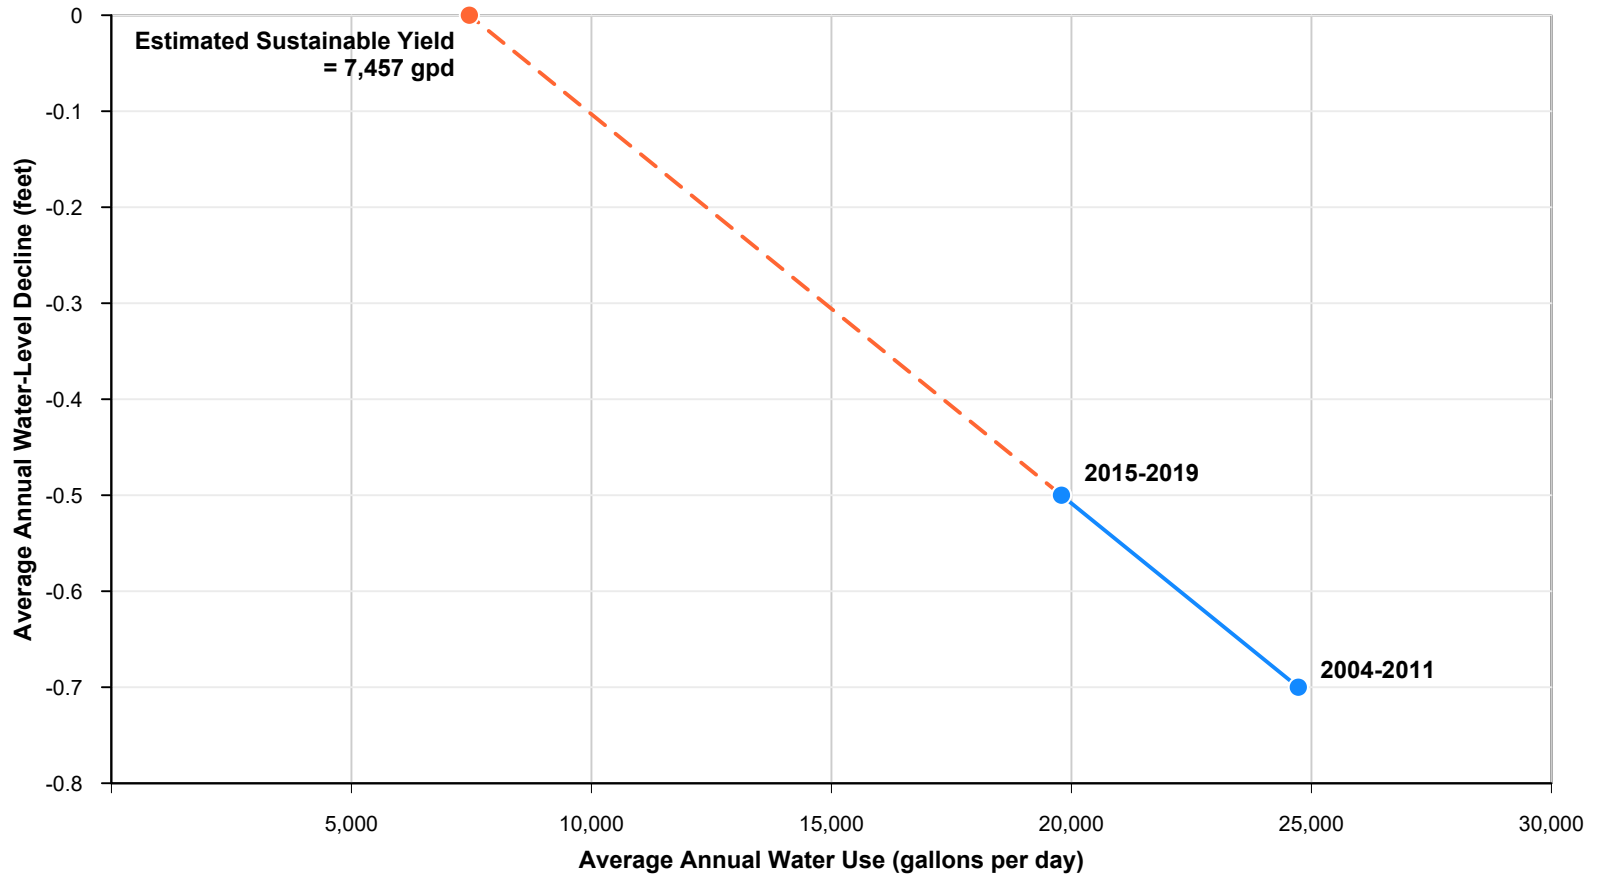
**Figure 8**  
**First Estimate of Sustainable Yield**

The relationship between annual pumping and annual change in water level can theoretically be used to estimate the sustainable yield, which is the amount of pumping associated with zero change in water level. Three methods were tested to apply this concept, none with accurate results. The first method was to create a scatterplot of annual net water-level change versus annual pumping. When tested with the Pescadero data set, the points were too scattered to infer a linear relationship between the variables and thereby calculate the sustainable yield. A variation of this approach was tried in which the data were averaged over longer time periods. This reduced the data to two points: average water use and water-level decline during 2004-2011 and average water use and water-level decline during 2015-2019. These represent the initial and final slopes of the hydrograph for Well No. 1 (Figure 6). The results are shown in **Figure 8**. Extrapolating the line connecting the two data points up to where it crosses the X axis (zero annual water-level change) produces an estimate of sustainable yield. By this method, the estimated sustainable yield is 7,457 AFY, or only 38 percent of average annual pumping. This method is not very accurate because of the long projection distance from the data points to the X axis. A small change in the plotting position of either of the two data points results in a large change in the estimate of sustainable yield. If this yield estimate is correct, then two-thirds of current pumping

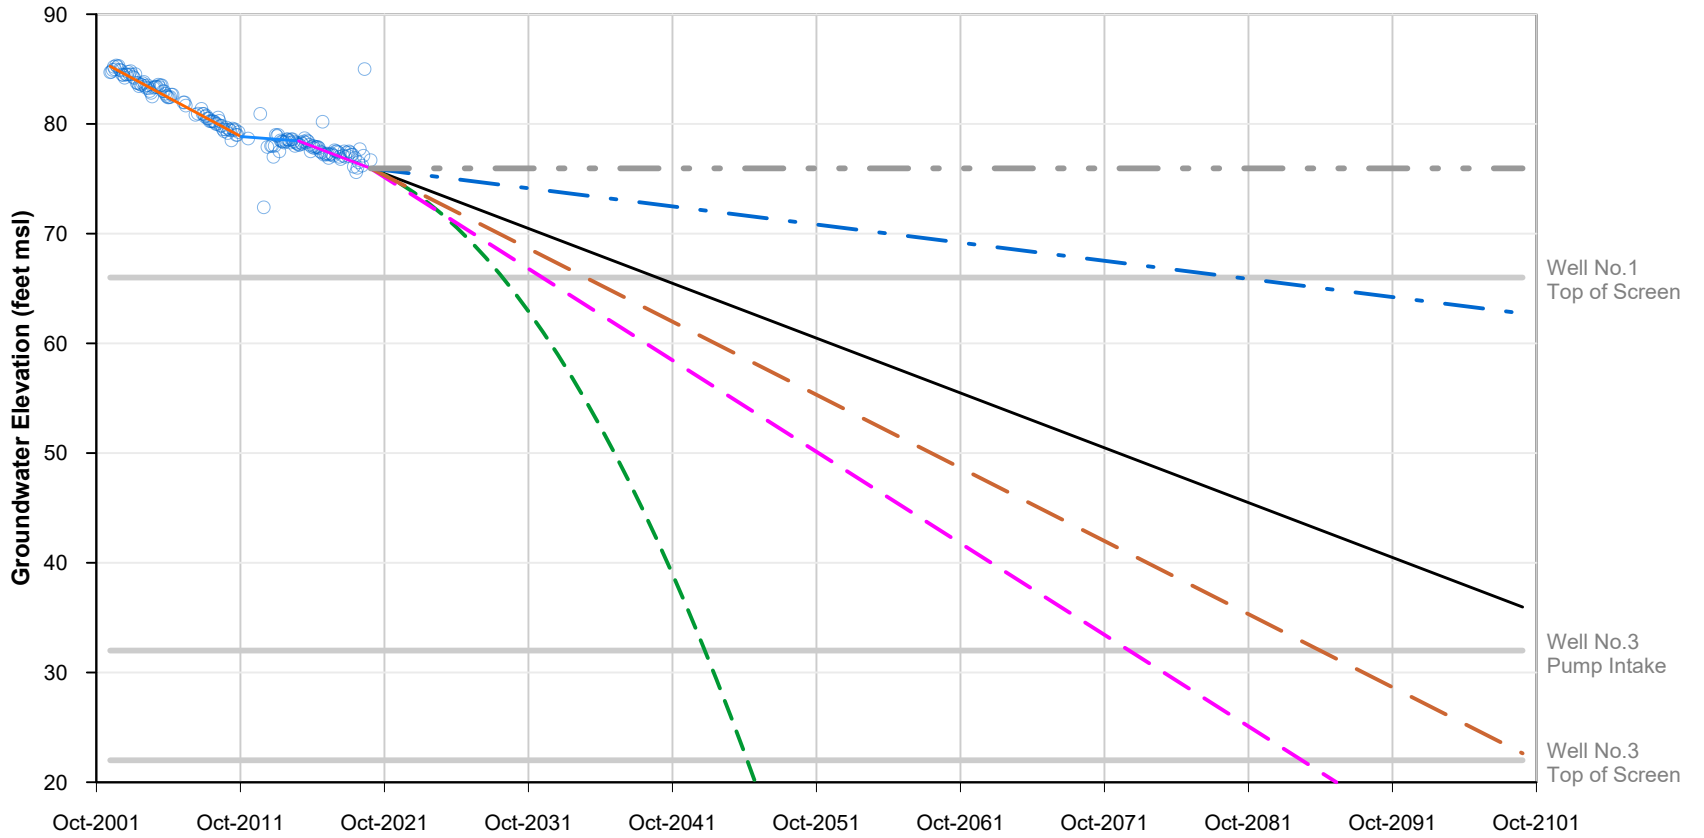
**Figure 9**  
**Projected Future**  
**Water Levels**

**Figure 9** shows static (non-pumping) water levels in Well No. 1 projected to 2100 under various scenarios. If the current 0.5 ft/yr rate of water level decline continues, the water level will drop below the top of the Well No. 1 well screen around 2039 (solid blue line). It would not reach the pump intake in Well No. 3 until approximately 2105. Adding the demand from the school and fire station would shorten those time frames to about 2035 and 2074, respectively (dashed orange line). These results are sensitive to the estimate of sustainable yield because a small percent change in the yield estimate creates a much larger percent change in the overdraft estimate. For example, if the current estimate of yield is increased or decreased by 10 percent, the projected water-level trends for current demand (without the school and fire station) are shown as the blue dot-dashed line and dashed magenta line, respectively. This range of uncertainty is larger than the effect of adding the school and fire station.

- Well No.1 Top of Screen
- Well No.3 Pump Intake
- Well No.3 Top of Screen
- Historical
- Trend 2002-2011
- Trend 2012-2014
- Trend 2015-2019
- Existing Trend
- Growth to Buildout
- Existing Pumping 90% Yield
- Existing + School + Fire
- Existing Pumping
- Pumping = Sustainable Yield

If the additional future water demand were supplied by the existing CSA-11 wells, water level declines would accelerate rapidly, as indicated by the downward-curving dashed green line in Figure 9. That curve reflects an assumption of a linear increase from existing demand to buildout demand over a 50-year period. Water levels would decline to the Well No. 3 pump intake by 2044 and to the top of the screen by 2047. Clearly, new water supplies would be needed to support the growth envisioned in the LCP.

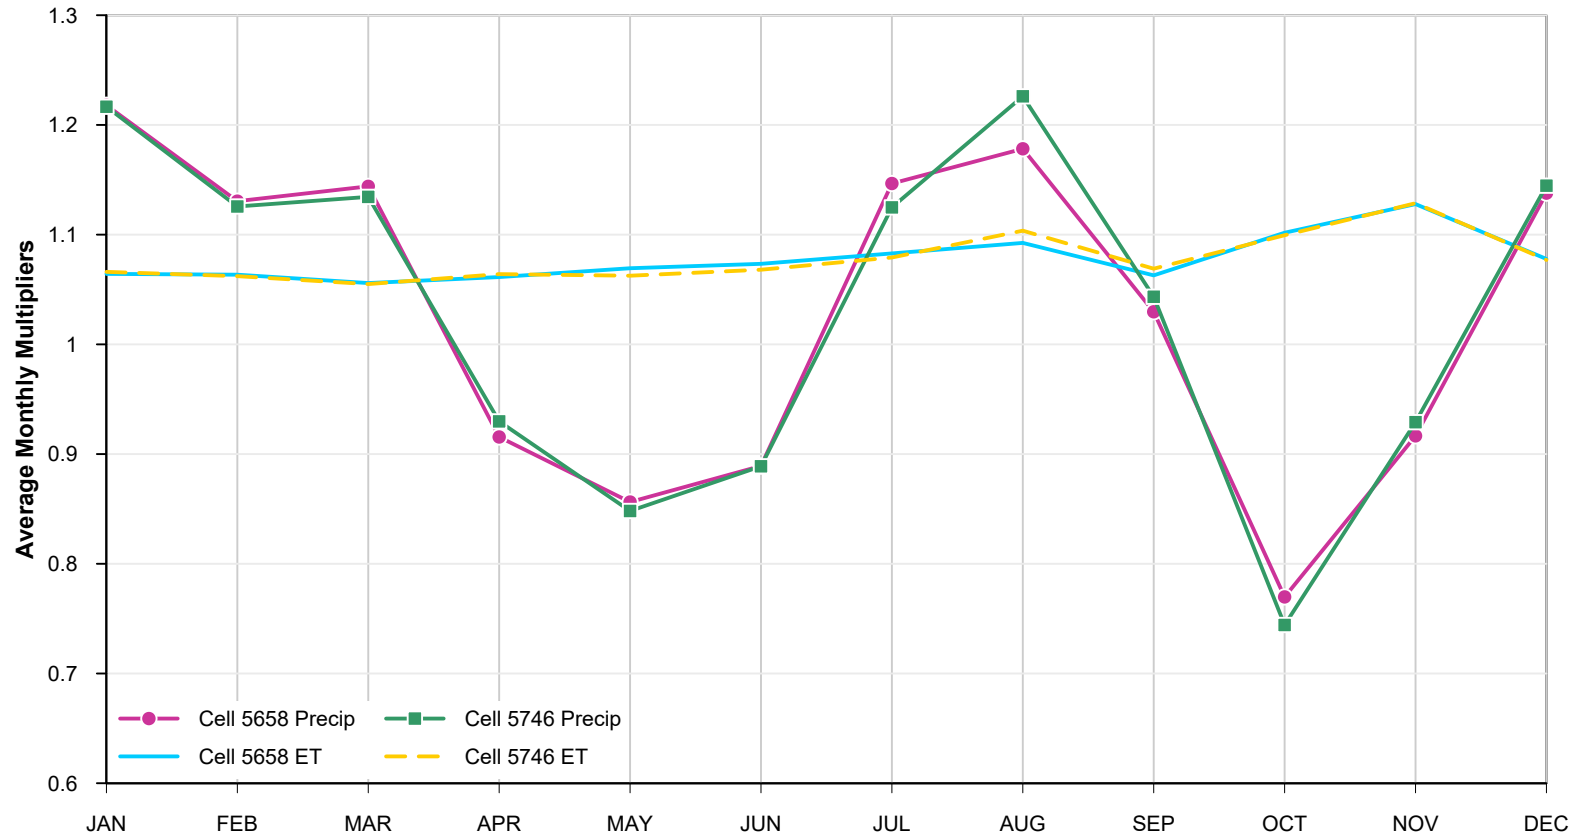
**Figure 11**  
**Precipitation and**  
**ETo Multipliers for**  
**2070 Climate Conditions**

The California Department of Water Resources has developed statewide grids of climate change factors representing anticipated precipitation and reference evapotranspiration (ET<sub>o</sub>) conditions in 2030 and 2070. The factors are sets of 1,164 monthly multipliers to be applied to historical rainfall and ET<sub>o</sub> data for 1915-2011 to estimate the amounts that would have occurred under 2030 or 2070 global climatic conditions. Pescadero is located at the boundary between grid cells 5658 and 5746. The monthly multipliers for 2070 conditions were obtained for both cells, and average values for each month of the year were calculated. The results are shown in **Figure 11**. The ET<sub>o</sub> multipliers are greater than 1.0 in all months of the year, which means that plant ET and irrigation demand would both be greater under 2070 climate conditions. Precipitation multipliers have two seasonal peaks, one of which is in summer. However, precipitation is negligible in that season, so that peak has negligible effects on recharge and demand. Of primary importance are the multipliers for the peak in the wet season months of December-March, all of which are greater than 1.0. This means that rainfall and hence groundwater recharge are expected to be greater under 2070 climate conditions, which at least partly offsets the effect of increased ET on water supply. Thus, the warmer but wetter climate expected by 2070 would not likely cause a large net increase or decrease in net water consumption.

### 2070 Climate Change Factors

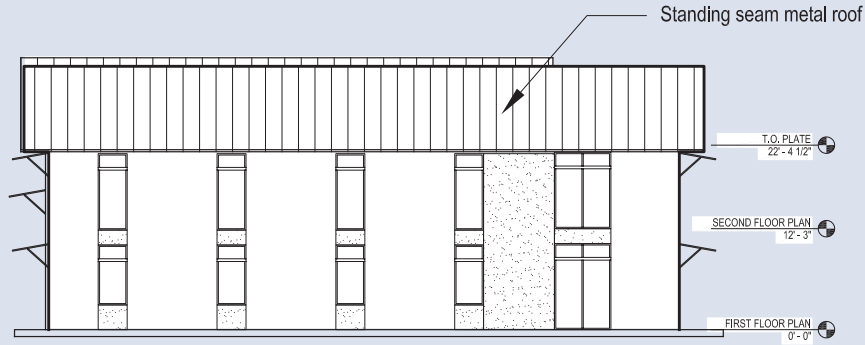
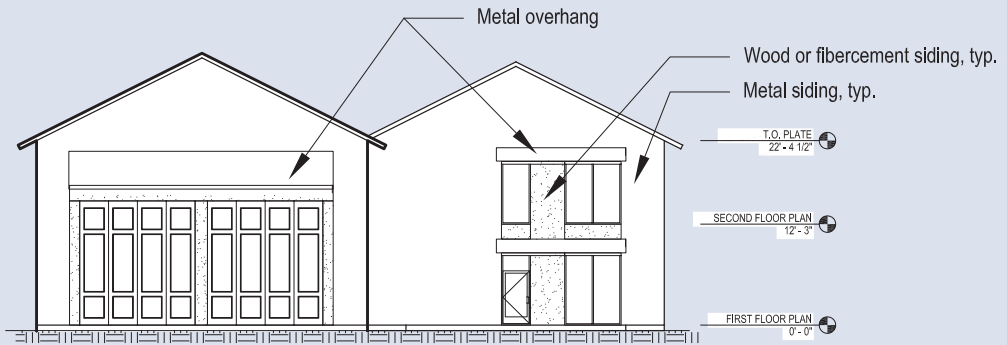
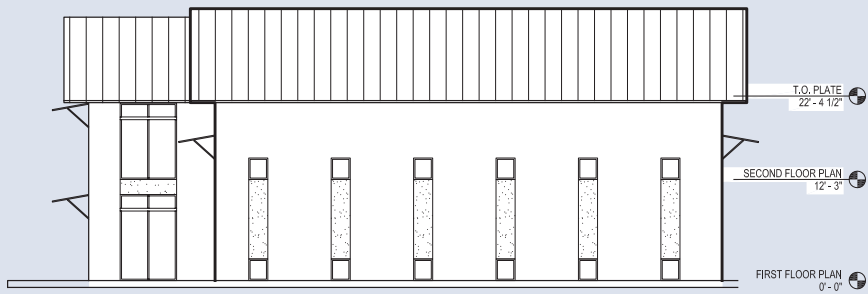
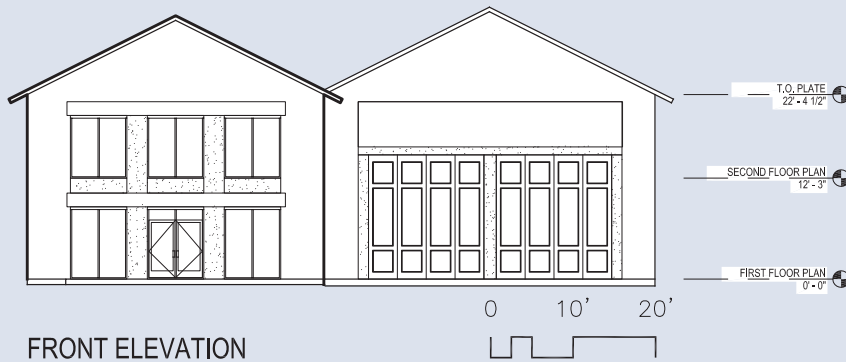
# SK A3. (New site) Elevations

LEFT SIDE ELEVATION

BACK ELEVATION

RIGHT SIDE ELEVATION

FRONT ELEVATION

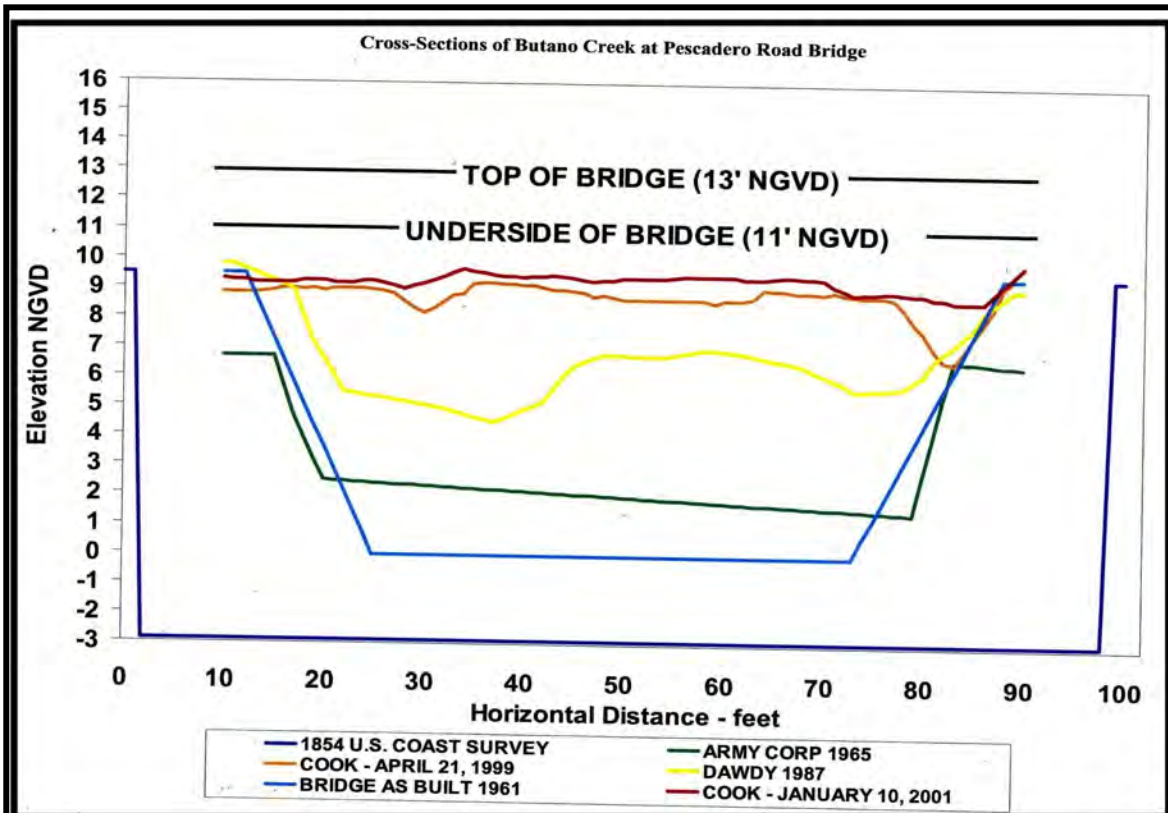
**Attachment A: Silt-up Profiles of Butano Creek Bridge**

This image shows the profile of the Butano Creek streambed below the Pescadero Creek Road Bridge. Early surveys show the streambed some 12 feet below the bottom of the bridge. Today, the bridge clears the silted and debris-filled creek bottom by only 2 feet.
