## Item 12

**SUBJECT:** Consideration of Local Coastal Program amendment to facilitate future construction of a replacement fire station (County Fire Station Number 59) and extension of CSA-11 to serve the fire station and Pescadero Middle/High School located at 350-360 Butano Cut Off. Both projects are located in the Pescadero area of the unincorporated San Mateo County.

County File Number: PLN 2021-00056 (County of San Mateo)

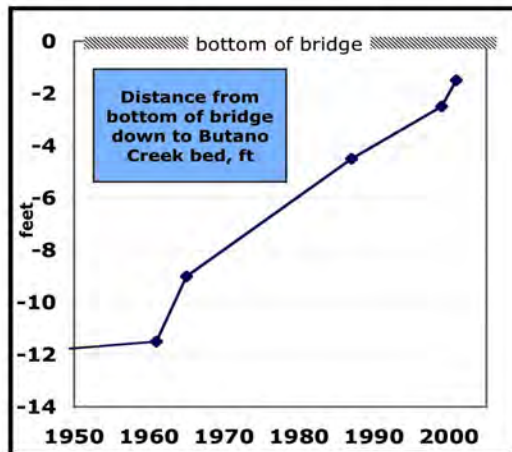
from  
 "Restoration of  
 Butano Creek ...."  
 2001  
 page 10

This image shows the profile of the Butano Creek streambed below the Pescadero Creek Road Bridge. Early surveys show the streambed some 12 feet below the bottom of the bridge. Today, the bridge clears the silted and debris-filled creek bottom by only 2 feet.

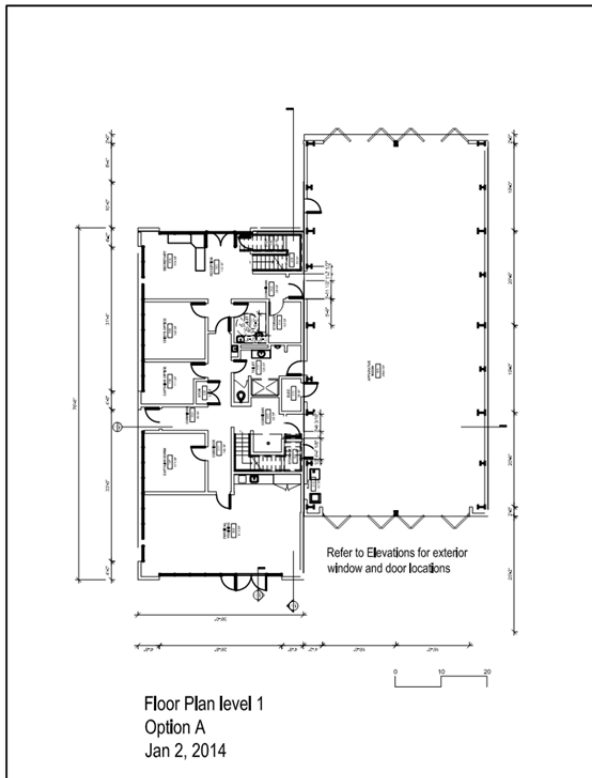
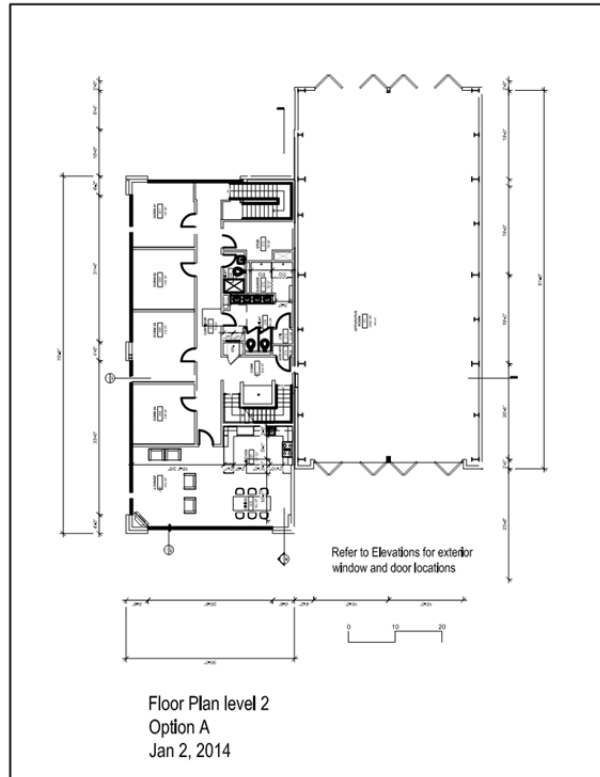
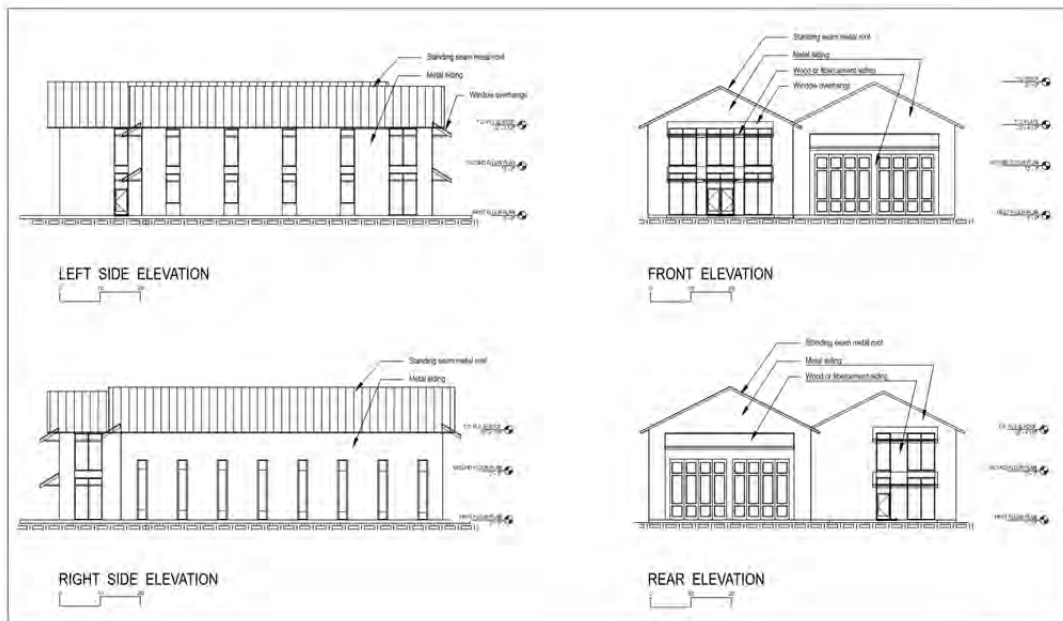
The structural system narrative is based on the concept architectural plans for a new apparatus building adjacent to an office and living quarters building as shown below. The two structures will be separate by a seismic joint.

The structural gravity system for the apparatus structure consists of steel beams in the transverse direction and along the perimeter supported on steel columns. Light gauge or wood roof framing members span between the steel beams to form the roof system. Exterior cladding is composed of either light gauge steel studs or wood studs spanning from the foundation to the roof framing level. The lateral system consists of steel moment frames in the transverse direction and plywood shear walls in the longitudinal direction. Reinforced masonry shear walls is an option to the plywood walls in the longitudinal direction. A plywood roof diaphragm is used to transfer seismic forces to the lateral system.

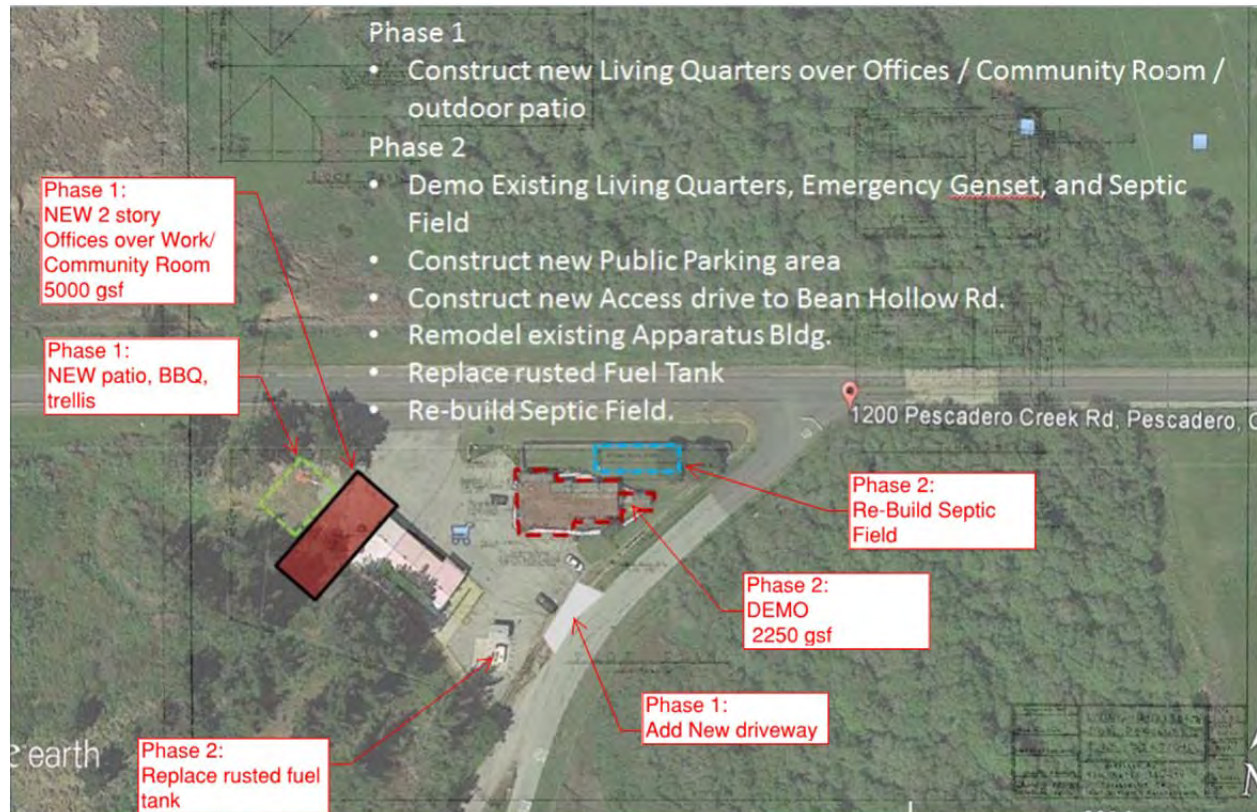
The structural system narrative is based on the concept architectural plans shown on this page. The new Living Quarters/Office portion of the structure is assumed to be the same layout as Option A.

The station would consist of two separate building structures: new Office/Living Quarters and renovated Apparatus.

The structural gravity system for the Office/Living Quarters structure consists of light gauge or wood joists at the roof and floor levels. The joists at both levels are supported by light gauge or wood stud interior and exterior bearing walls. Roof joists span the transverse direction and are supported on interior corridor walls as required. The direction of floor joists framing is dependent on the Level One wall layout. As an alternate to roof and floor joists, trusses can be utilized at both levels. The lateral system in both transverse and longitudinal directions consists of plywood shear walls. Plywood roof and floor diaphragms are used to transfer seismic forces to the lateral system. For both gravity and lateral systems to be implemented efficiently, a series of interior walls in both the longitudinal and transverse direction must be “stacked” between the first and second levels to provide continuous load paths to the foundation. In addition at the front and rear exterior walls one or more of the wall segments must have a height to width ratio no greater than 2:1 between each framing level for plywood shear walls to be utilized.

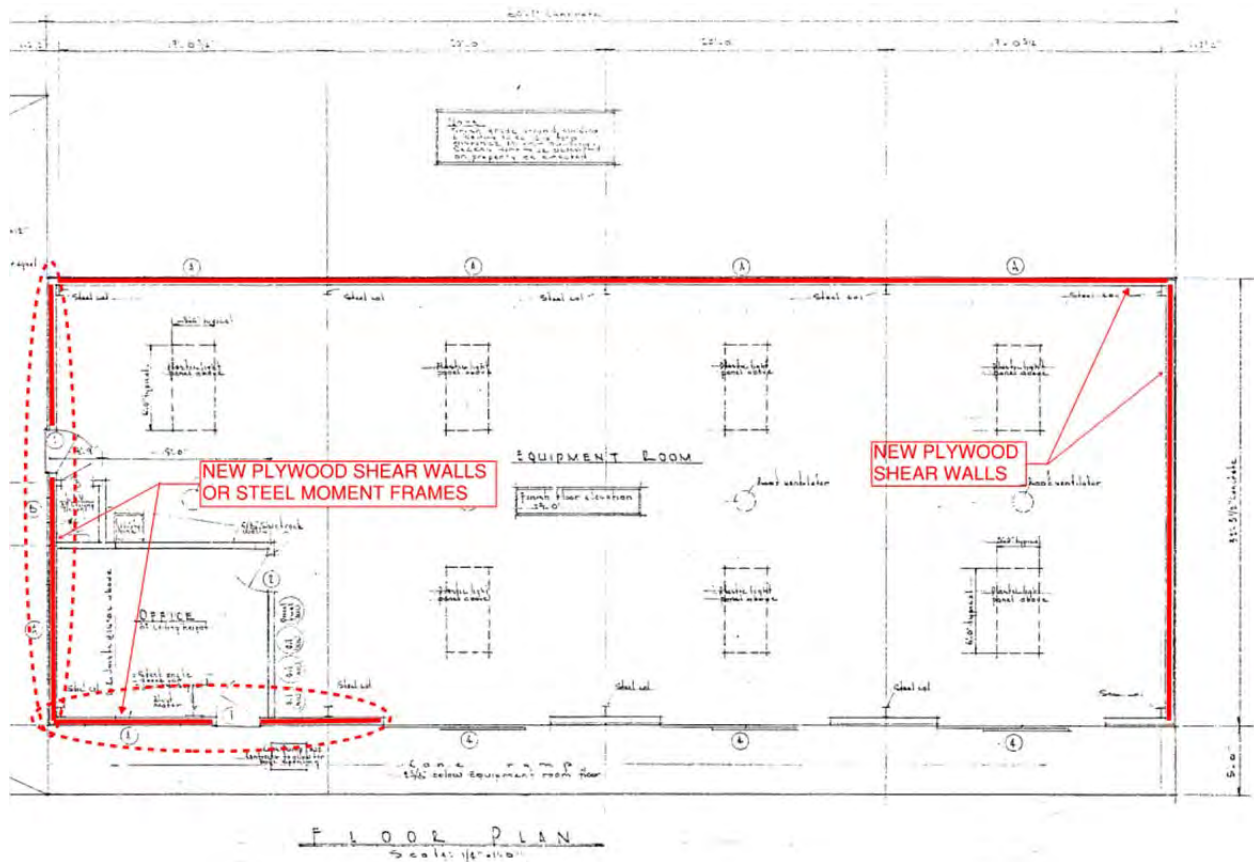
structure lacks a lateral system adequate to meet the requirements of Immediate Occupancy for Emergency Response building occupancies. As described in the existing apparatus building evaluation the structure is a single-story, pre-engineered and pre-fabricated steel building. In general this type of system is designed for maximum efficiency of material and cost and not for a high performance during seismic events. Therefore, the existing lateral system will be abandoned in place and allowing the steel frames to remain as the primary gravity system only. A new lateral system will supersede the existing system. The new system will consist of plywood shear walls on as many as four sides of the structure over new light gauge or wood stud exterior walls. Depending on the height to width ratios of the new shear walls, the existing foundation may be determined to be adequate if the ends of the walls terminate at steel column locations. At the front and left side of the structure new steel moment frames may need to be installed to resist lateral forces if the existing window and door openings cannot be modified to allow for plywood shear walls to be utilized. New foundation elements will be required at steel moment frame locations. Plywood roof diaphragm will be used to transfer seismic forces to the new lateral system.

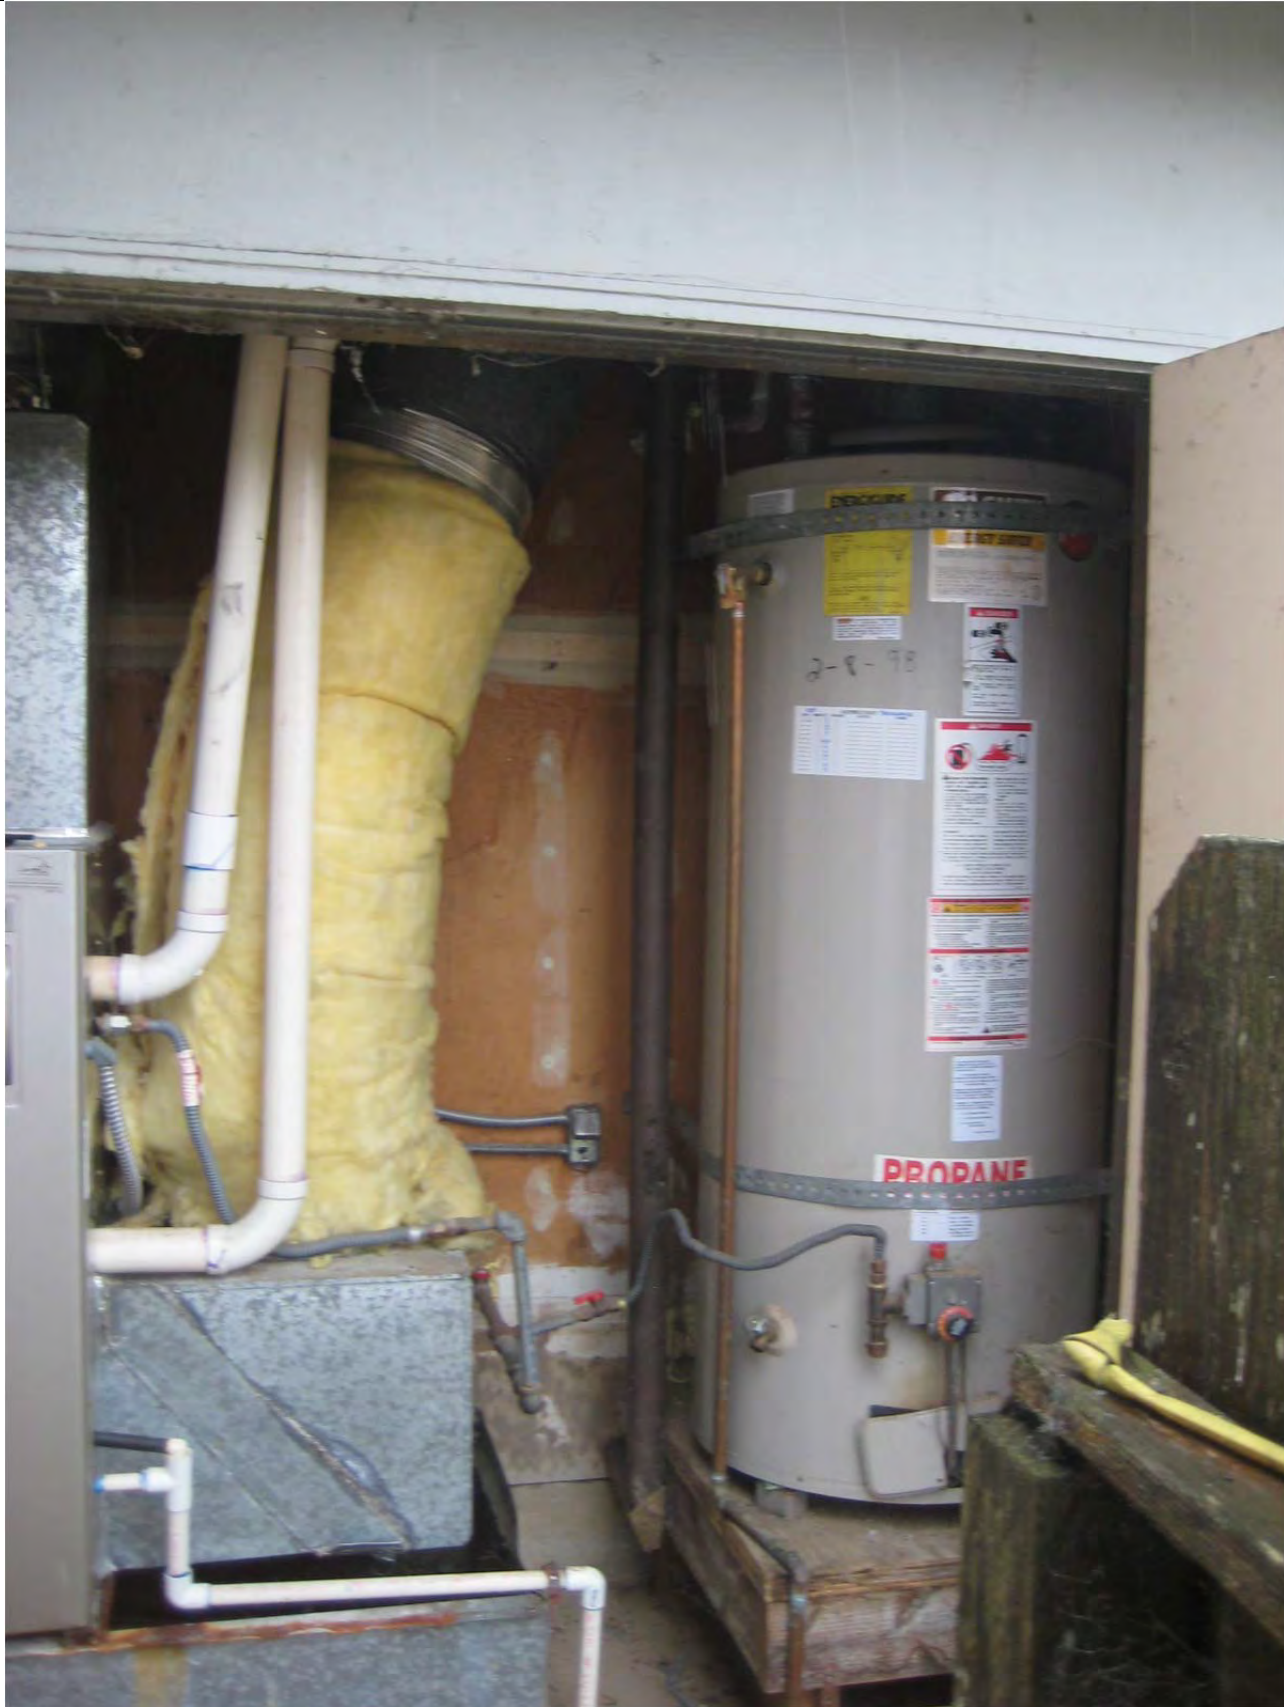
ME1 – Water heater and furnace

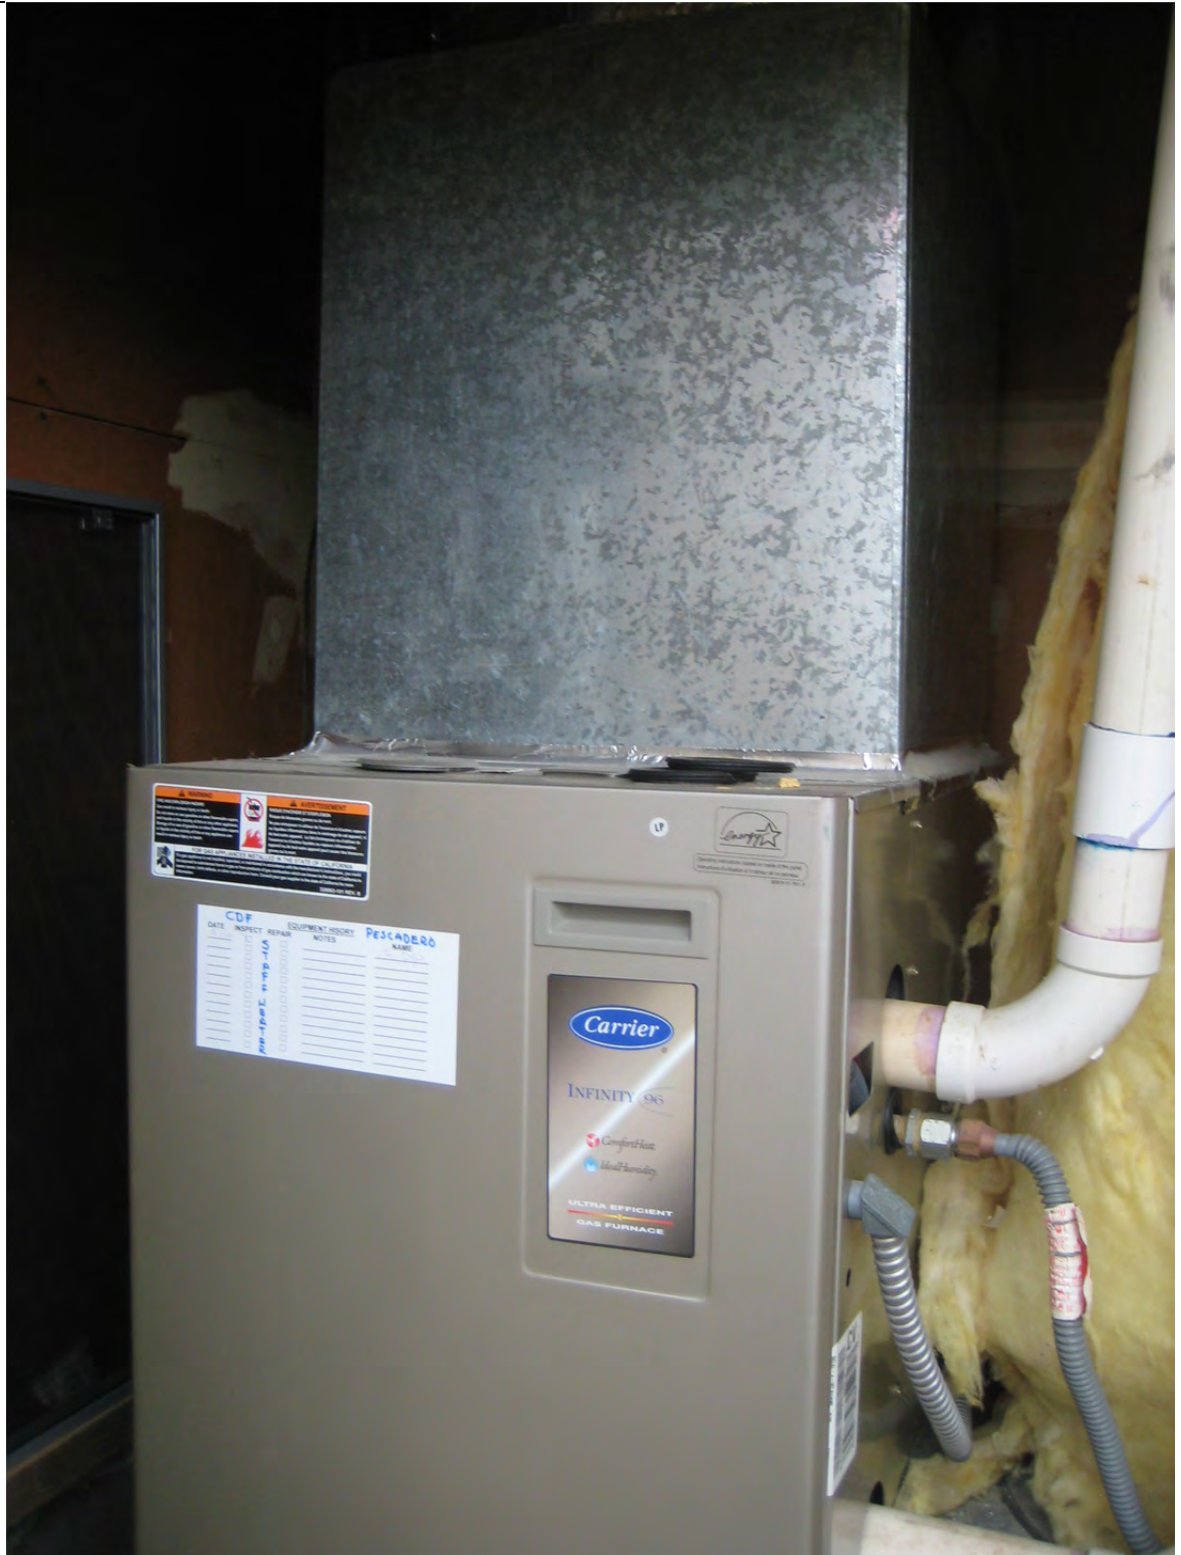
ME2 – Gas furnace

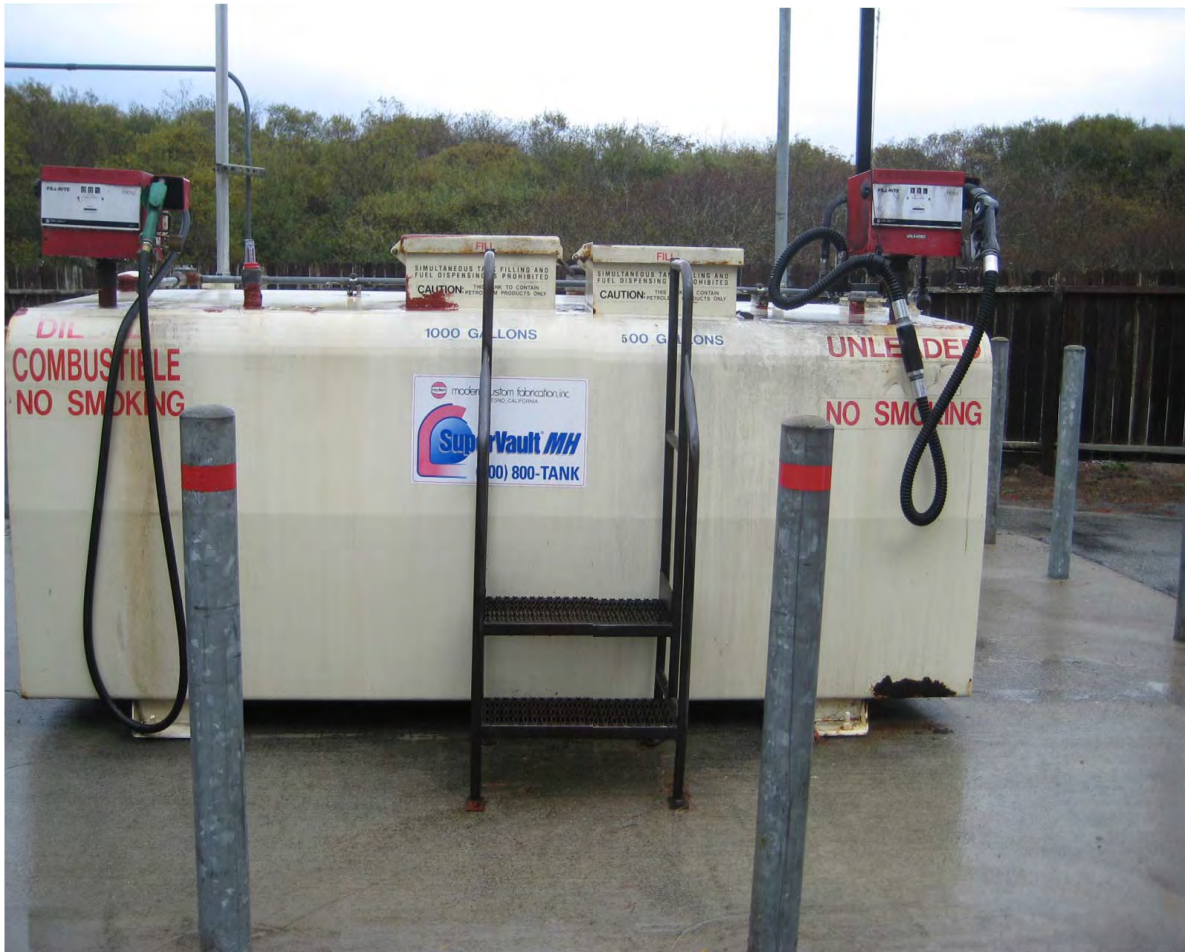
ME3 – Liquid fuel tank

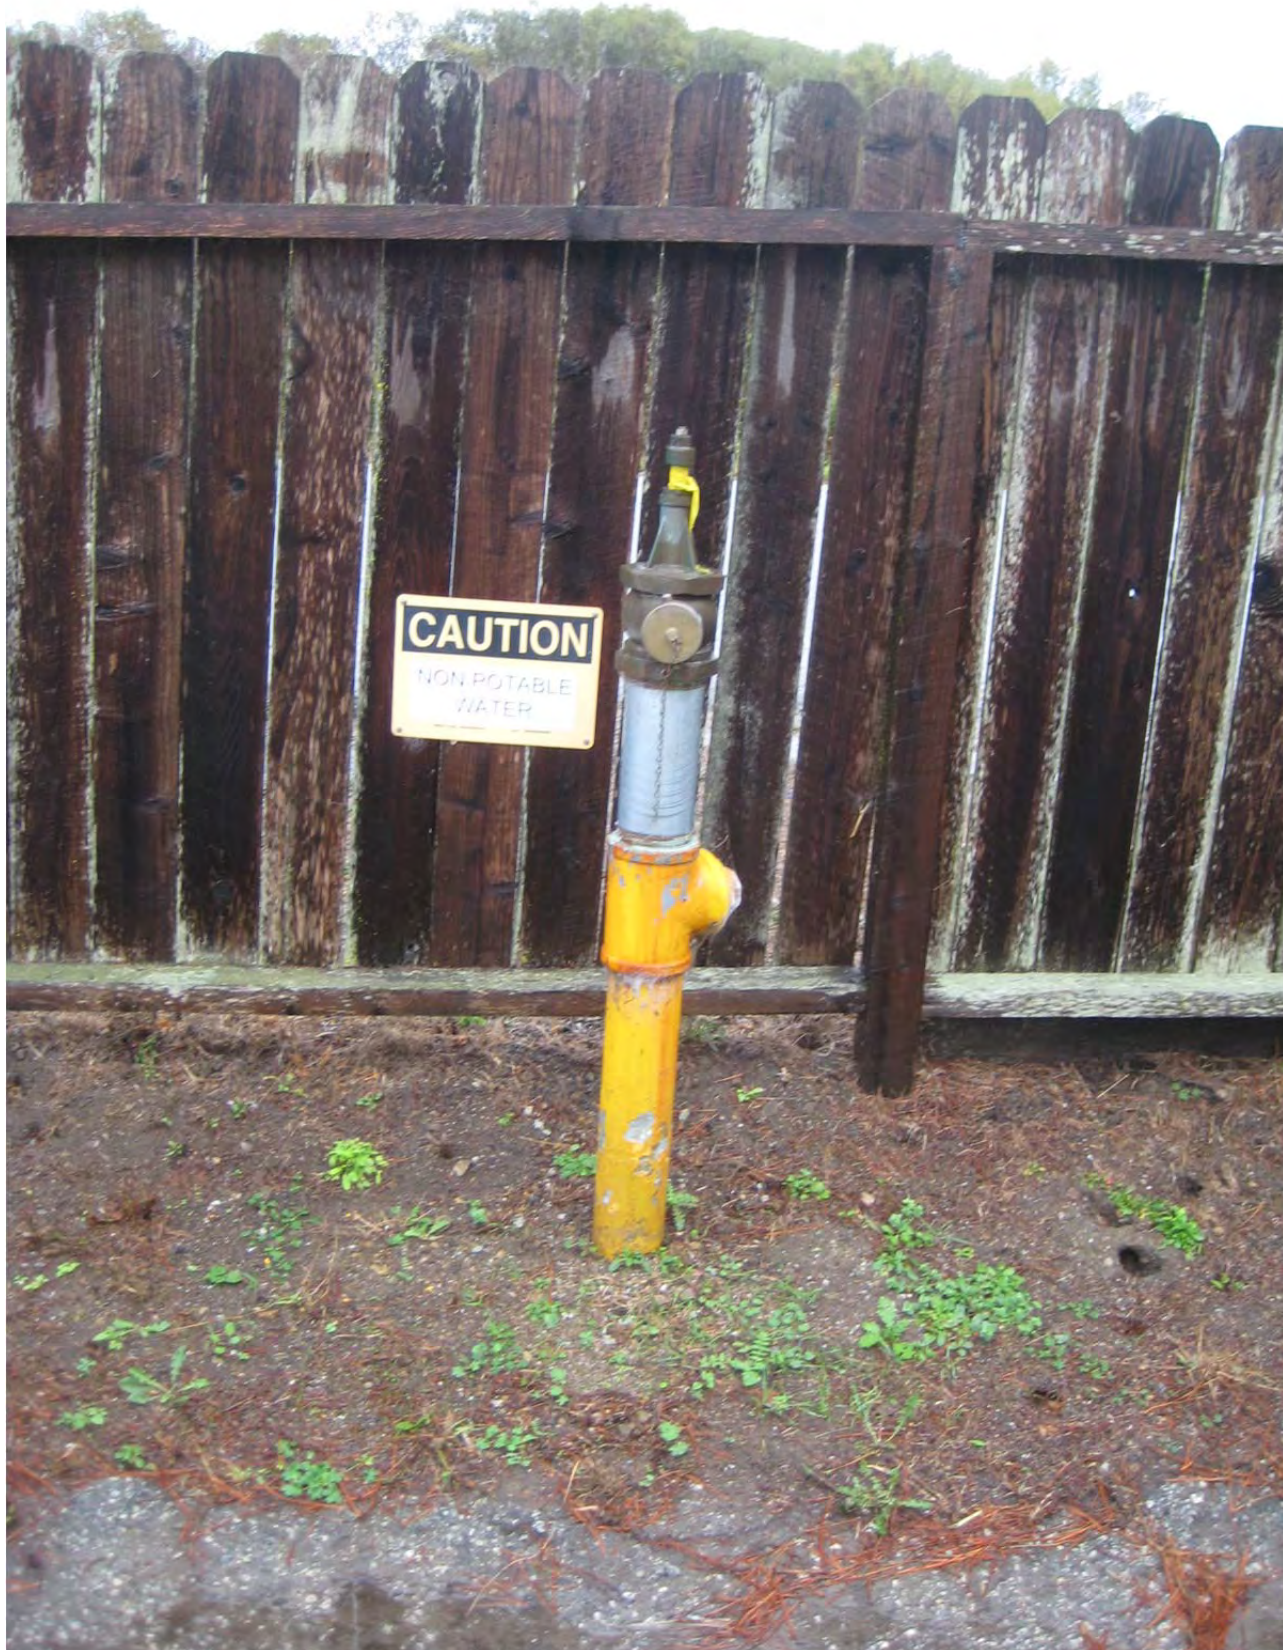
ME4 – Non-potable water connection

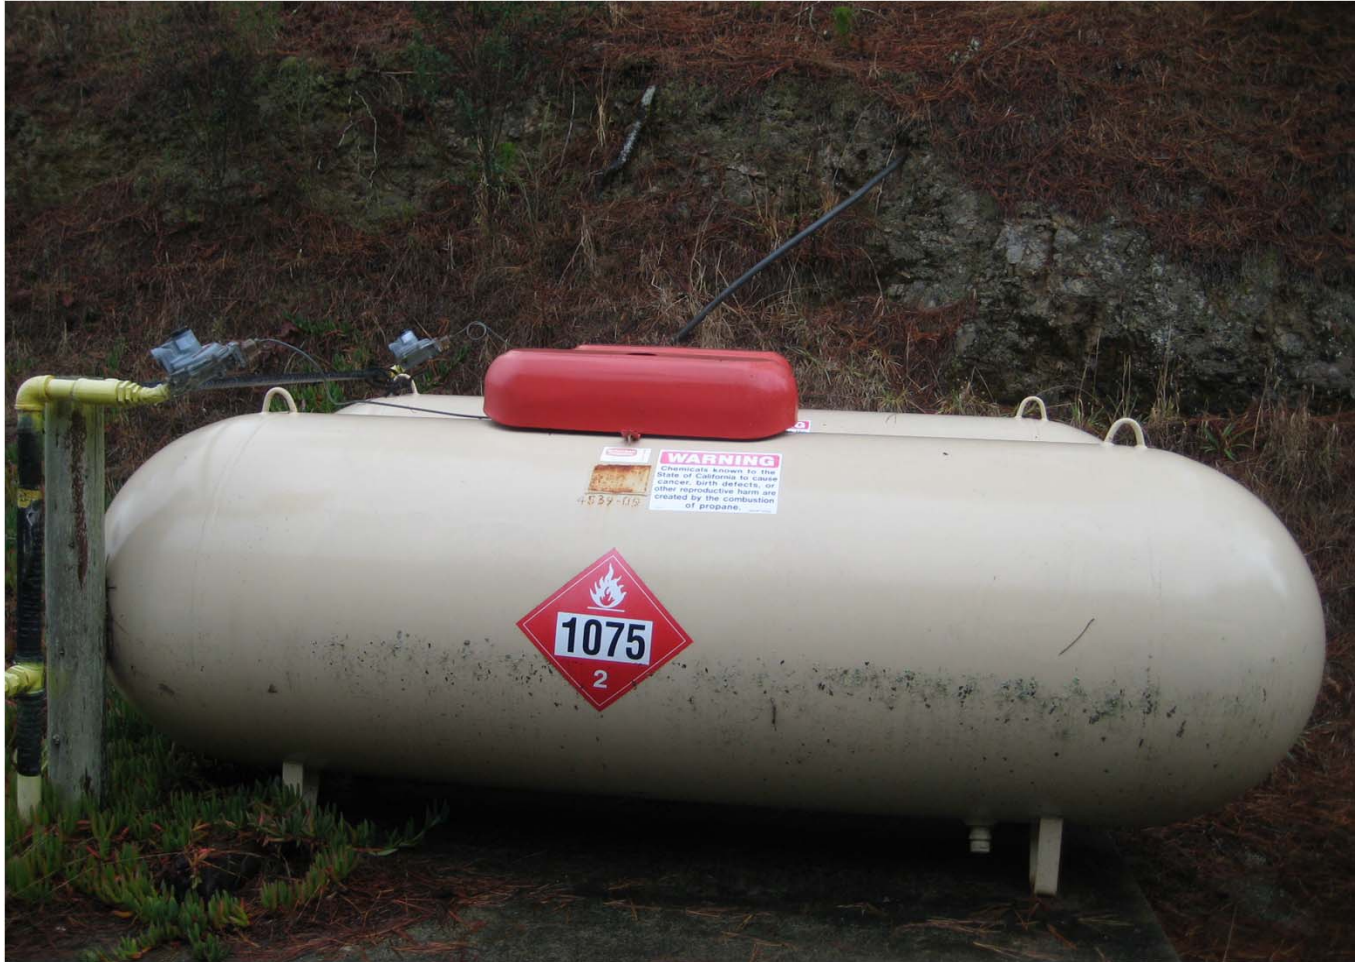
ME5 – Propane fuel tank

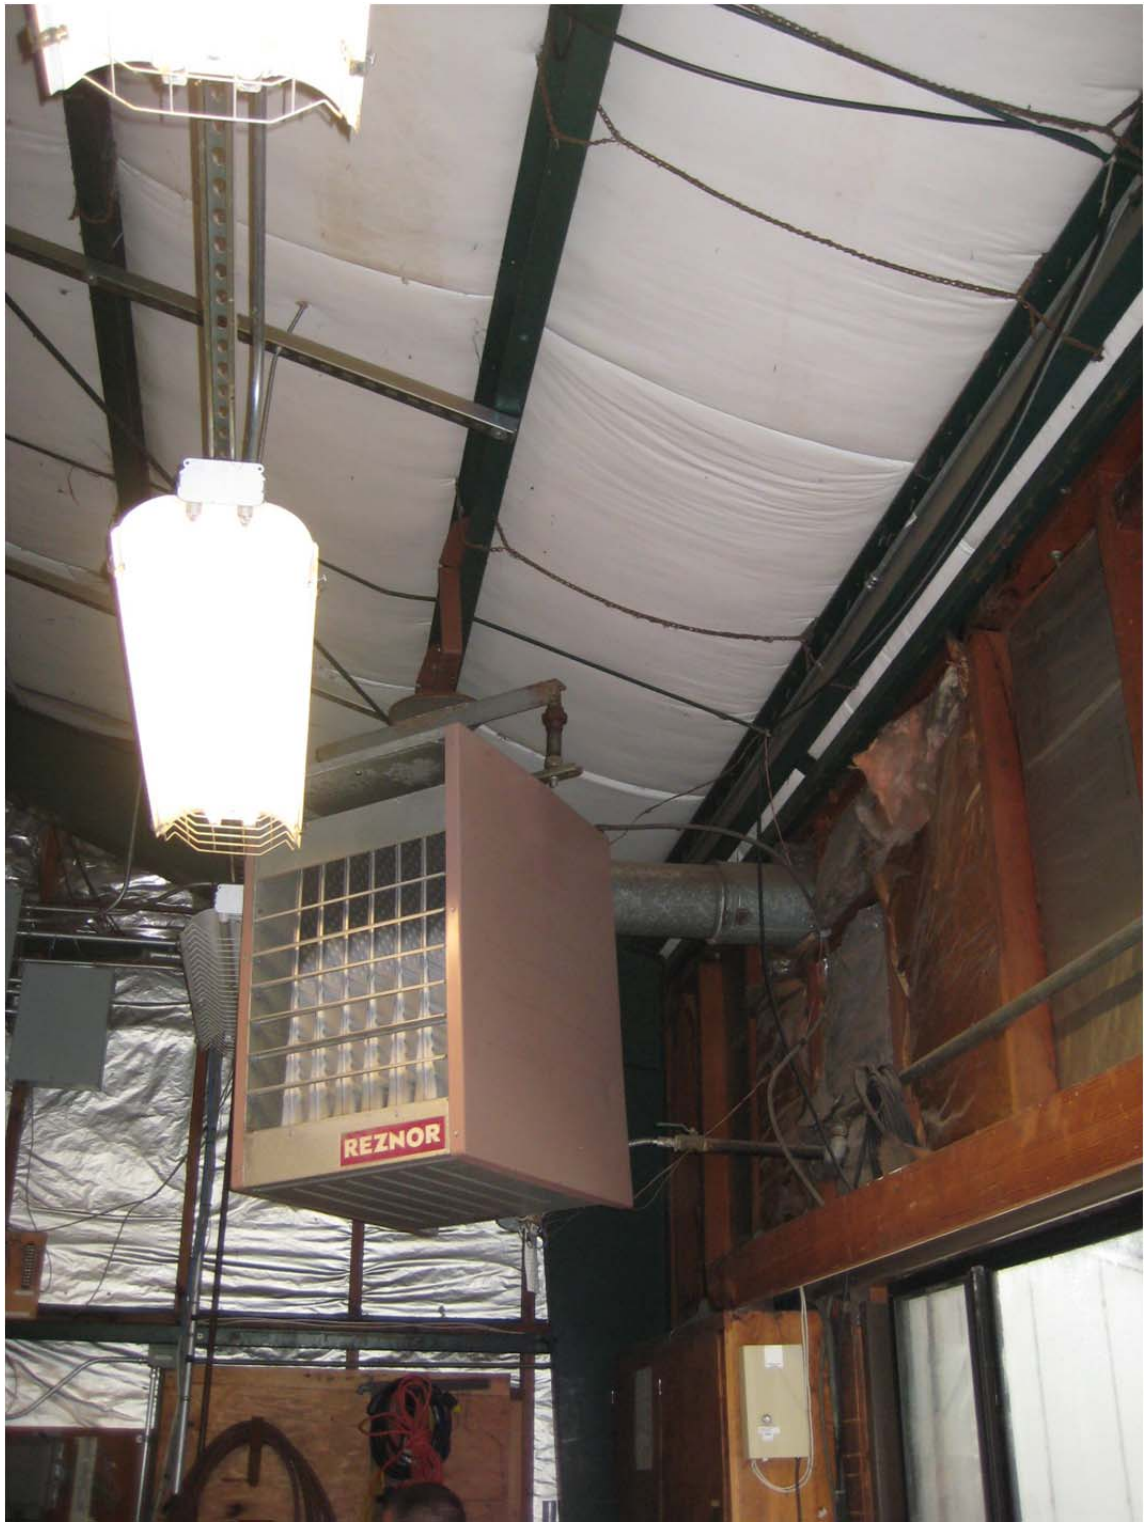
ME6 – Gas unit heater

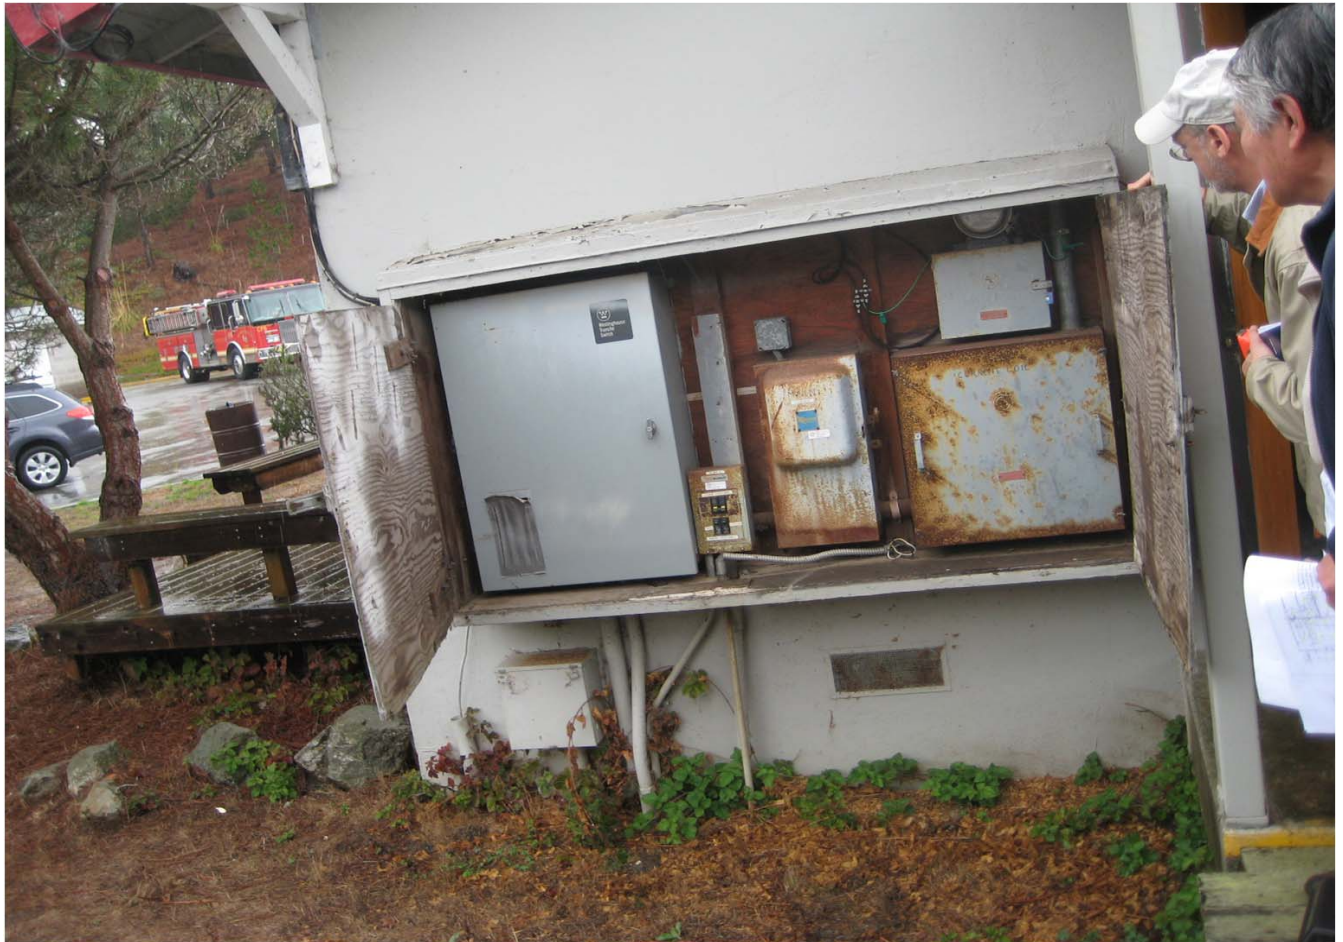
EE1 – Fire Station entrance equipment cabinet

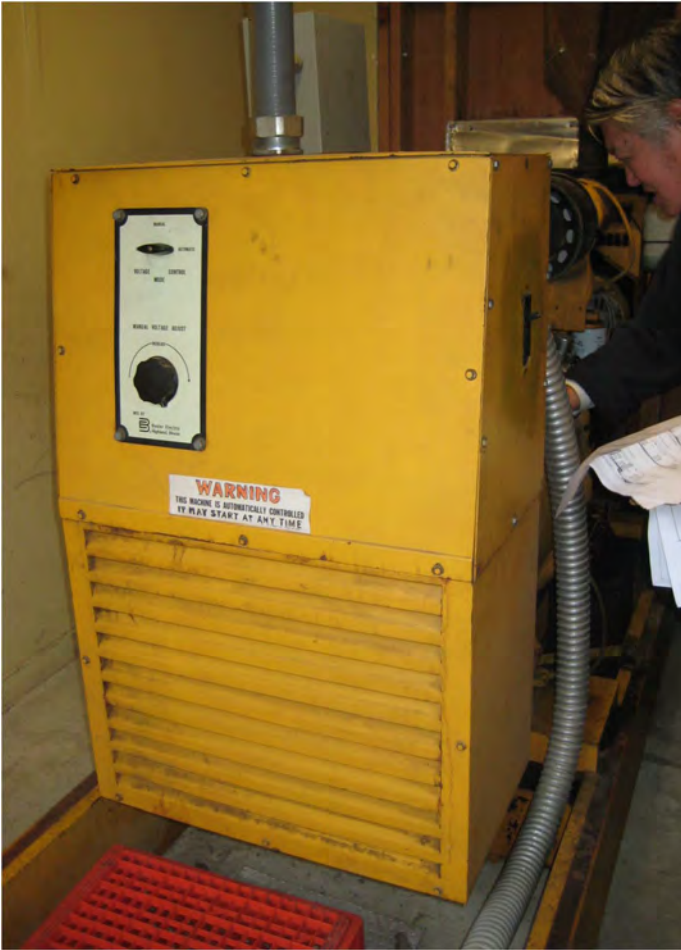
EE2 – Single phase diesel fuel standby generator

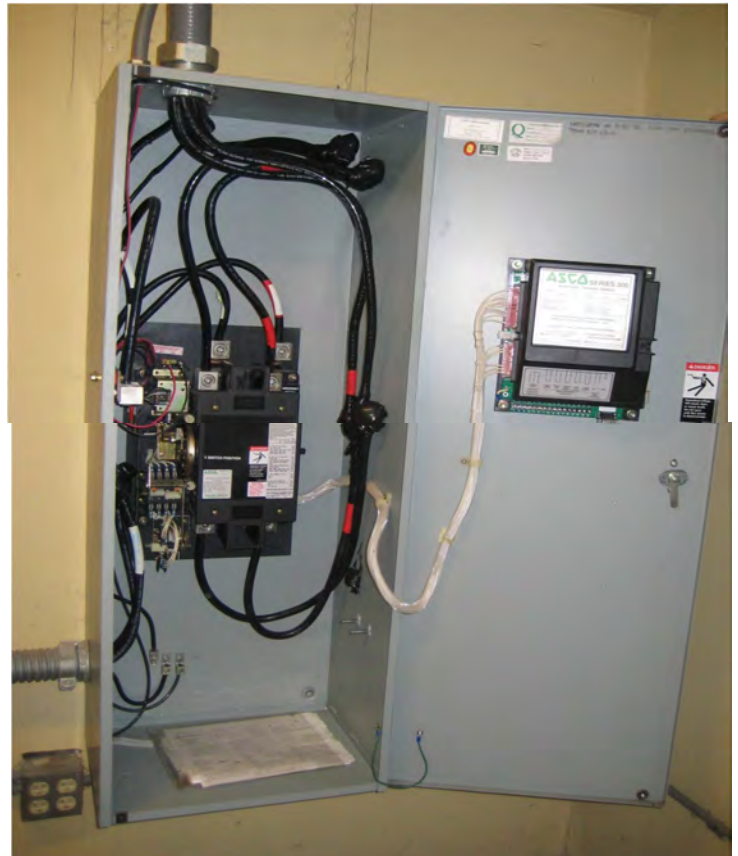
EE3 – Automatic transfer switch

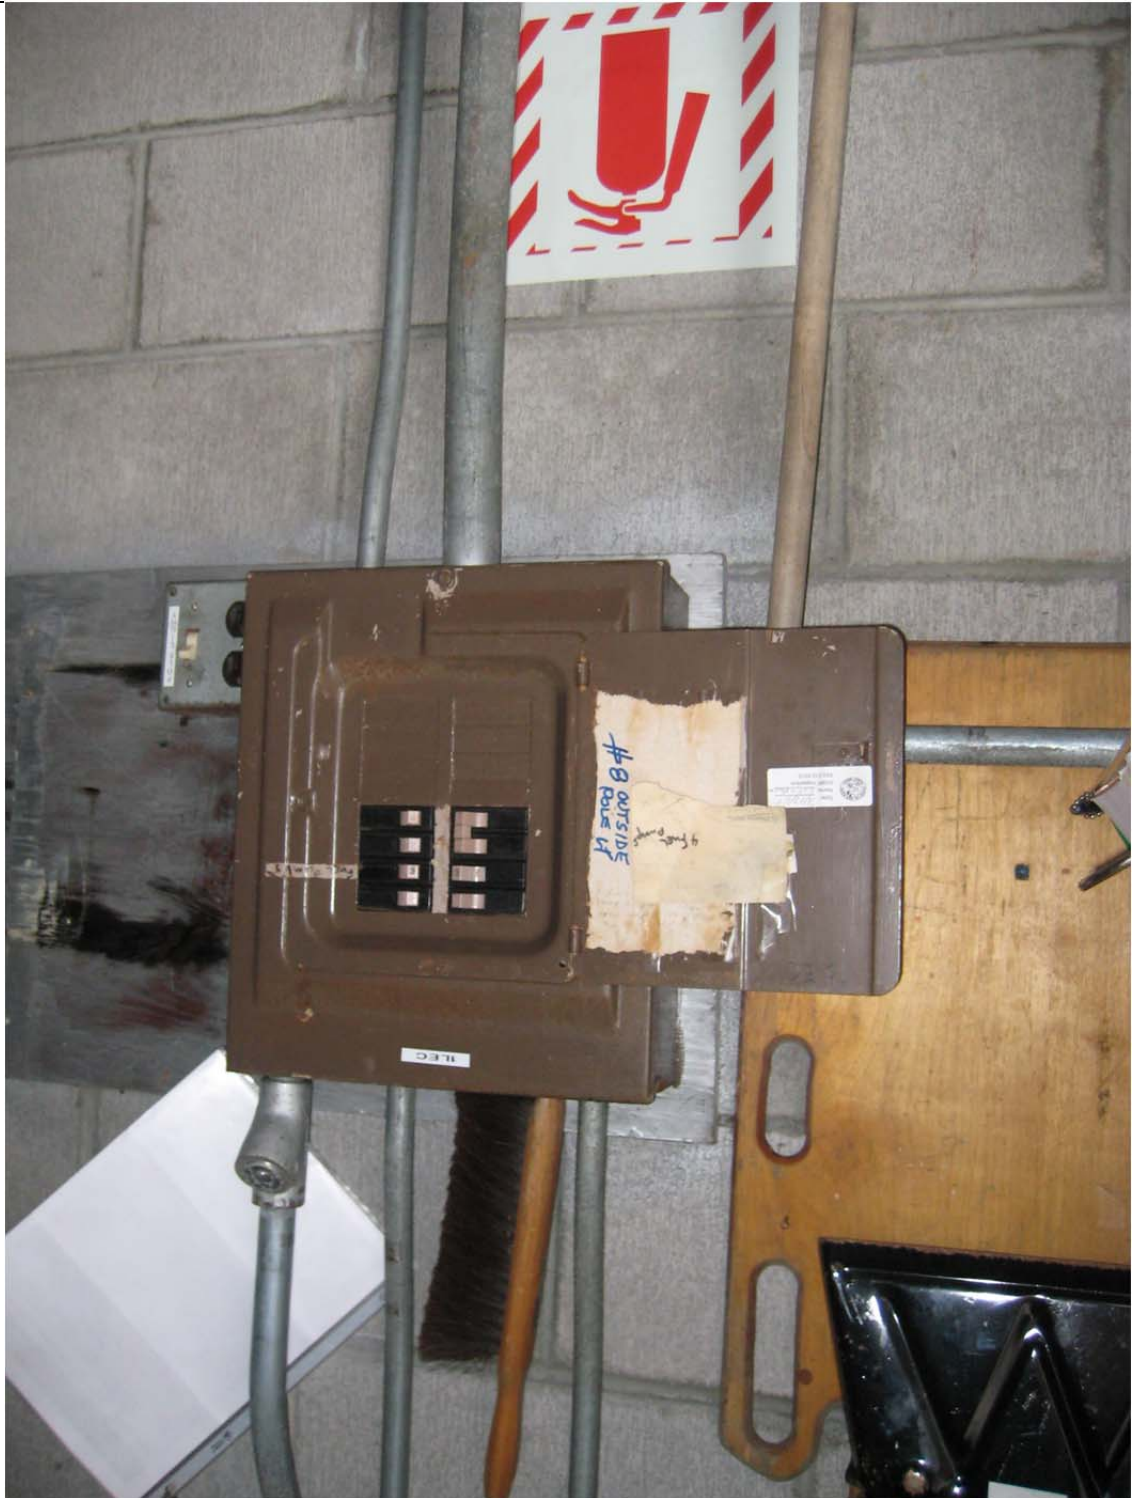
EE4 – Storage Room panel

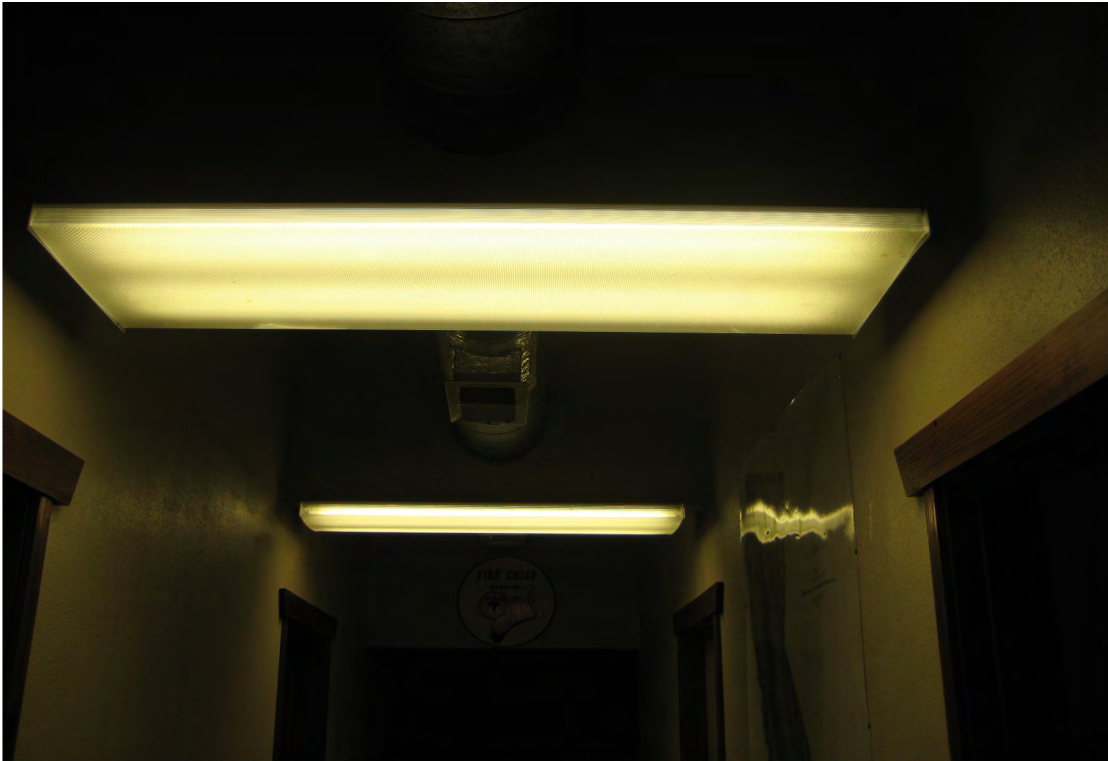
EE5 – Living quarters corridor lights

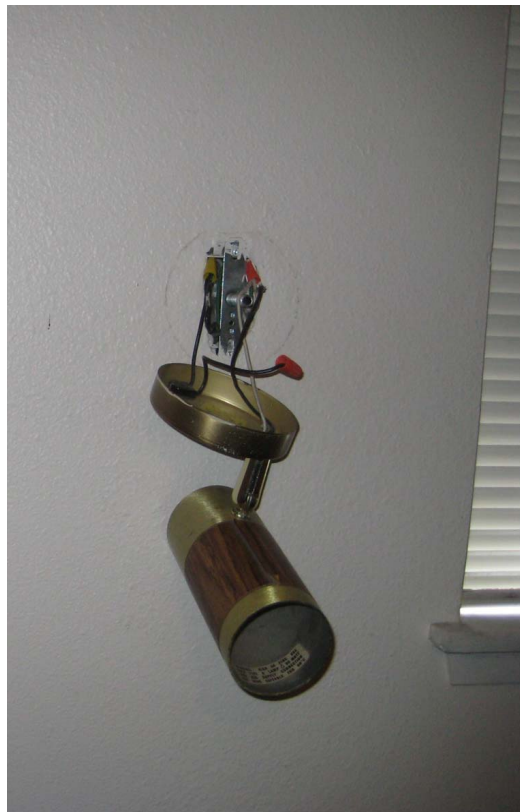
EE6 – Damaged light, Living Quarters

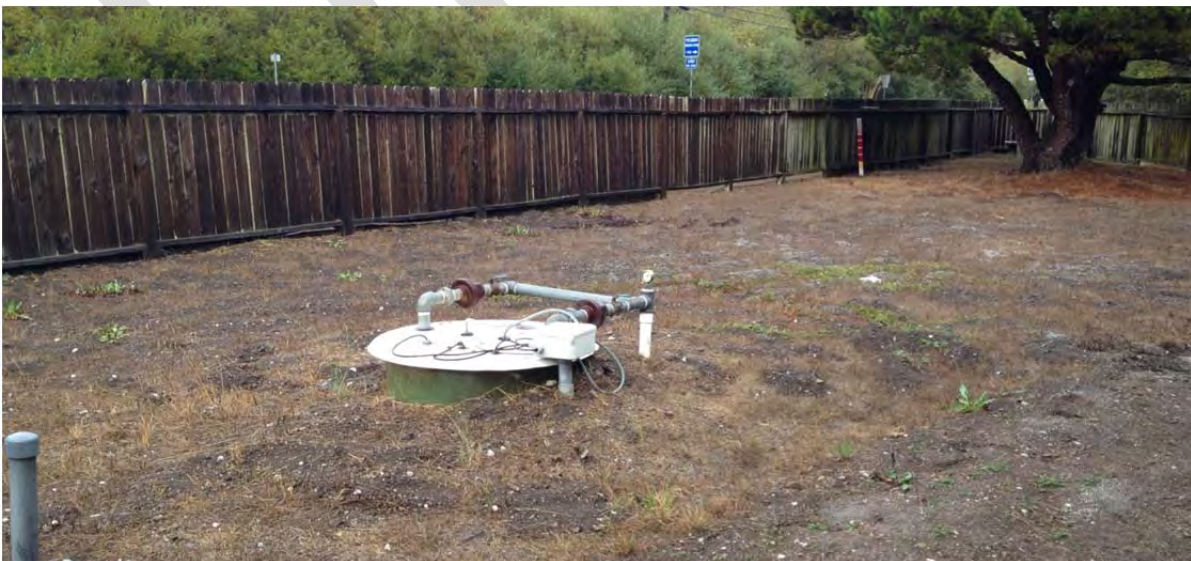
A new septic system will likely be required. The location of the existing system would be the ideal location if it has adequate space and soil conditions to accommodate a system that meets current code. Due to the likelihood of high groundwater at the location of the existing system, a shallow pressure dosing system would likely be required. However, because this location becomes inundated with water during flood events (see Photo 1), it is unlikely that this location will meet code. As such, alternative locations on site should be considered such as the western side of the site or on the hillside along the southern end of the site. It is unlikely, however, that the southern end will be feasible due to the steep slope and the confined area.

*Septic field with flood elevation marker (white post with red marks) shown in the background*
