## Item 12

**SUBJECT:** Consideration of Local Coastal Program amendment to facilitate future construction of a replacement fire station (County Fire Station Number 59) and extension of CSA-11 to serve the fire station and Pescadero Middle/High School located at 350-360 Butano Cut Off. Both projects are located in the Pescadero area of the unincorporated San Mateo County.

County File Number: PLN 2021-00056 (County of San Mateo)

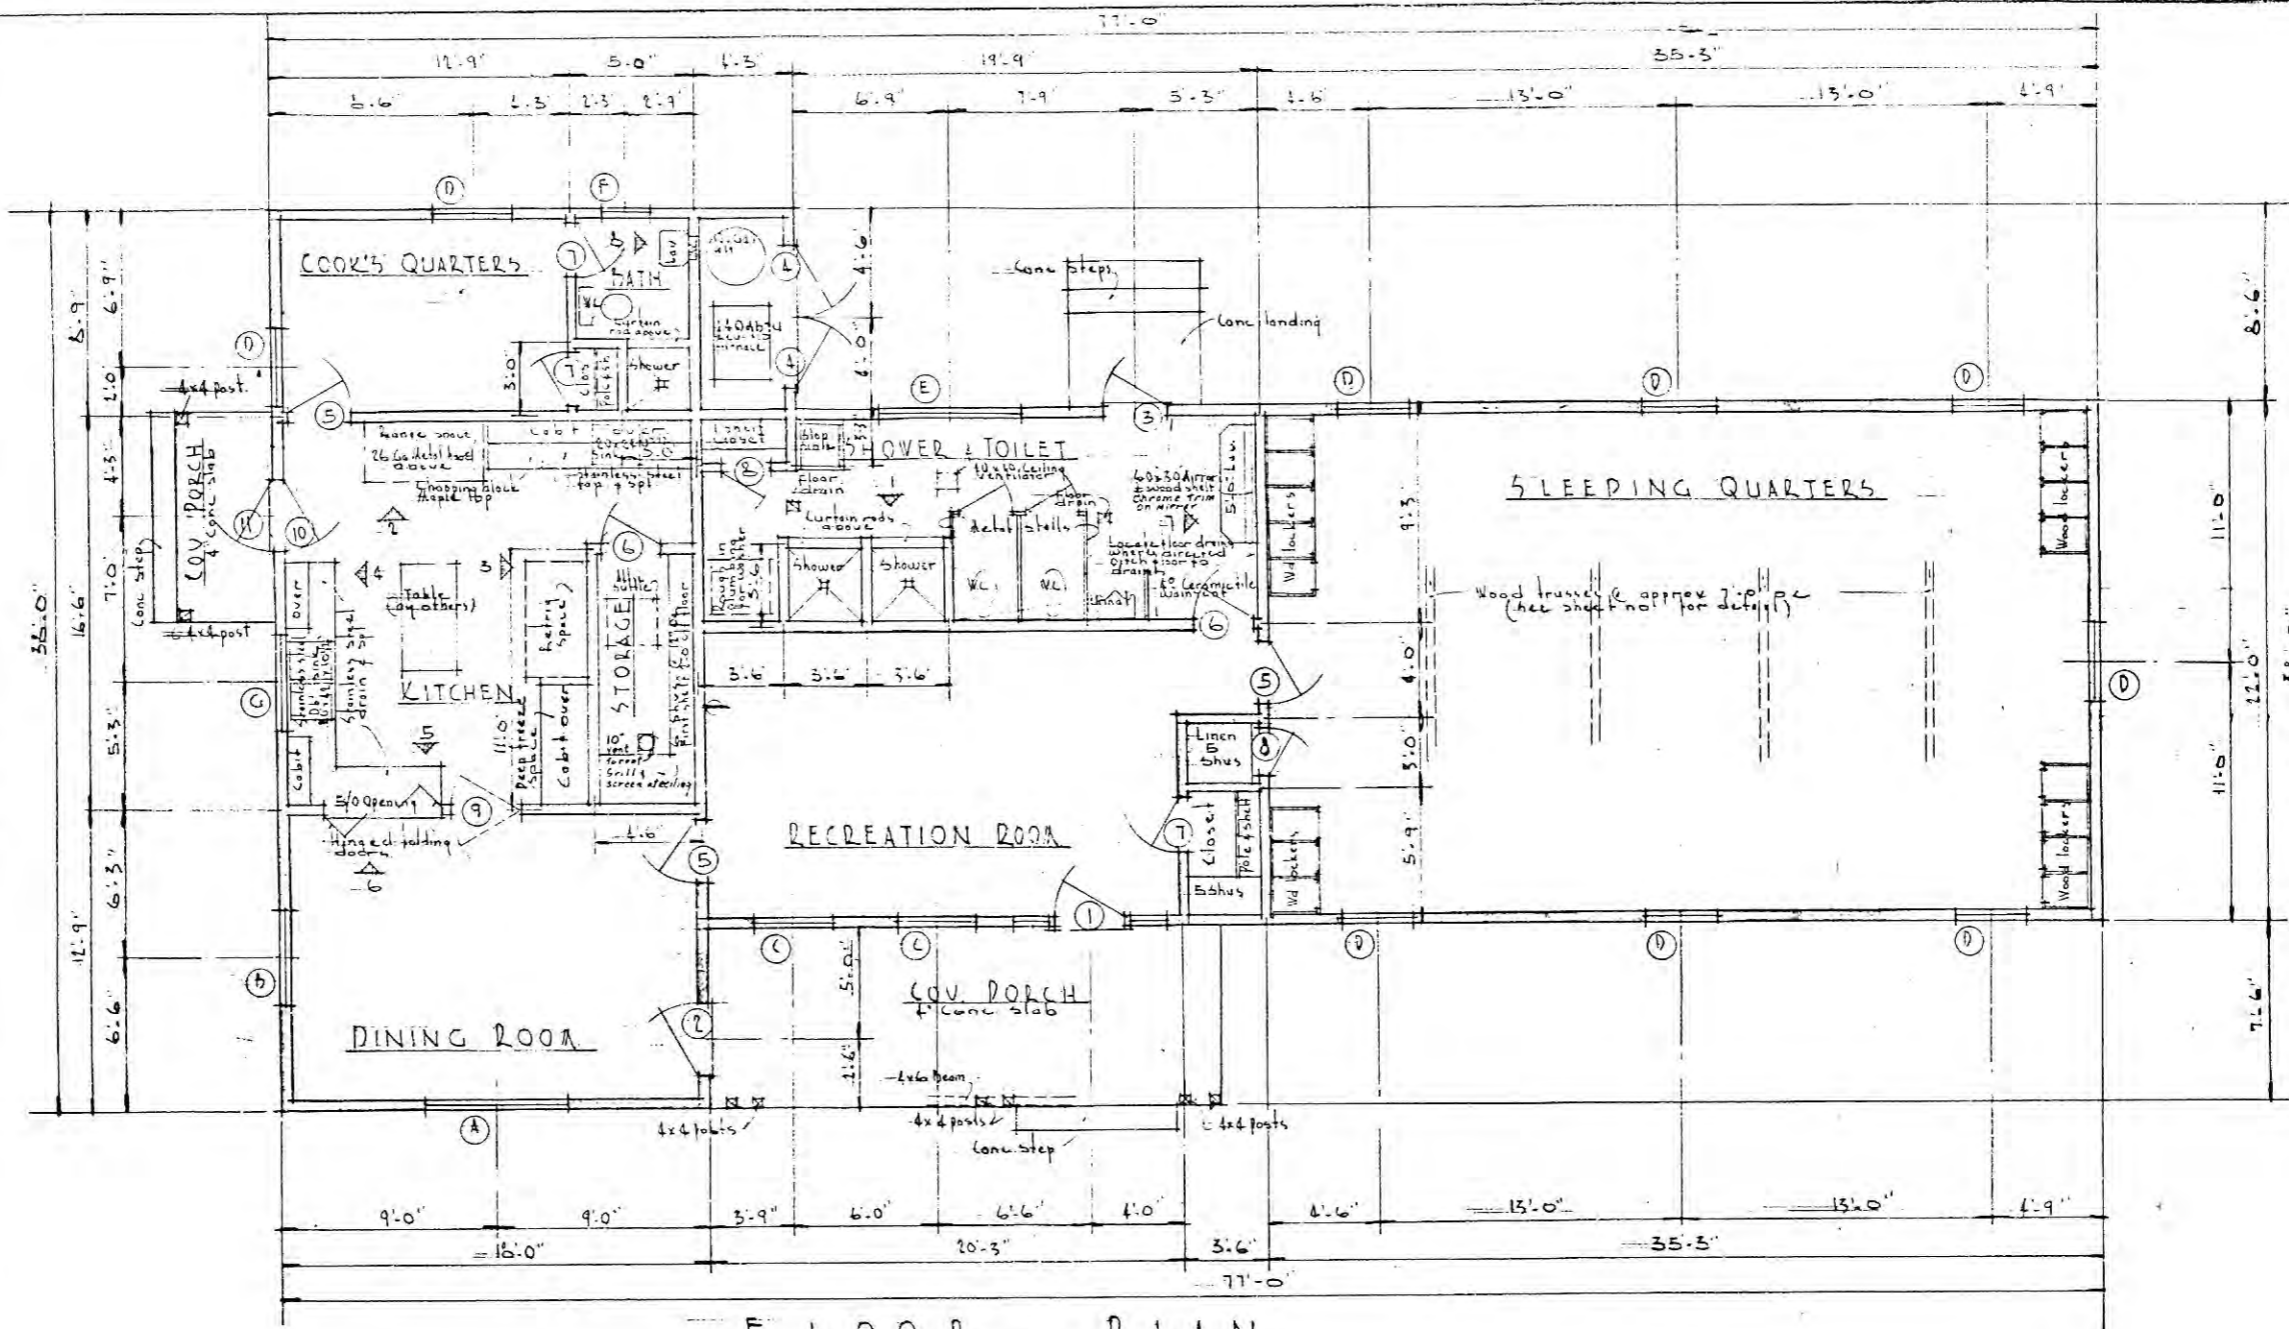
**FLOOR PLAN**  
 Scale: 1/4" = 1'-0"  
 See sheet no. 3 for truss detail

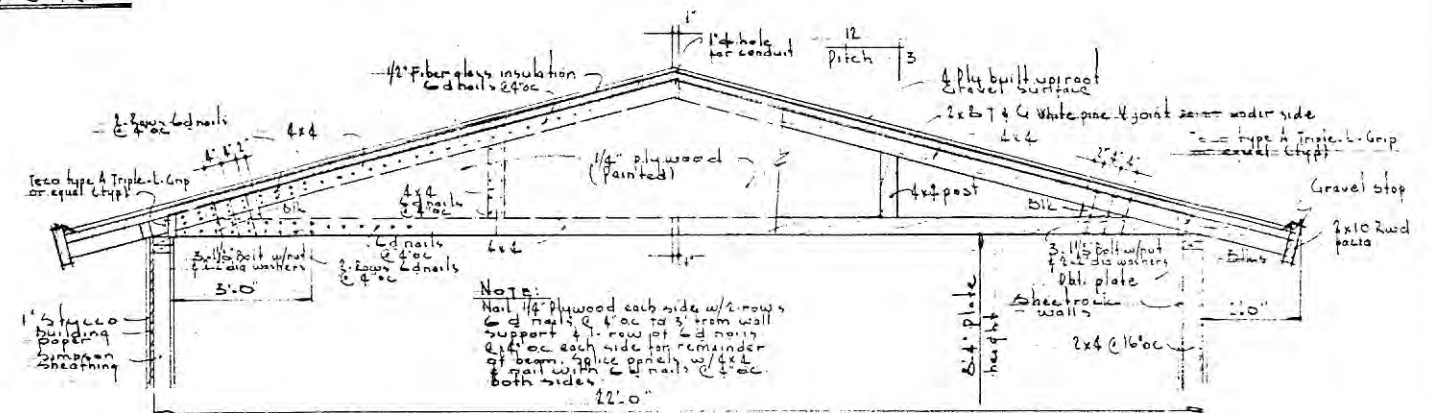
TRUSS DETAIL AT SLEEPING QUARTERS

Truss detail only by FRED L. HASTING - CIVIL ENGINEER

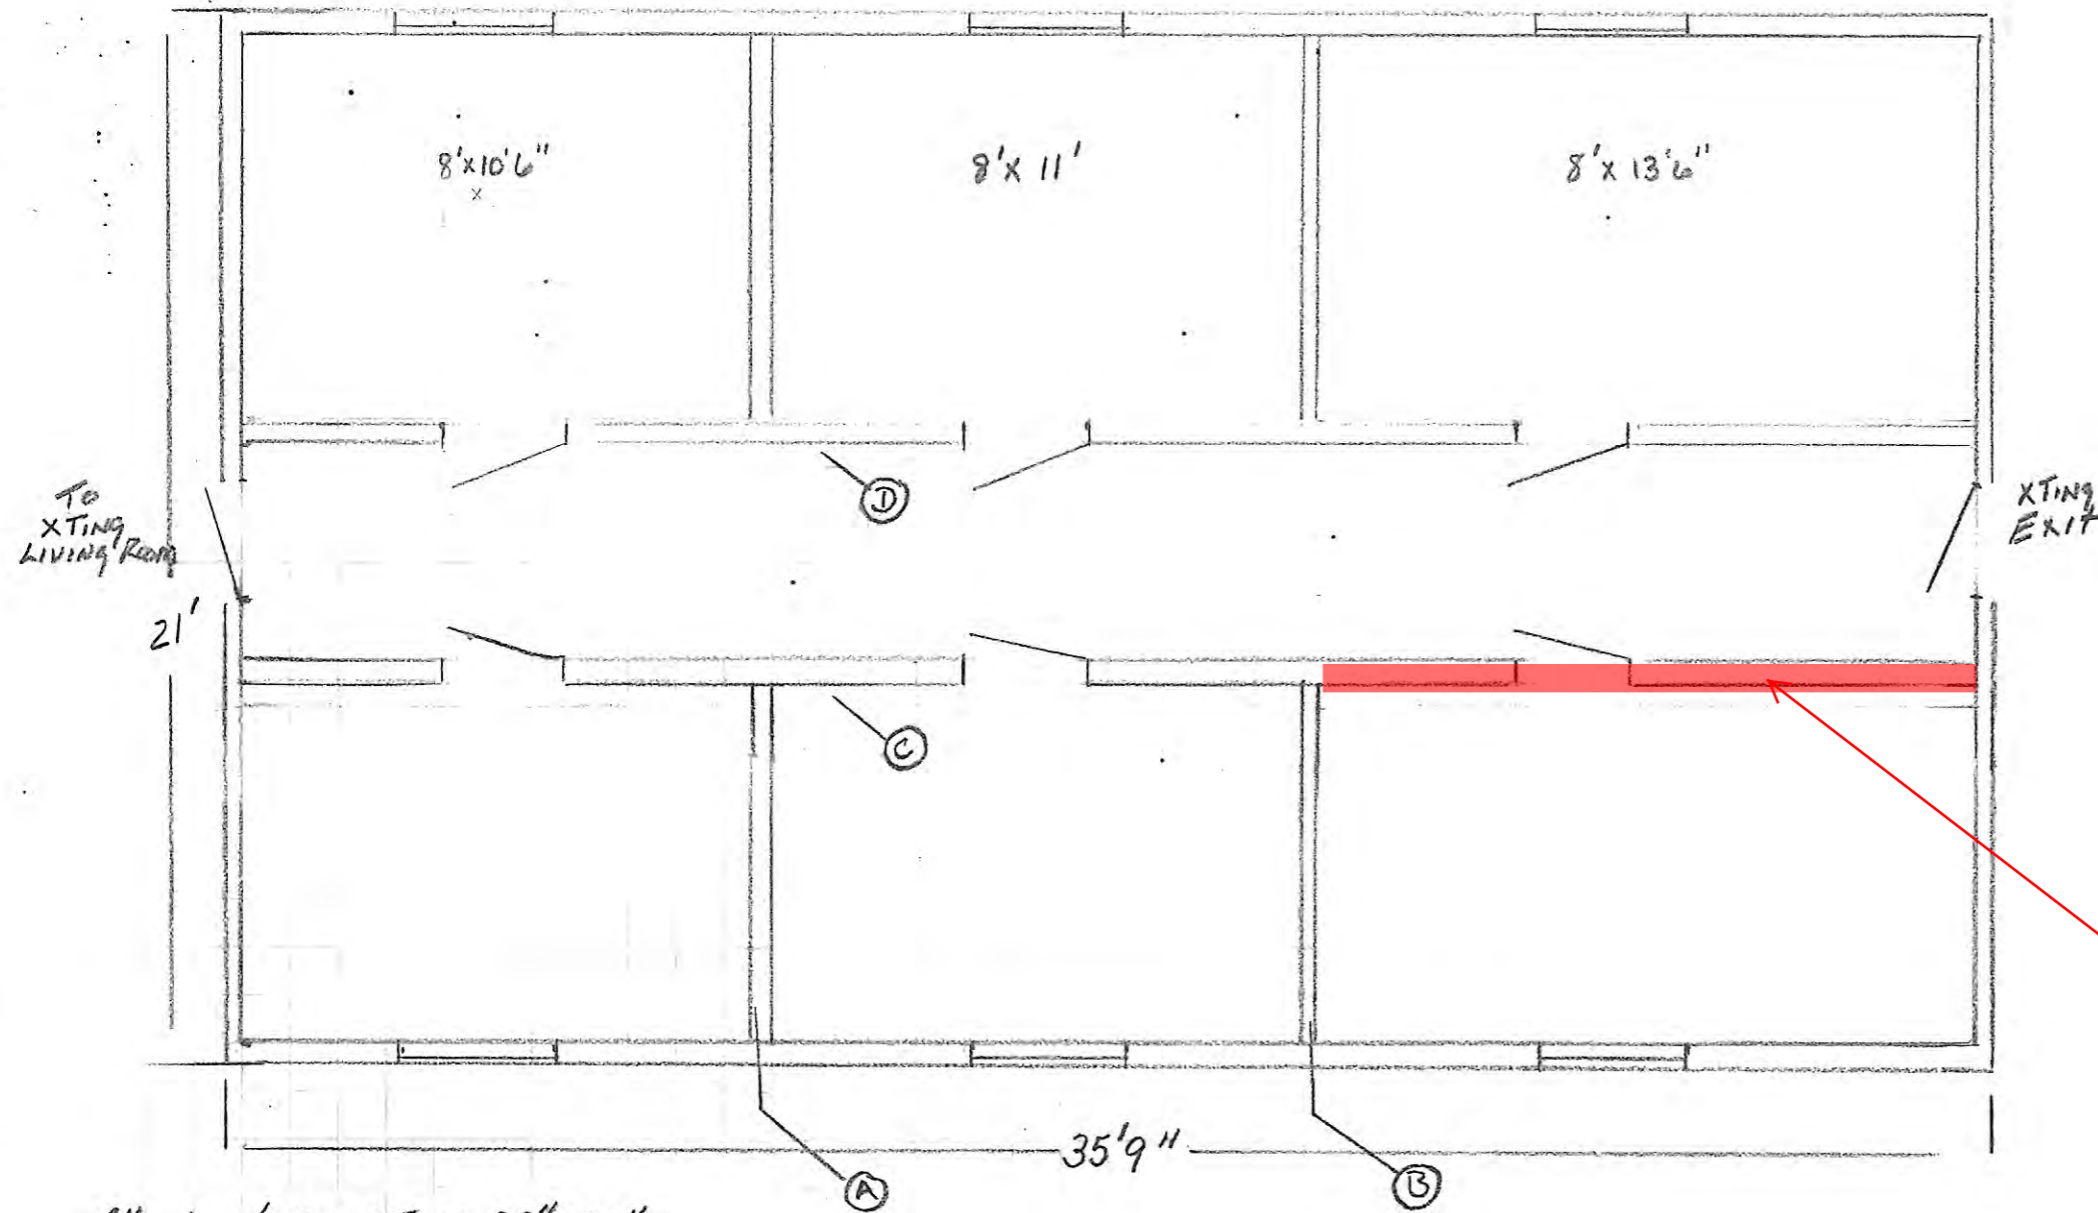
This wall was not built.  
Confirmed on 11/20/13.  
Note:  
"xting" means "Existing Condition"

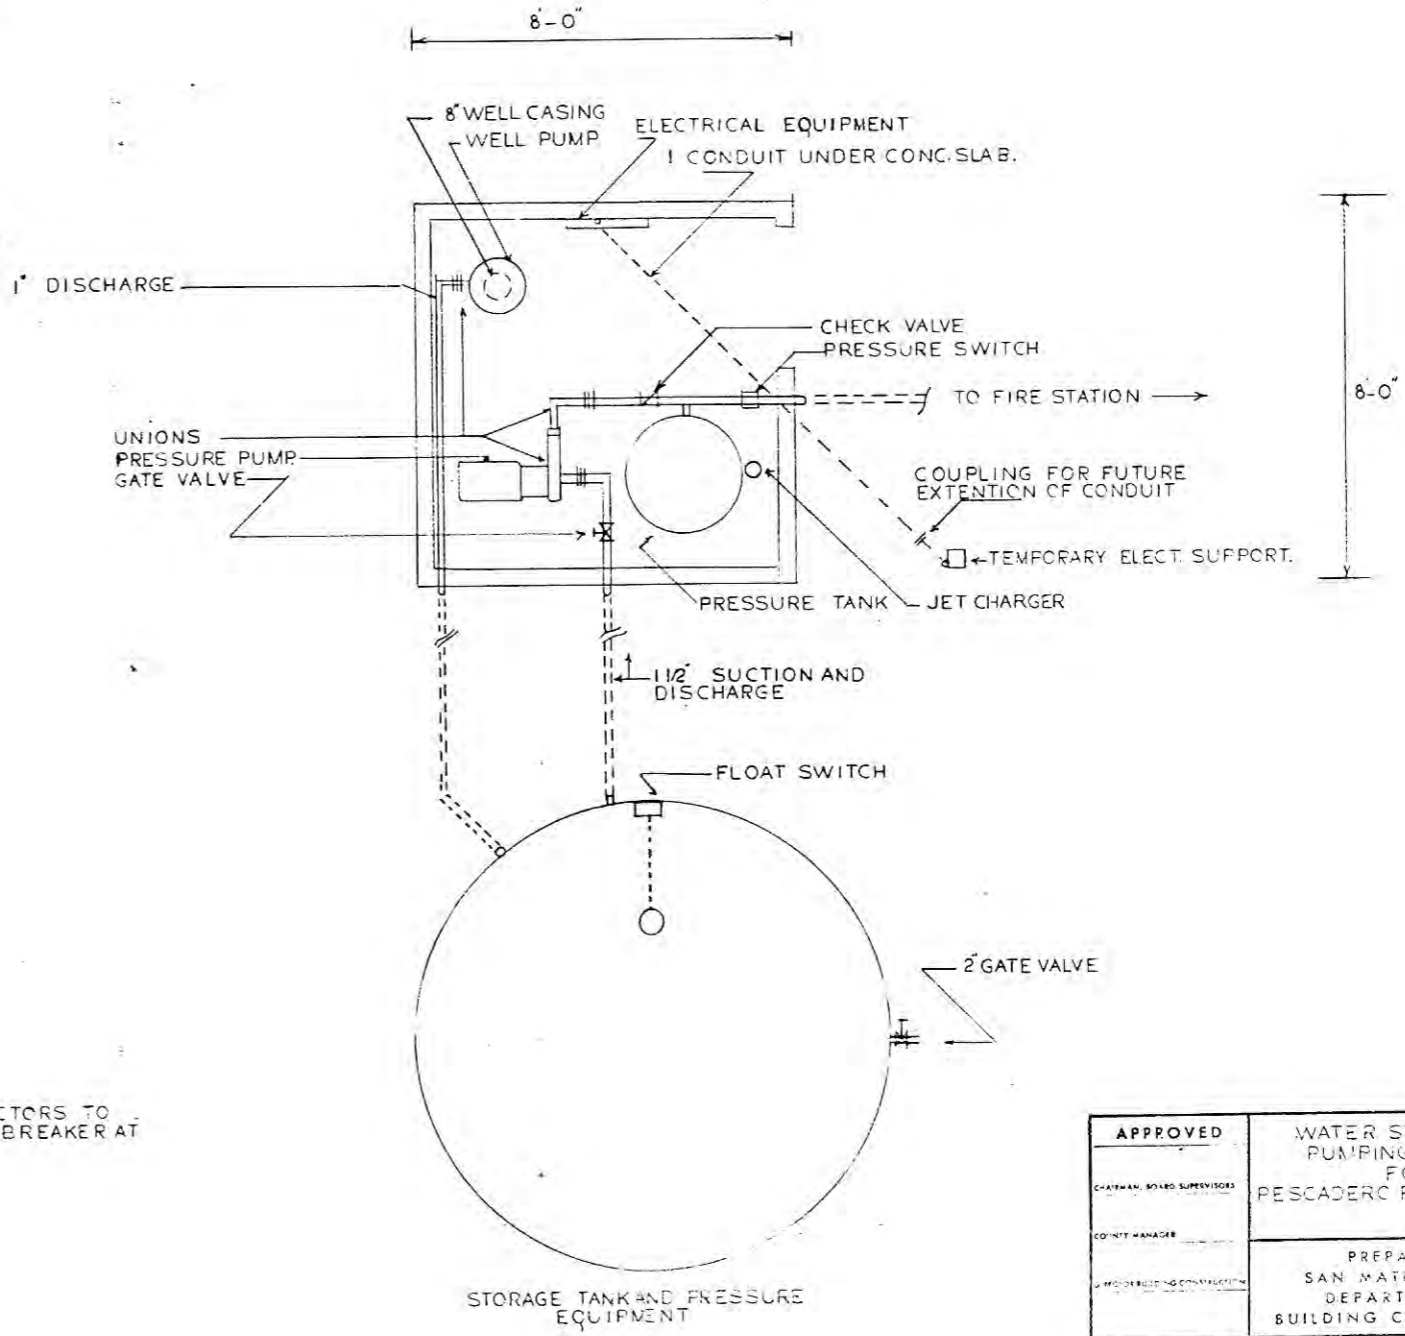
STORAGE TANK AND PRESSURE EQUIPMENT

APPROVED	WATER STORAGE AND PUMPING SYSTEM FOR PESCADERO FIRE STATION	DATE 6-28-57
CHAIRMAN, BOARD SUPERVISORS		1:2=10'
COUNTY MANAGER		J.C.P.
ENGINEER	PREPARED BY SAN MATEO COUNTY DEPARTMENT OF BUILDING CONSTRUCTION

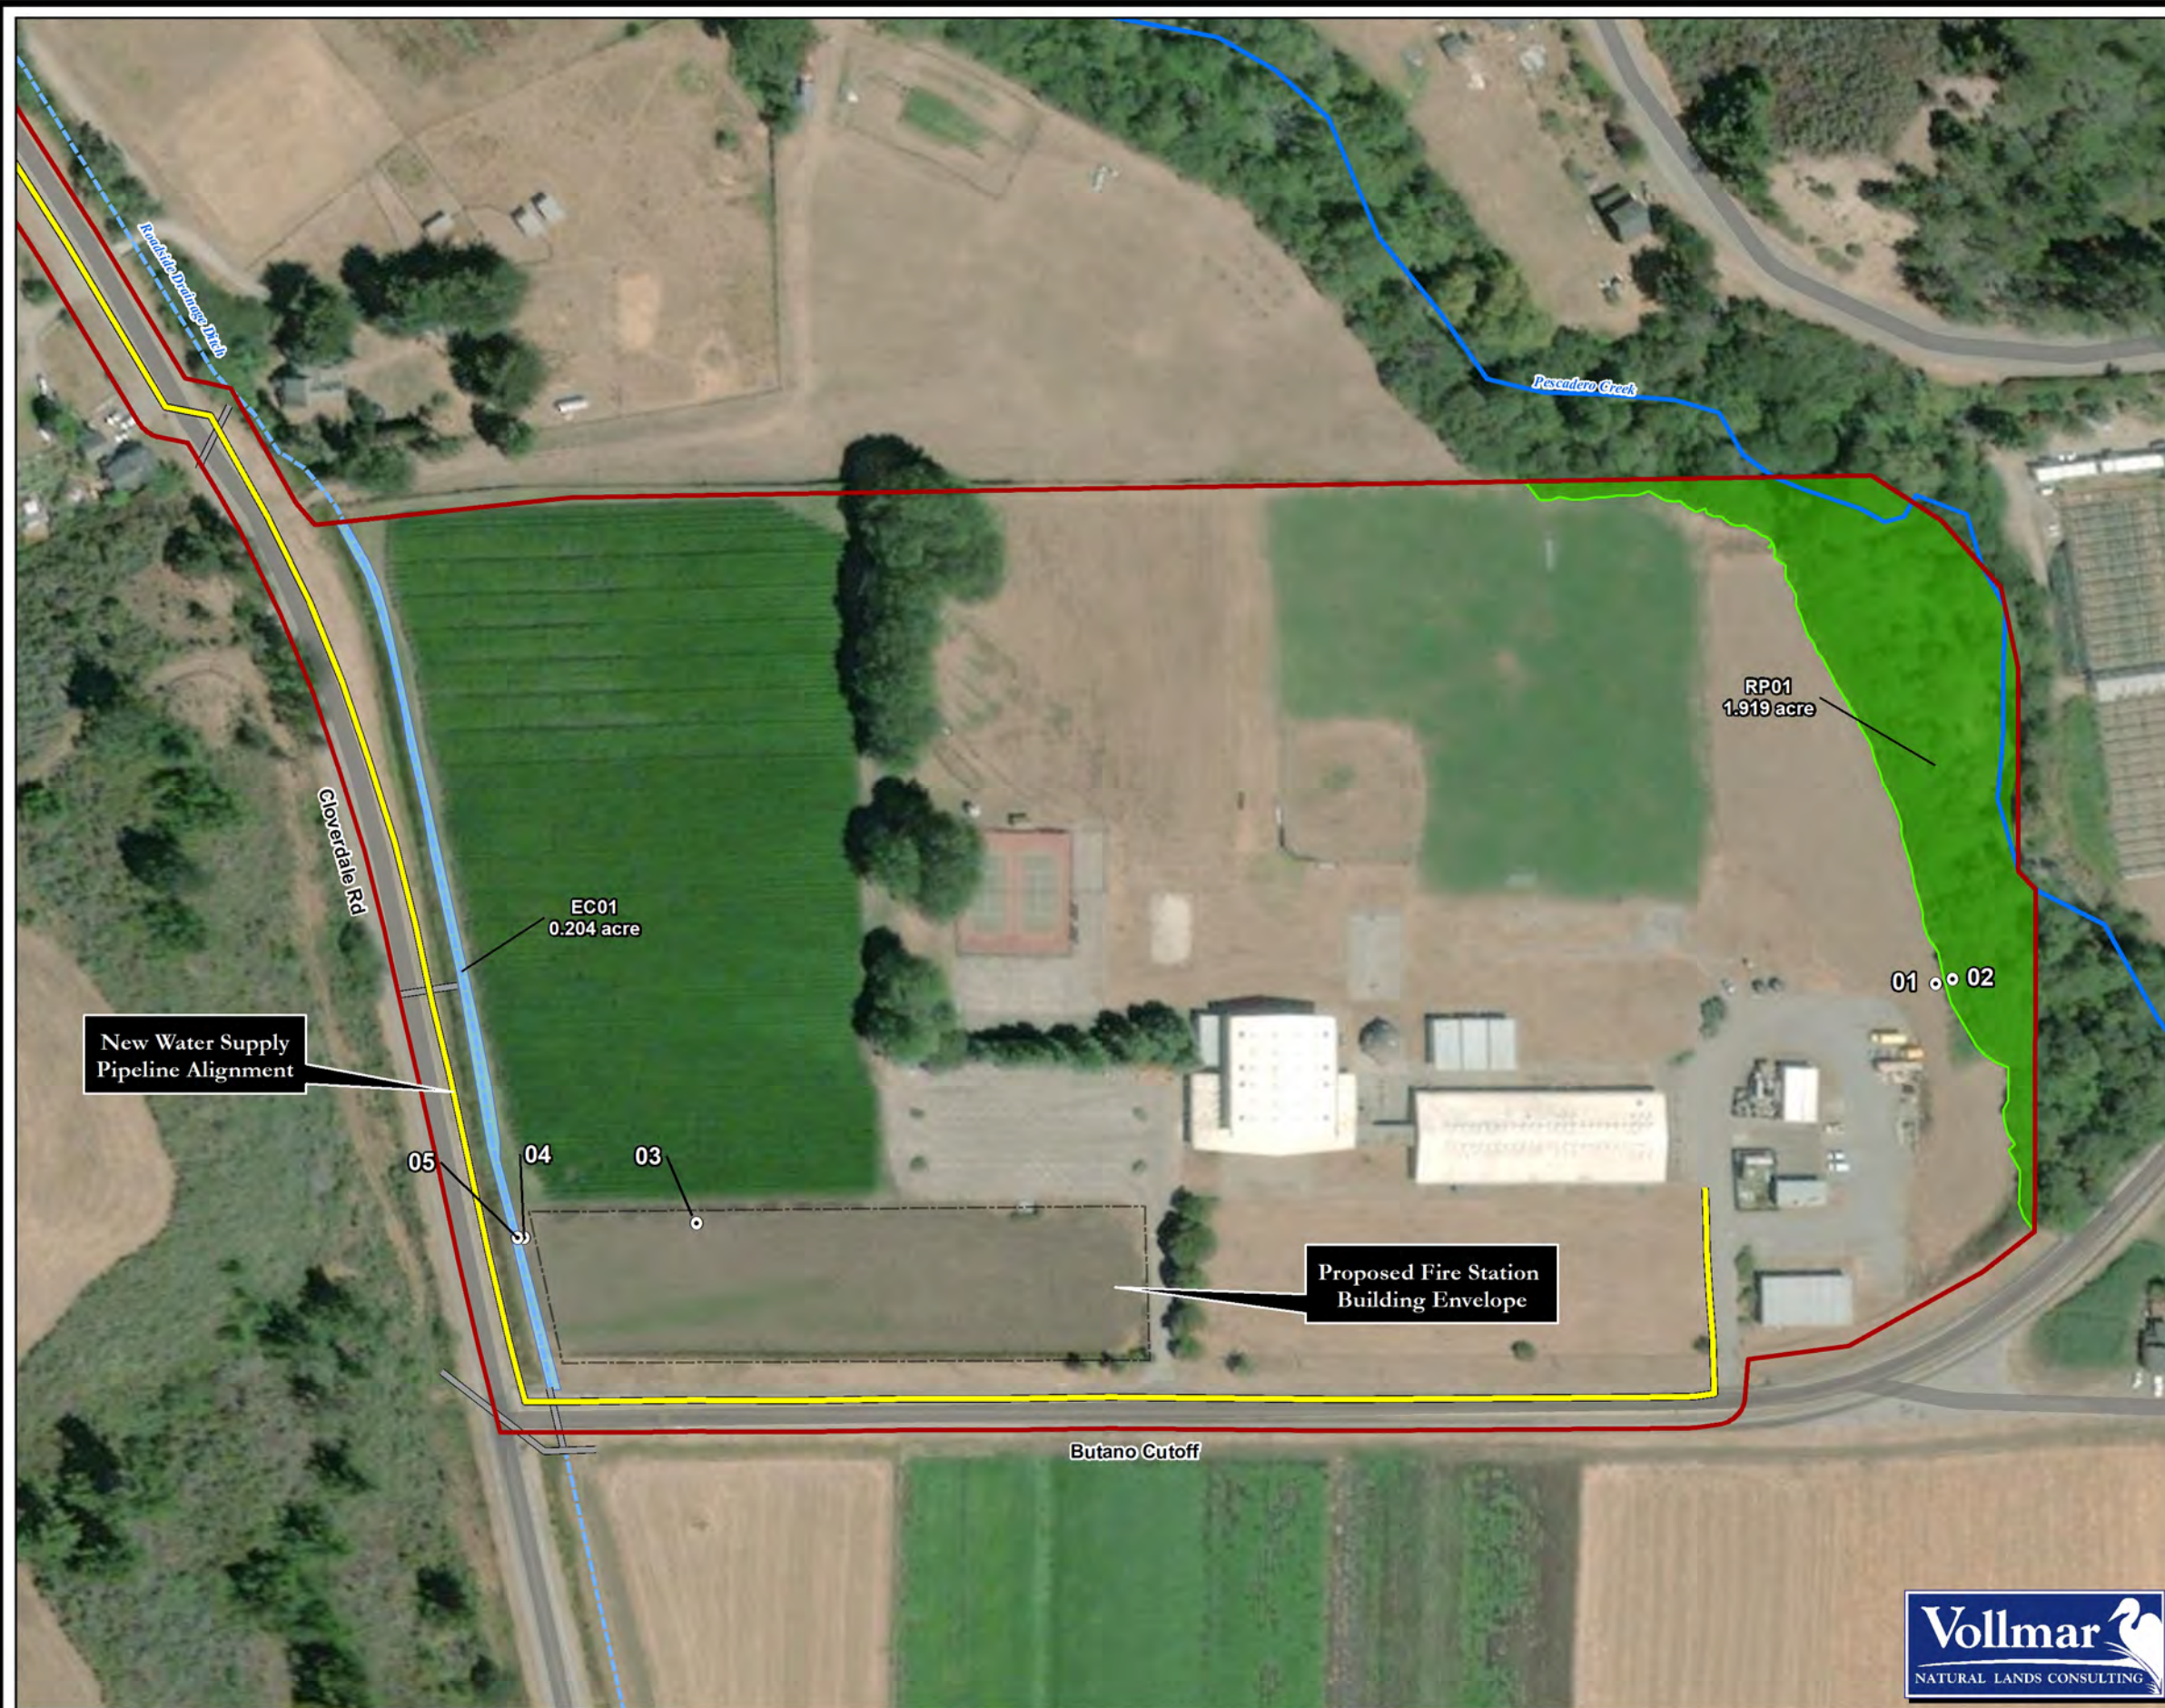
**FIGURE 4d**  
**Map of Potential**  
**Jurisdictional Waters**

- Project and Study Area (39.306 ac)
  - Road
  - Proposed Pipe Alignment
  - Existing Water Conveyance Structures
  - Stream
  - Roadside Drainage Ditch
  - Riparian Canopy Dripline
  - Sample Points
- Potentially Jurisdictional Features**
- Emergent Channel (0.204 ac / 860 linear ft)
  - Riparian (1.919 ac)

**Table 2** below lists each of these habitat types, and all features are mapped on **Figure 4d**, which also provide acreage values for the individual features. General conditions, as well as vegetation, soil, and hydrology indicators of each wetland feature type are described below. **Appendix A** provides representative photographs of the habitats, and **Appendix B** presents the delineation data forms, of which there are 5, that were recorded throughout the Study Area.

**Feature RP01.** This feature is 1.191 acre, and is habitat associated with Pescadero Creek located in the northeastern corner of the Pescadero High School property (see **Figure 4d**). Pescadero Creek is a perennial stream with a canopy of mature riparian vegetation and steep banks, approximately 10-20 feet from top of bank to the water level. The riparian habitat supported by Pescadero Creek features bed and bank topography and a semi-closed canopy with dense understory, consisting of a mix of both native and non-native plant species. Pescadero Creek flows in a northwesterly direction for 3.5 miles, then empties into the Pacific Ocean (a territorial sea). Delineation data points 01 and 02 are representative points for the riparian area, with point 01 representing upland conditions outside of the riparian habitat, and point 02 representing riparian habitat (**Figure 4d**).

**Feature EC01.** This feature is part of the roadside drainage ditch that connects to Pescadero Creek approximately ¼ mile north of the high school (see **Figure 4c** and **4d**). Delineation data point 05 represents the emergent channel habitat and point 04 is the paired upland point.

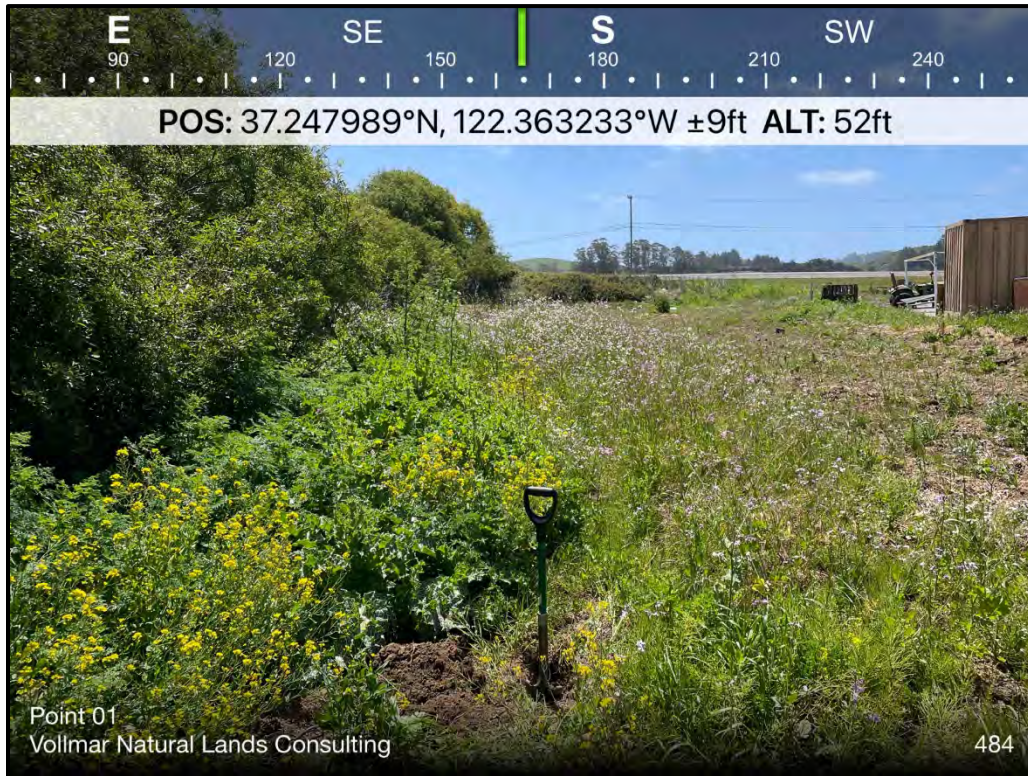
Point 01, facing south-southeast. Point 02 is located to the left of shovel, within riparian canopy.

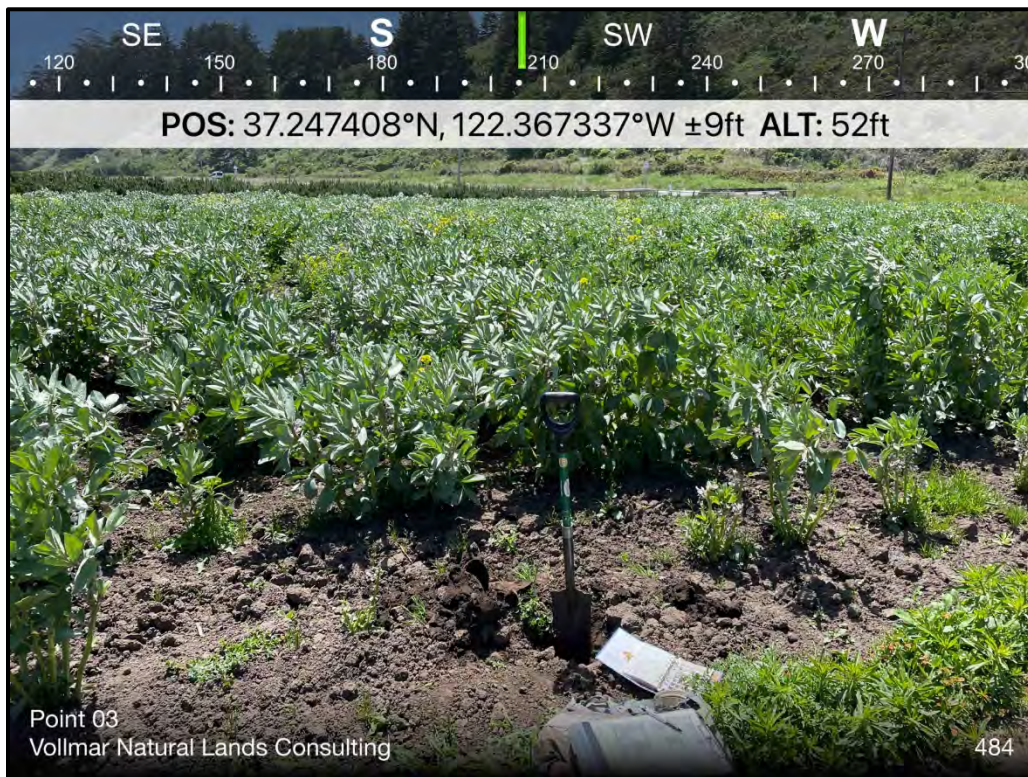
Point 03, facing southwest, located within fava bean field.

The vegetation at point 03 is representative of cultivated/disturbed conditions, located approximately halfway across the proposed building envelope for the fire station. Species observed include fava bean (UPL), growing with other species characteristic of disturbed habitats like scarlet pimpernel (*Lysimachia arvensis*, FAC) and mustard (*Brassica nigra*, UPL). This point does not support wetland vegetation.

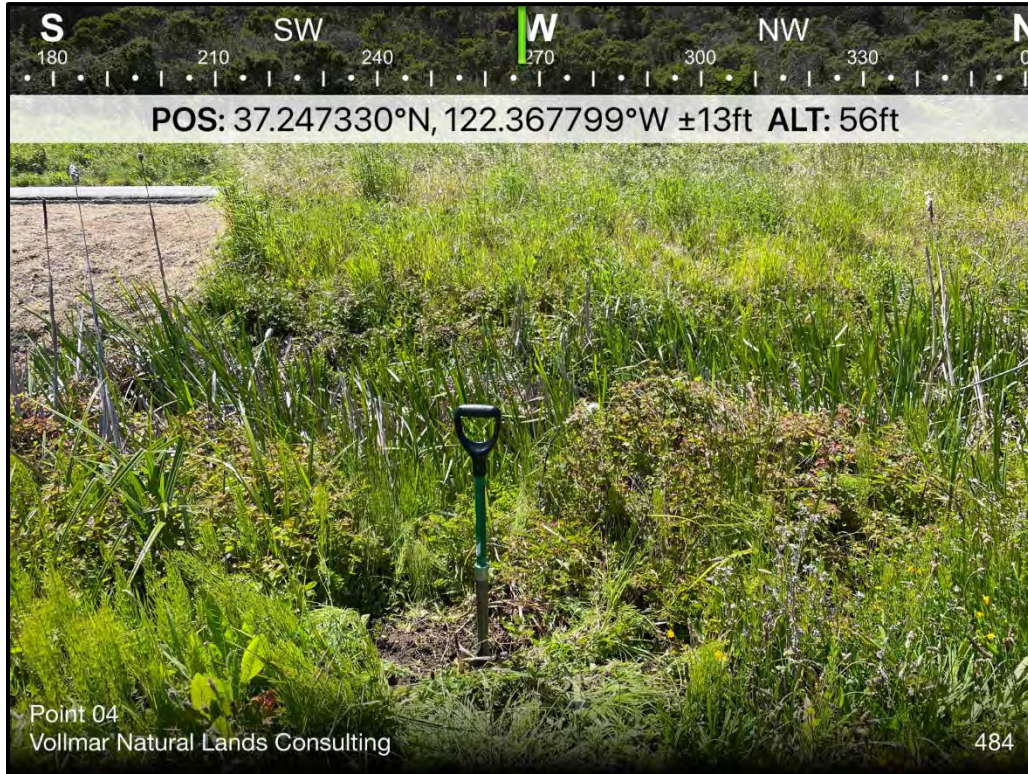
Point 04, facing west. Cloverdale Road is shown in the background, with emergent channel in the middle of the photo, and upland edge of channel in the foreground (comprised of California blackberry).

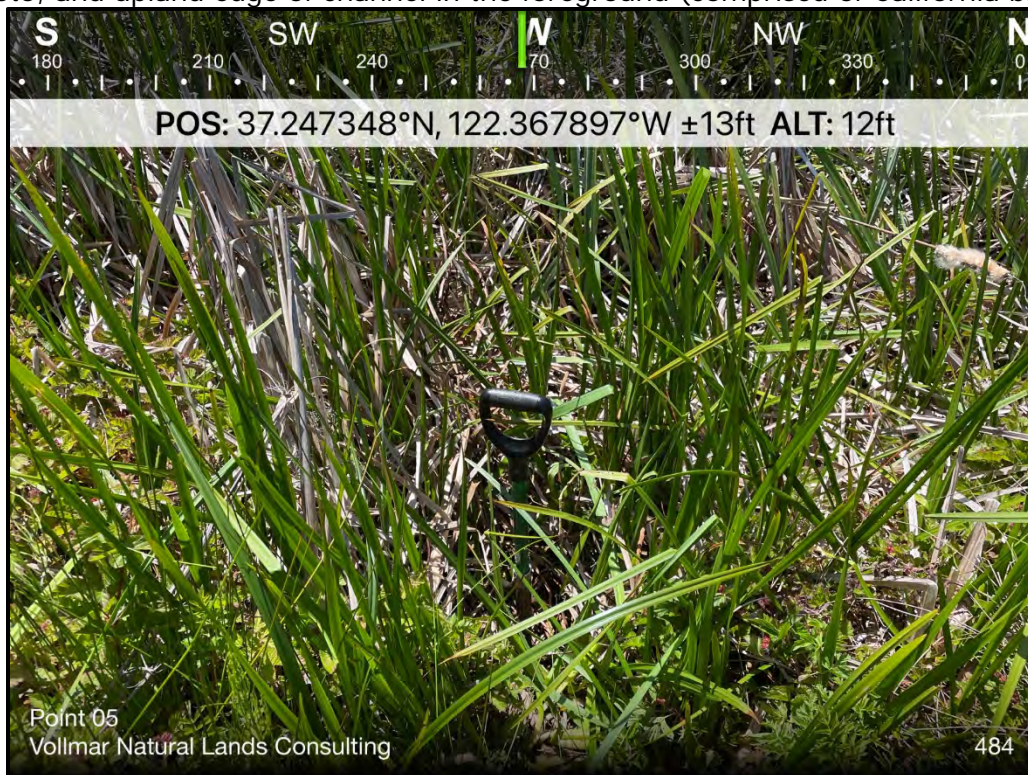
Point 05, facing west. Pure stand of cattails growing in emergent channel.

This feature supports emergent wetland species, with cattails (*Typha latifolia*, OBL) being dominant throughout the channel. Common rush (*Juncus effusus*, FACW) and giant horsetail was also observed to be growing in the channel, higher up along the edge of the feature.

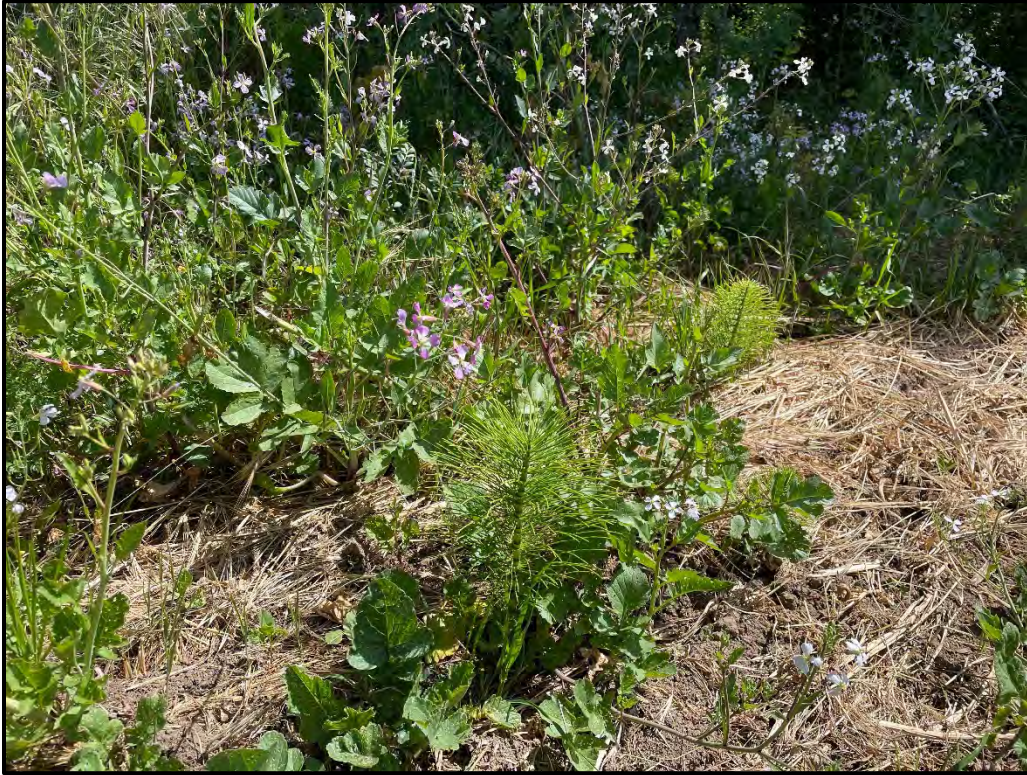
Giant horsetail growing among upland plant species, in an upland area outside of the Pescadero Creek riparian corridor. This photo was taken in an area that was not subject to recent soil/veg disturbance, and may represent mesic, but not wetland, conditions. Equisetum species are known to colonize disturbed areas and may be weedy, indicating that it may not be the best indicator for wetland, particularly if it's the only wetland species occurring.

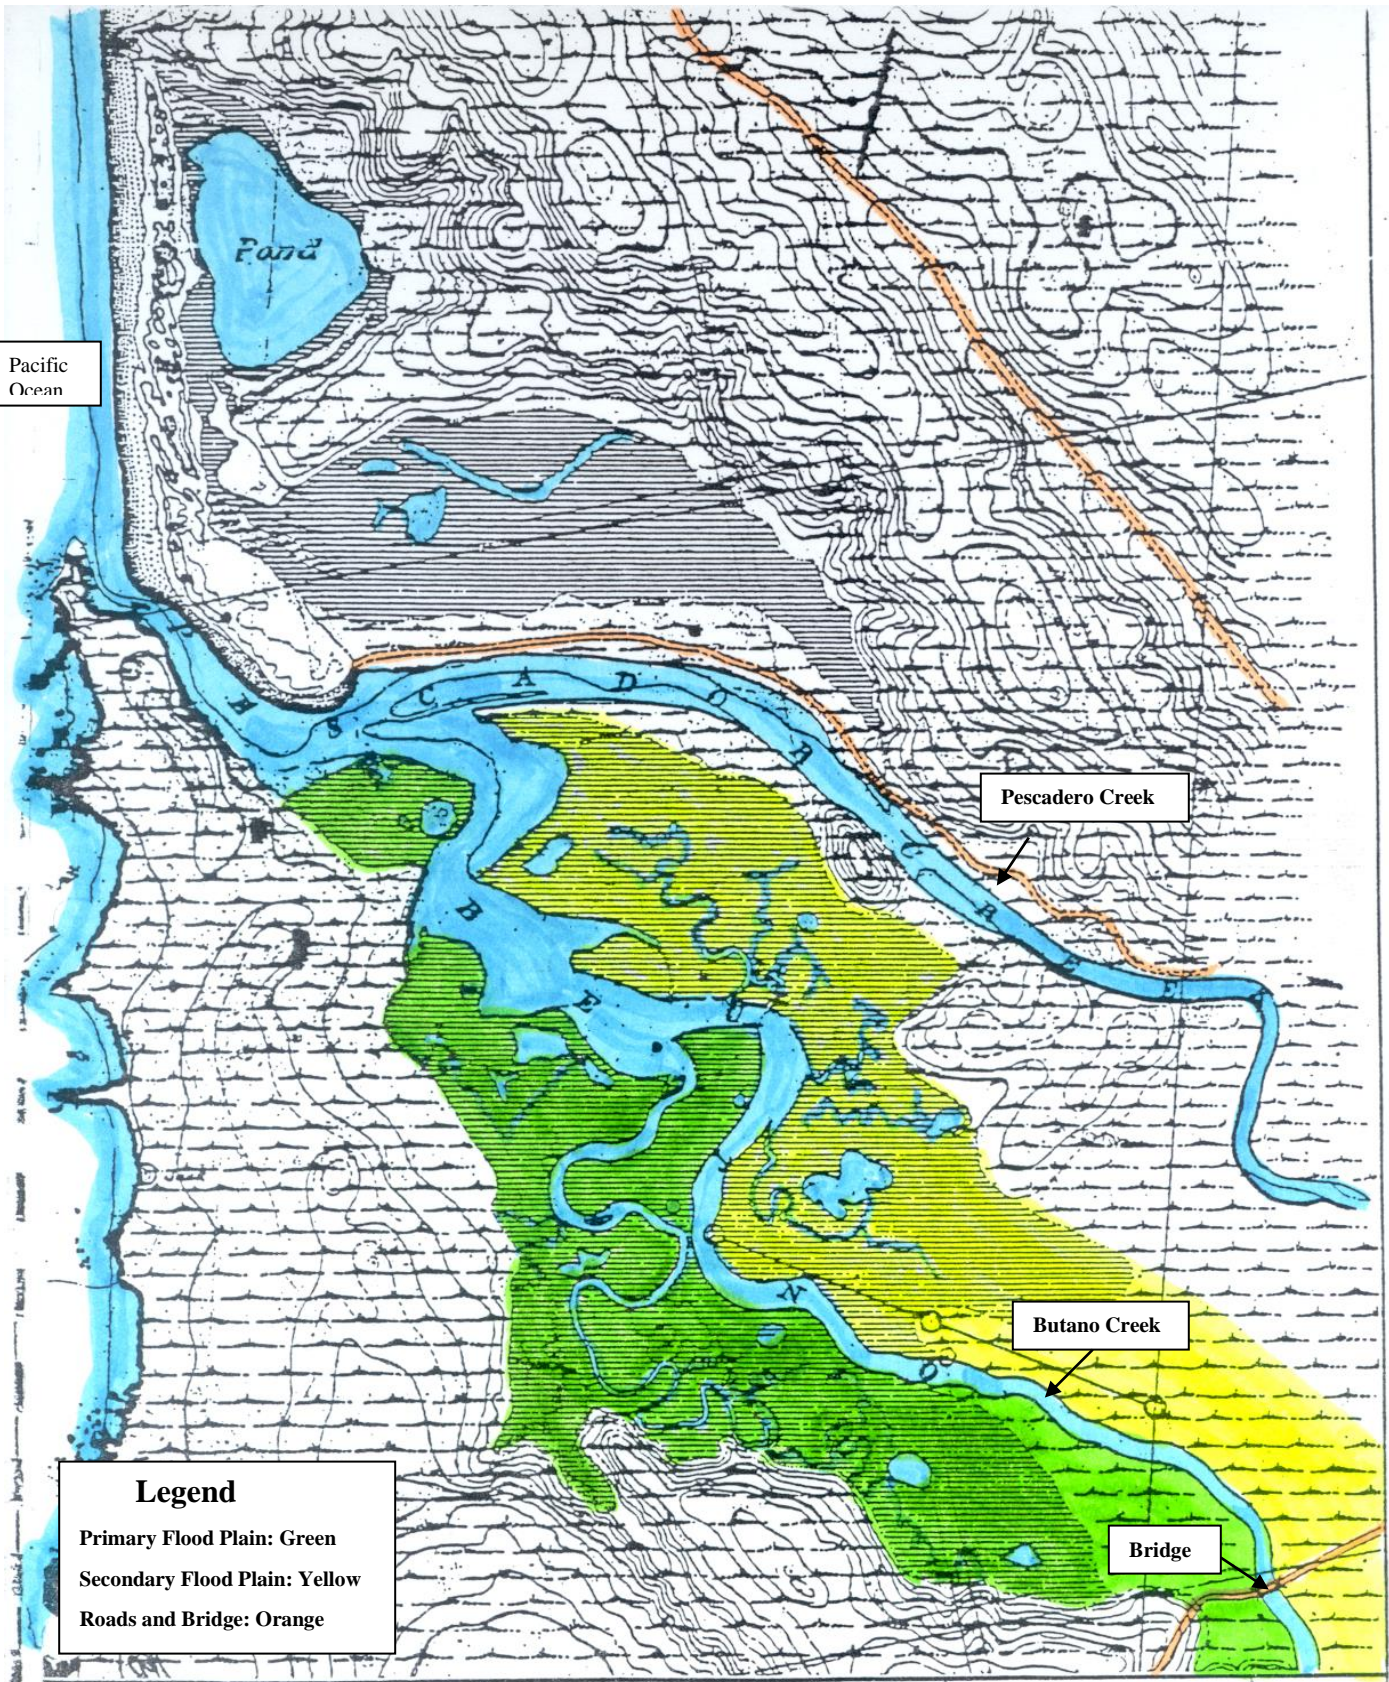
The lower channel of Butano Creek (then spelled Beutno, and still pronounced that way) was very wide, and both creek channels were much deeper than at present. There was already a bridge over Butano Creek (highlighted in orange and labeled on the 1854 map), close to the location of the present Pescadero Road Bridge. The low water line on the map extends up Butano Creek only a short distance,

In 1854 (shortly after California attained statehood) the U.S. Coast Survey created the first accurate map of the Pescadero Marsh. It was based upon a geodetic network and done by careful surveyors. This map is very useful to our management and restoration efforts because it accurately describes the marsh, in detail, when it was functioning hydraulically as a natural system, before it was significantly modified by European settlers. (Phillip Williams & Associates, 1990)

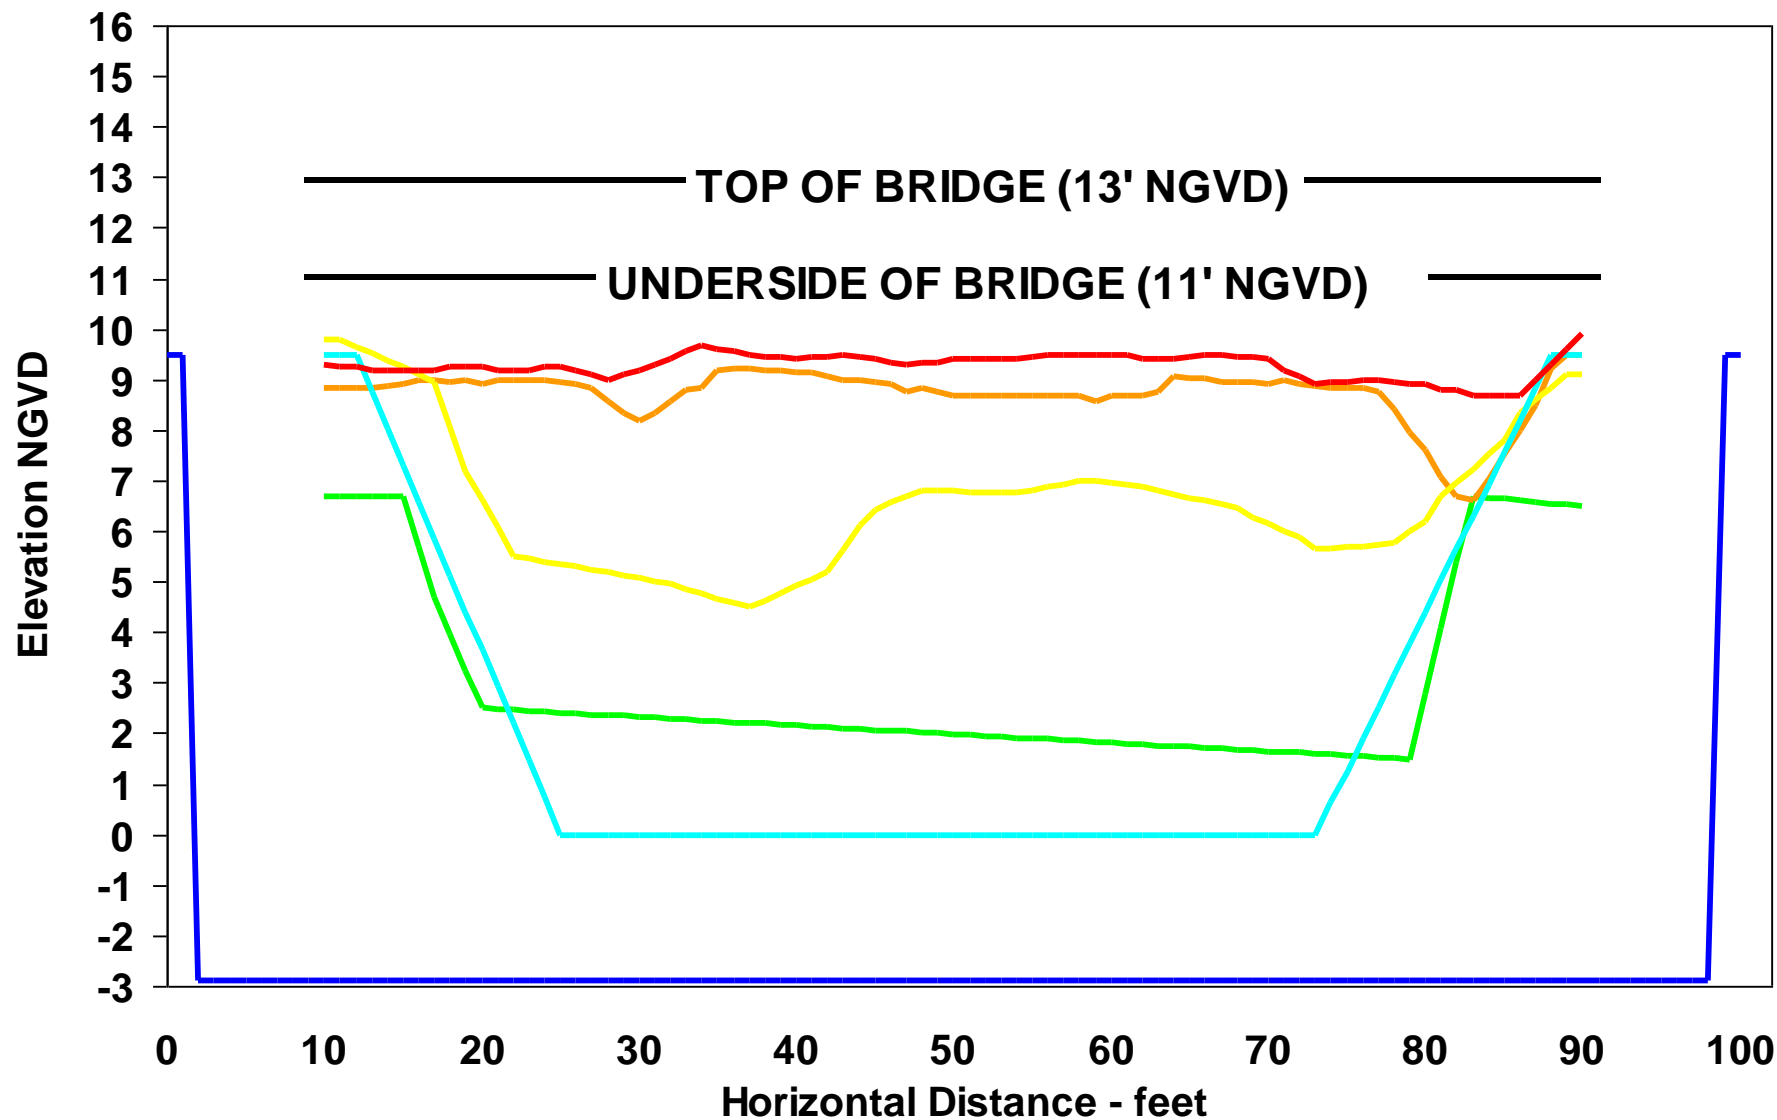
Cross-Sections of Butano Creek at Pescadero Road Bridge

- 1854 U.S. COAST SURVEY
- ARMY CORP 1965
- COOK - APRIL 21, 1999
- DAWDY 1987
- BRIDGE AS BUILT 1961
- COOK - JANUARY 10, 2001

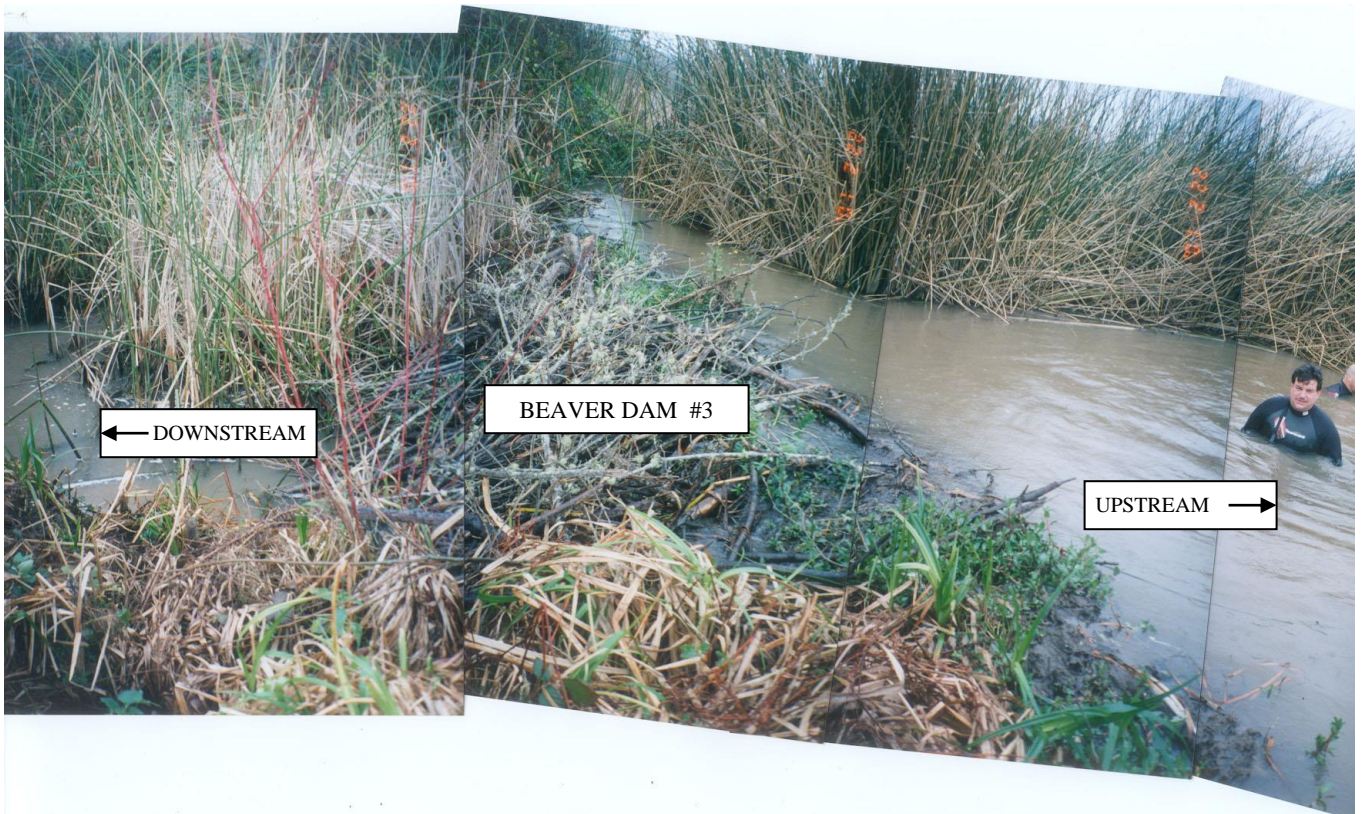
Butano Creek and Beaver Dam #3 Prior to Removal
