## Item 12

**SUBJECT:** Consideration of Local Coastal Program amendment to facilitate future construction of a replacement fire station (County Fire Station Number 59) and extension of CSA-11 to serve the fire station and Pescadero Middle/High School located at 350-360 Butano Cut Off. Both projects are located in the Pescadero area of the unincorporated San Mateo County.

County File Number: PLN 2021-00056 (County of San Mateo)

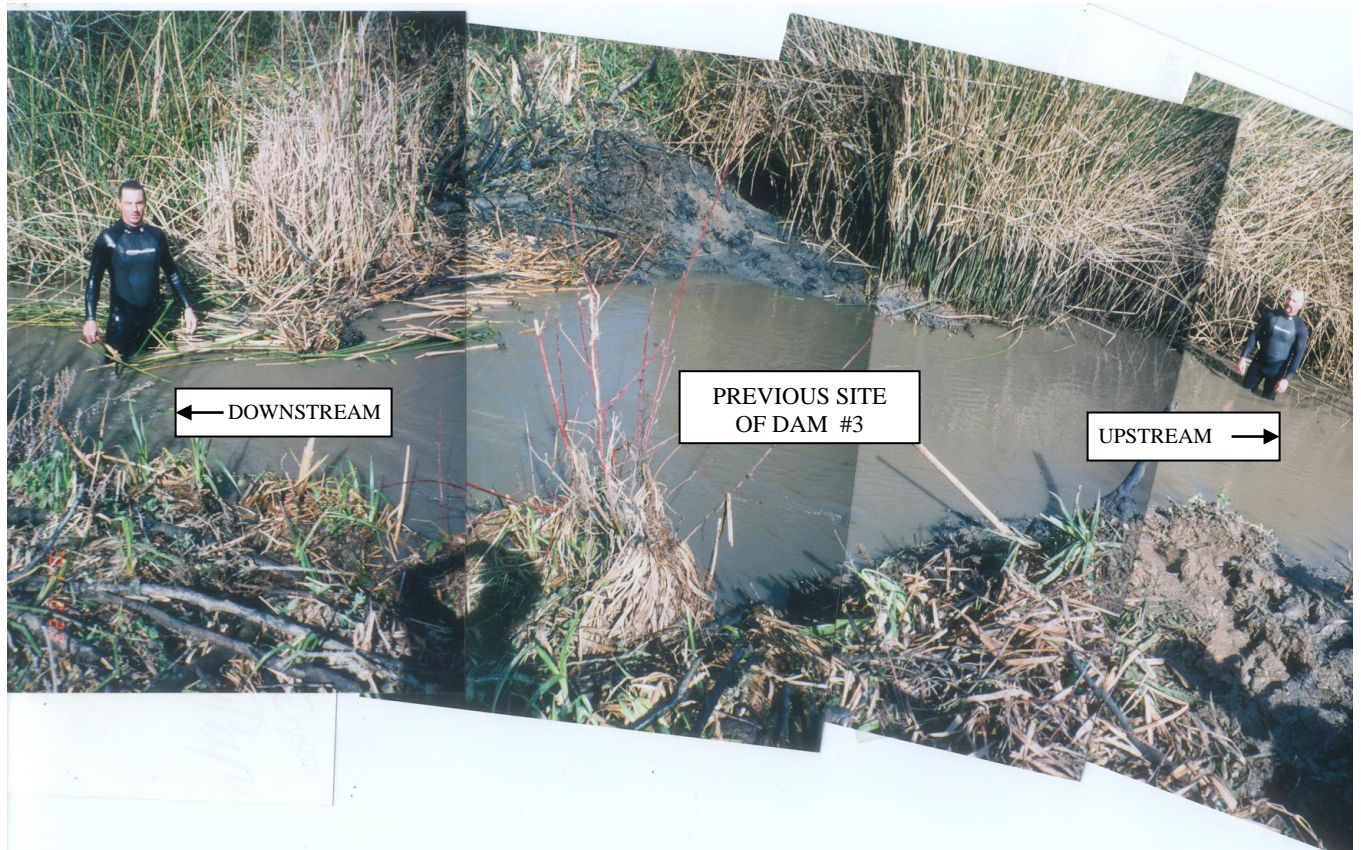
Butano Creek Channel Re-Established after Removal of Beaver Dam #3

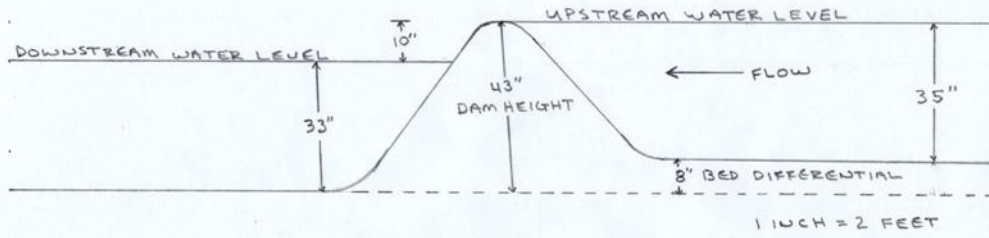
### DAM #1

#### DAM WIDTH & WATER DEPTH

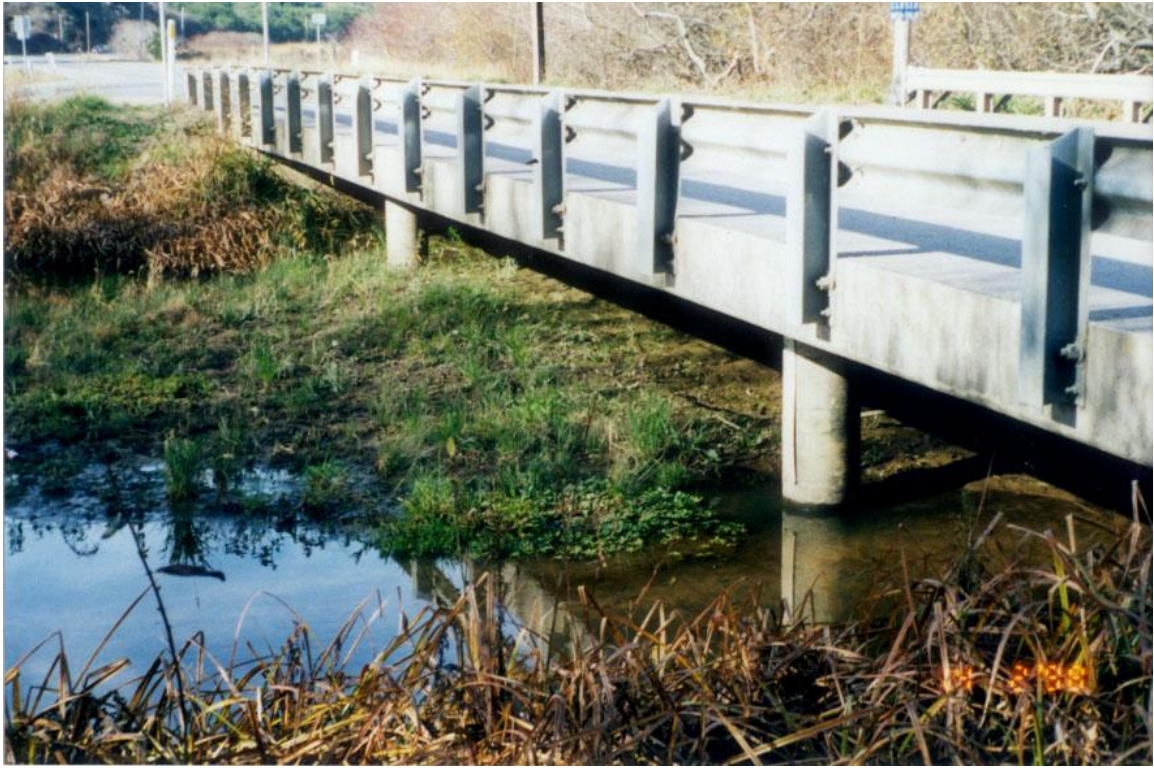
Pescadero Road Bridge Prior to Beaver Dam Removal (January 1999)

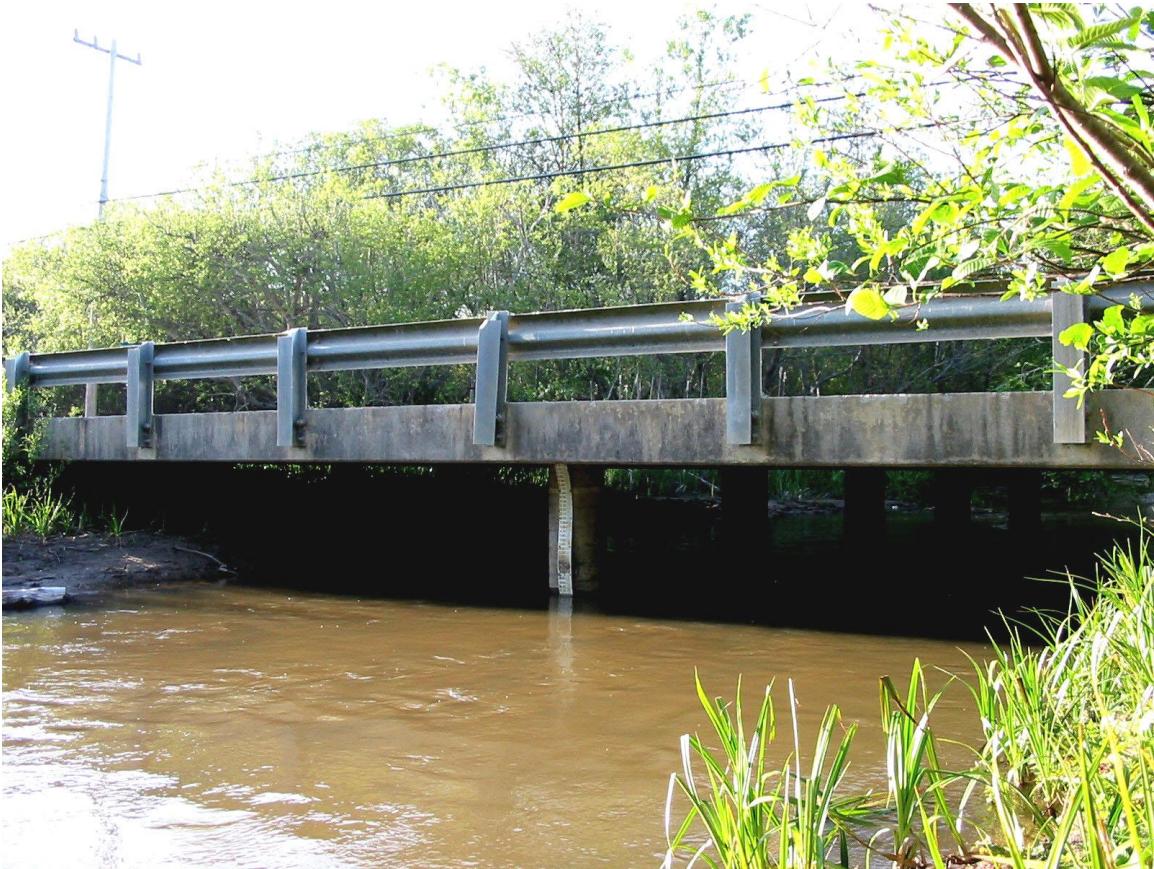
Pescadero Road Bridge after Beaver Dam Removal (Winter 2002)

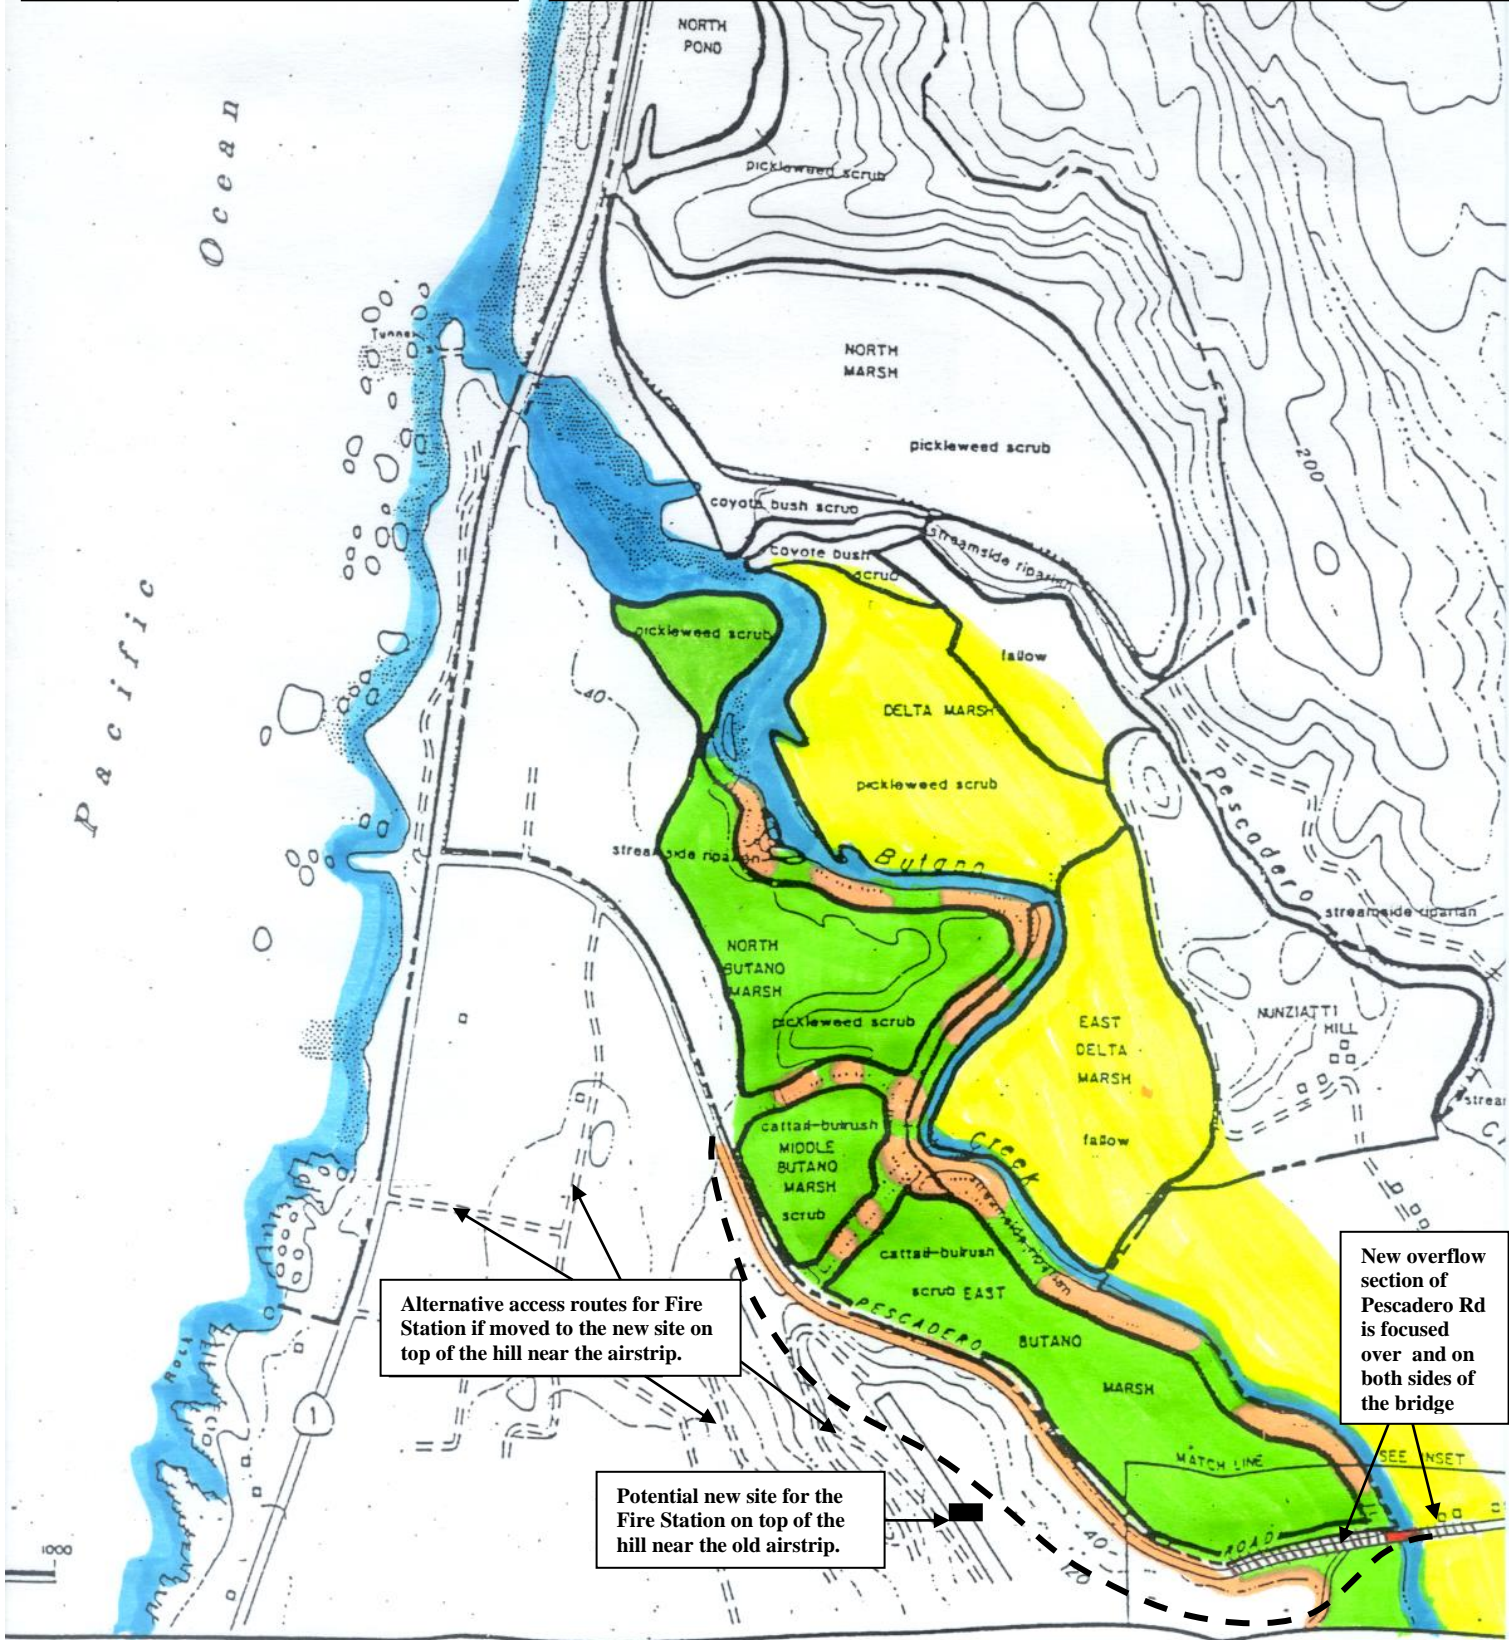
## With the Butano Creek Channel Restored And Reconnected to its Primary Flood Plain
