GEOTECHNICAL AND GEOLOGIC INVESTIGATION

*Proposed New Residence
Vacant Lot on Arbor Lane
APN# 037-123-430
Moss Beach, San Mateo County, California*

Re: Geotechnical and Geologic Investigation
Proposed New Residence
Vacant Lot on Arbor Lane
APN# 037-123-430
Moss Beach, San Mateo County, California

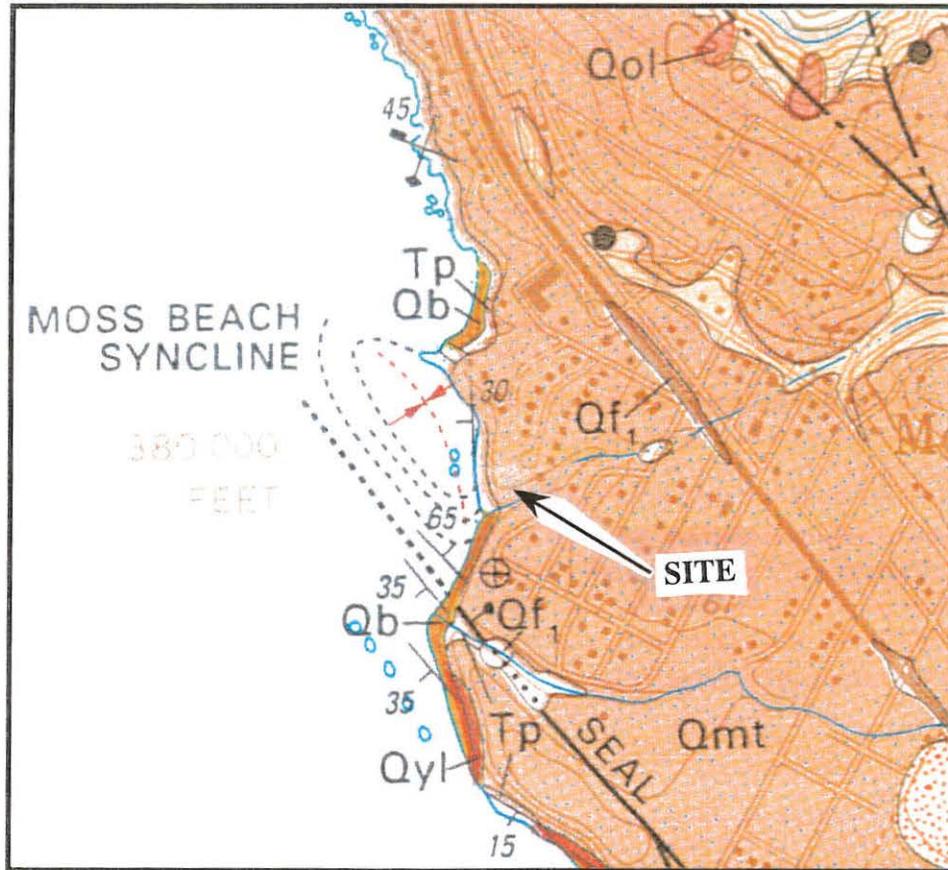
Figure 3

A A' Cross Section (Figures 9 - 11)
-

The purpose of our study was to evaluate the soil and geologic conditions that occur at the site, and if found geologically feasible, to provide geotechnical recommendations and design criteria pertaining to building foundations, site grading, retaining walls, drainage, and other items that relate to the site soil and geologic conditions. An overview of the property, including the location of test borings performed in conjunction with our study, is included on the attached Site Plan/Engineering Geologic Map, Figure 3.

In order to evaluate the geotechnical engineering characteristics of the soil layers which underlie the site, 3 borings were drilled at the approximate locations indicated on the attached Figure 3. The borings were drilled by Hew Drilling of Palo Alto on April 20, 2016, with hollow stem augering equipment. Relatively undisturbed samples were recovered in thin brass tubes from the borings at selected intervals with a free-falling, 140-pound automatic hammer advancing modified California, and in some cases standard penetration, drive samplers 18 inches into the subsurface soil layers. The brass tube encased samples were labeled in the field and carefully sealed to preserve their in-situ moisture content.

We excavated three test borings on the property at the approximate locations shown on the attached Figure 3. In general the materials encountered in the borings were very consistent. The only differences (and very slightly at that) were the depths to the various soil horizons at each boring location.

The conclusions and opinions expressed in this report are based upon the exploratory borings that were drilled on the site, spaced as shown on the Site Plan/Engineering Geologic Map, Figure 3. While in our opinion these borings adequately disclose the soil conditions across the site, the possibility exists that abnormalities or changes in the soil conditions, which were not discovered by this investigation, could occur between borings.

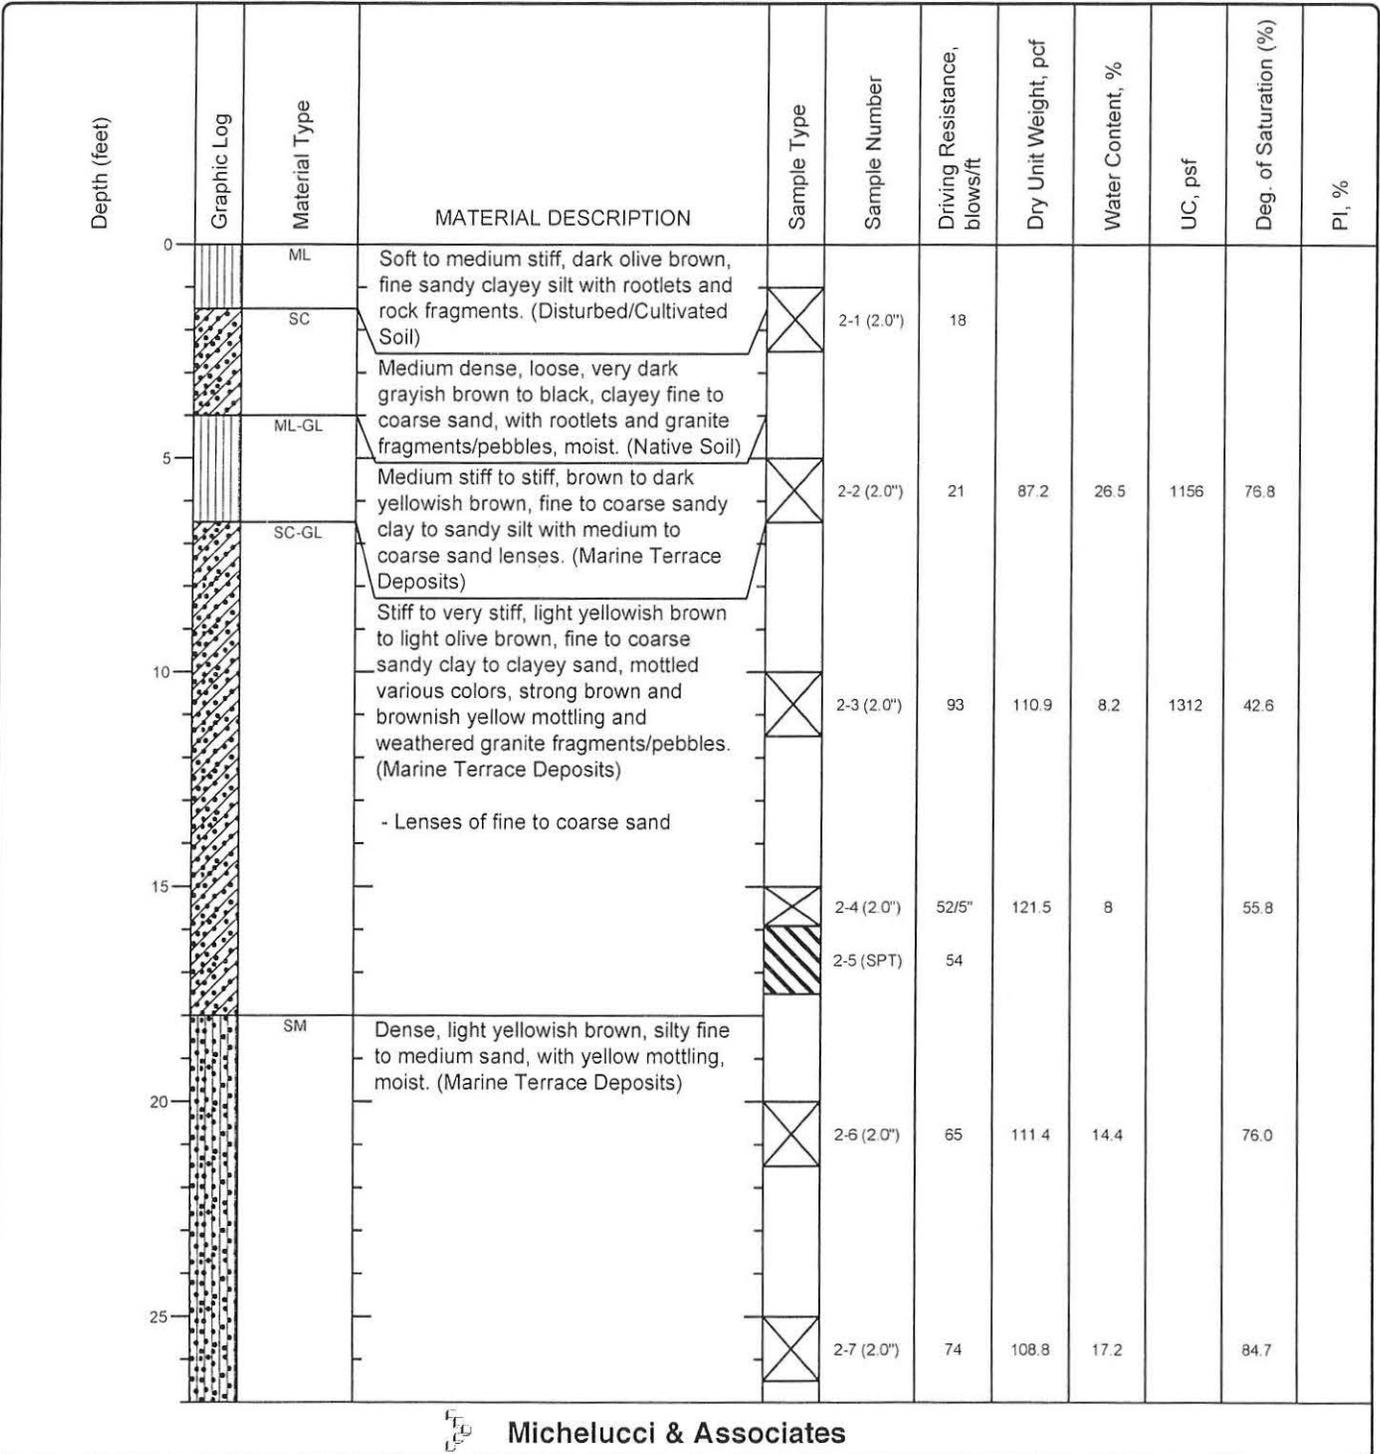
Project: 199 Arbor Lane Project Location: Moss Beach, CA Project Number: 16-4572	Log of Boring 2 Sheet 1 of 2
---	---

Date(s) Drilled 04/20/16	Logged By J.P	Checked By J.P
Drilling Method 6" hollow stem	Drill Bit Size/Type	Total Depth of Borehole 50.16 feet
Drill Rig Type CME-75 Truck Rig	Drilling Contractor	Approximate Surface Elevation
Groundwater Level and Date Measured Dry	Sampling Method(s) 2.0", SPT	Hammer Data 140 lb; Automatic
Borehole Backfill Grout

Laboratory tests were performed upon samples that were extruded from the brass tubes. These tests, which are useful in evaluation of the general strength properties of the materials tested, including the determinations of moisture content, dry density and unconfined compressive strength of selected samples. The results of these tests, along with the resistance to penetration of the sampler, are listed opposite the corresponding sample location on Figures 4 through 6. A Boring Log Key is also included as Figure 7.

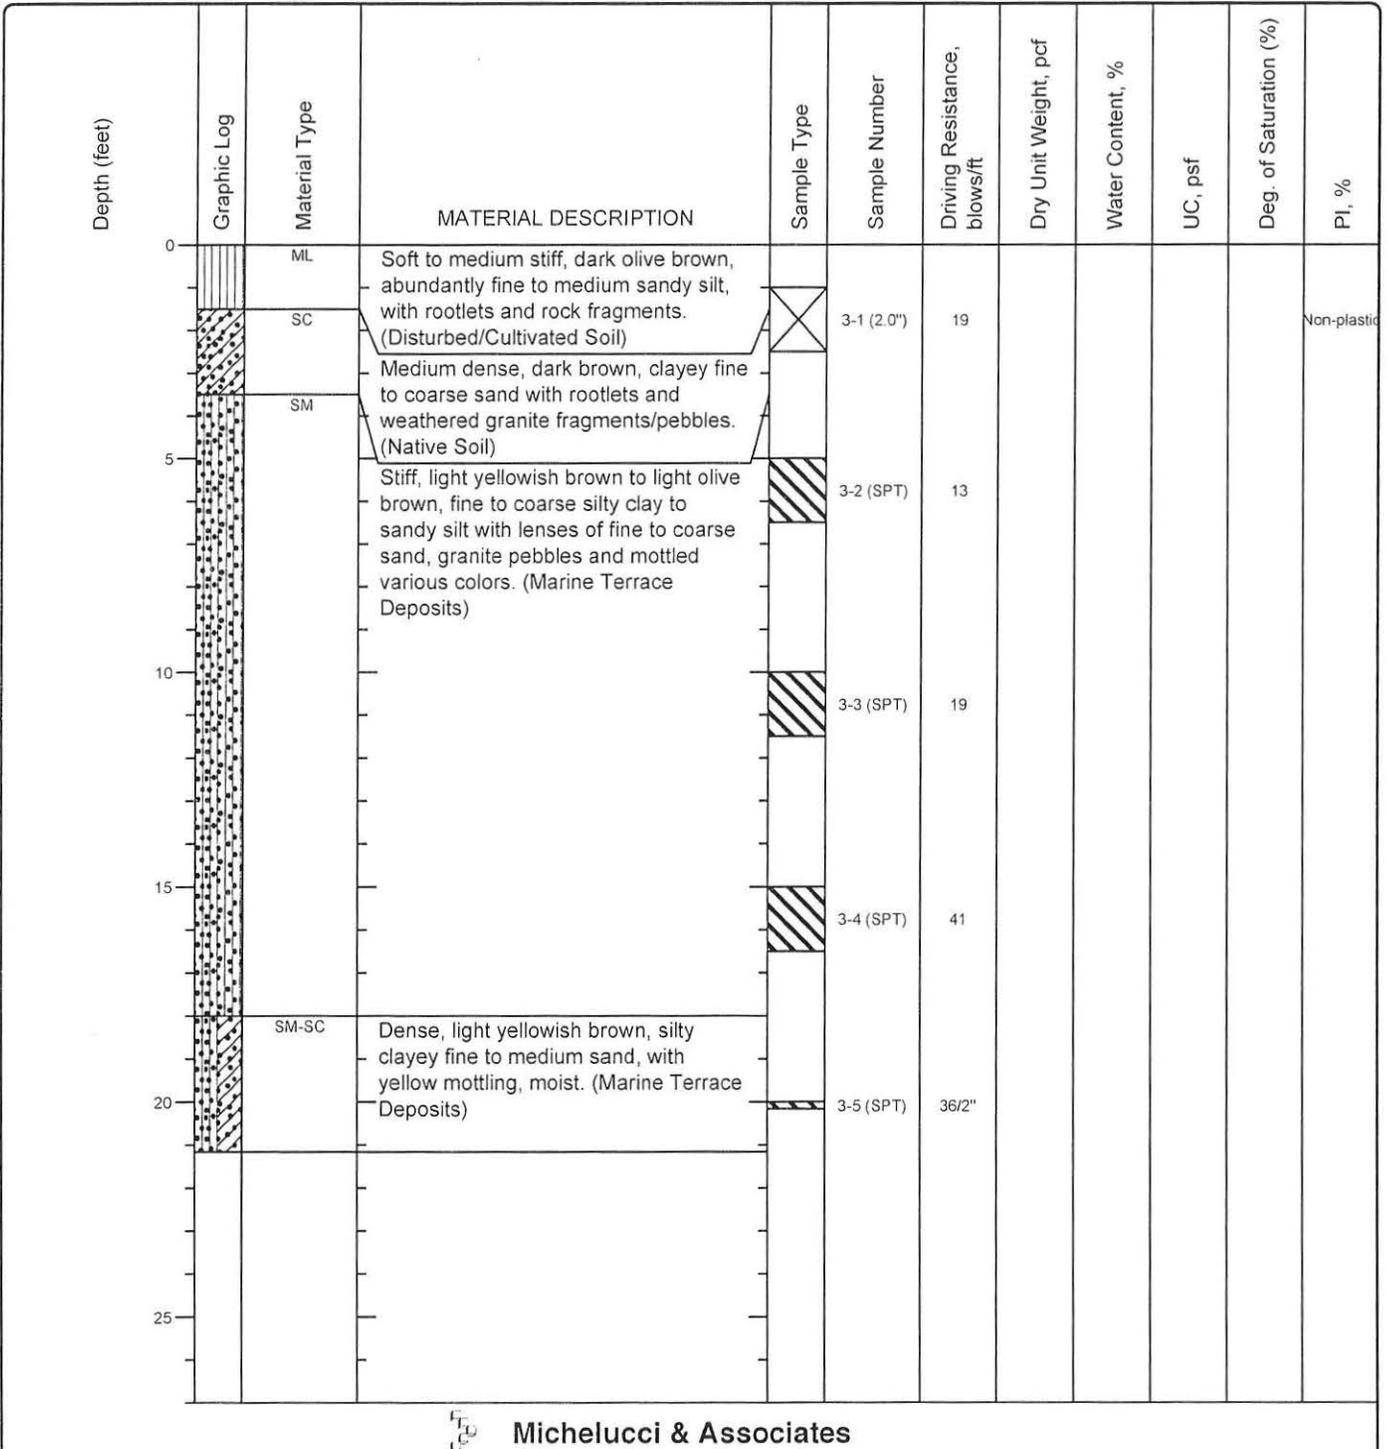
Figure 6

Project: 199 Arbor Lane Project Location: Moss Beach, CA Project Number: 16-4572	Log of Boring 3 Sheet 1 of 1
---	---

Date(s) Drilled 04/20/16	Logged By J.P	Checked By J.P
Drilling Method Continuous flight 6"	Drill Bit Size/Type	Total Depth of Borehole 21.16 feet
Drill Rig Type CME-75 Truck Rig	Drilling Contractor	Approximate Surface Elevation
Groundwater Level and Date Measured Dry	Sampling Method(s) 2.0", SPT	Hammer Data 140 lb; Automatic
Borehole Backfill Grout

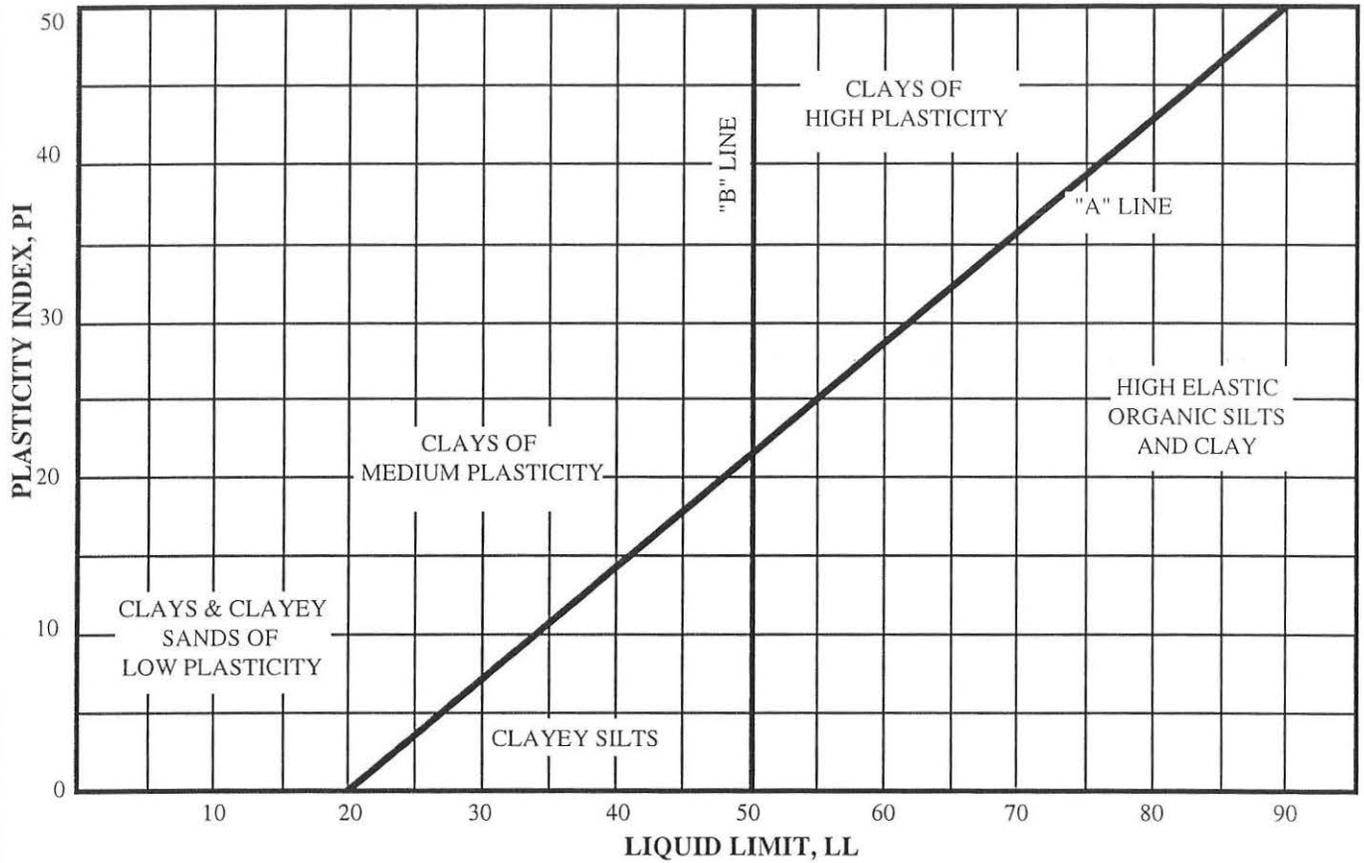
CLASSIFICATION TEST RESULTS									
SAMPLE IDENTIFICATION			ATTERBERG LIMITS			GRAIN SIZES % DRY WT.			
SAMPLE	LETTER DESIGNATION	DESCRIPTION	LIQUID LIMIT	PLASTICITY INDEX	SHRINKAGE LIMIT	SAND	SILT	CLAY	COLLOIDAL
3-1	-	Dark yellowish brown to brown silty clayey fine sand with pebbles (Native Soil)	NON PLASTIC			:	:	:	:

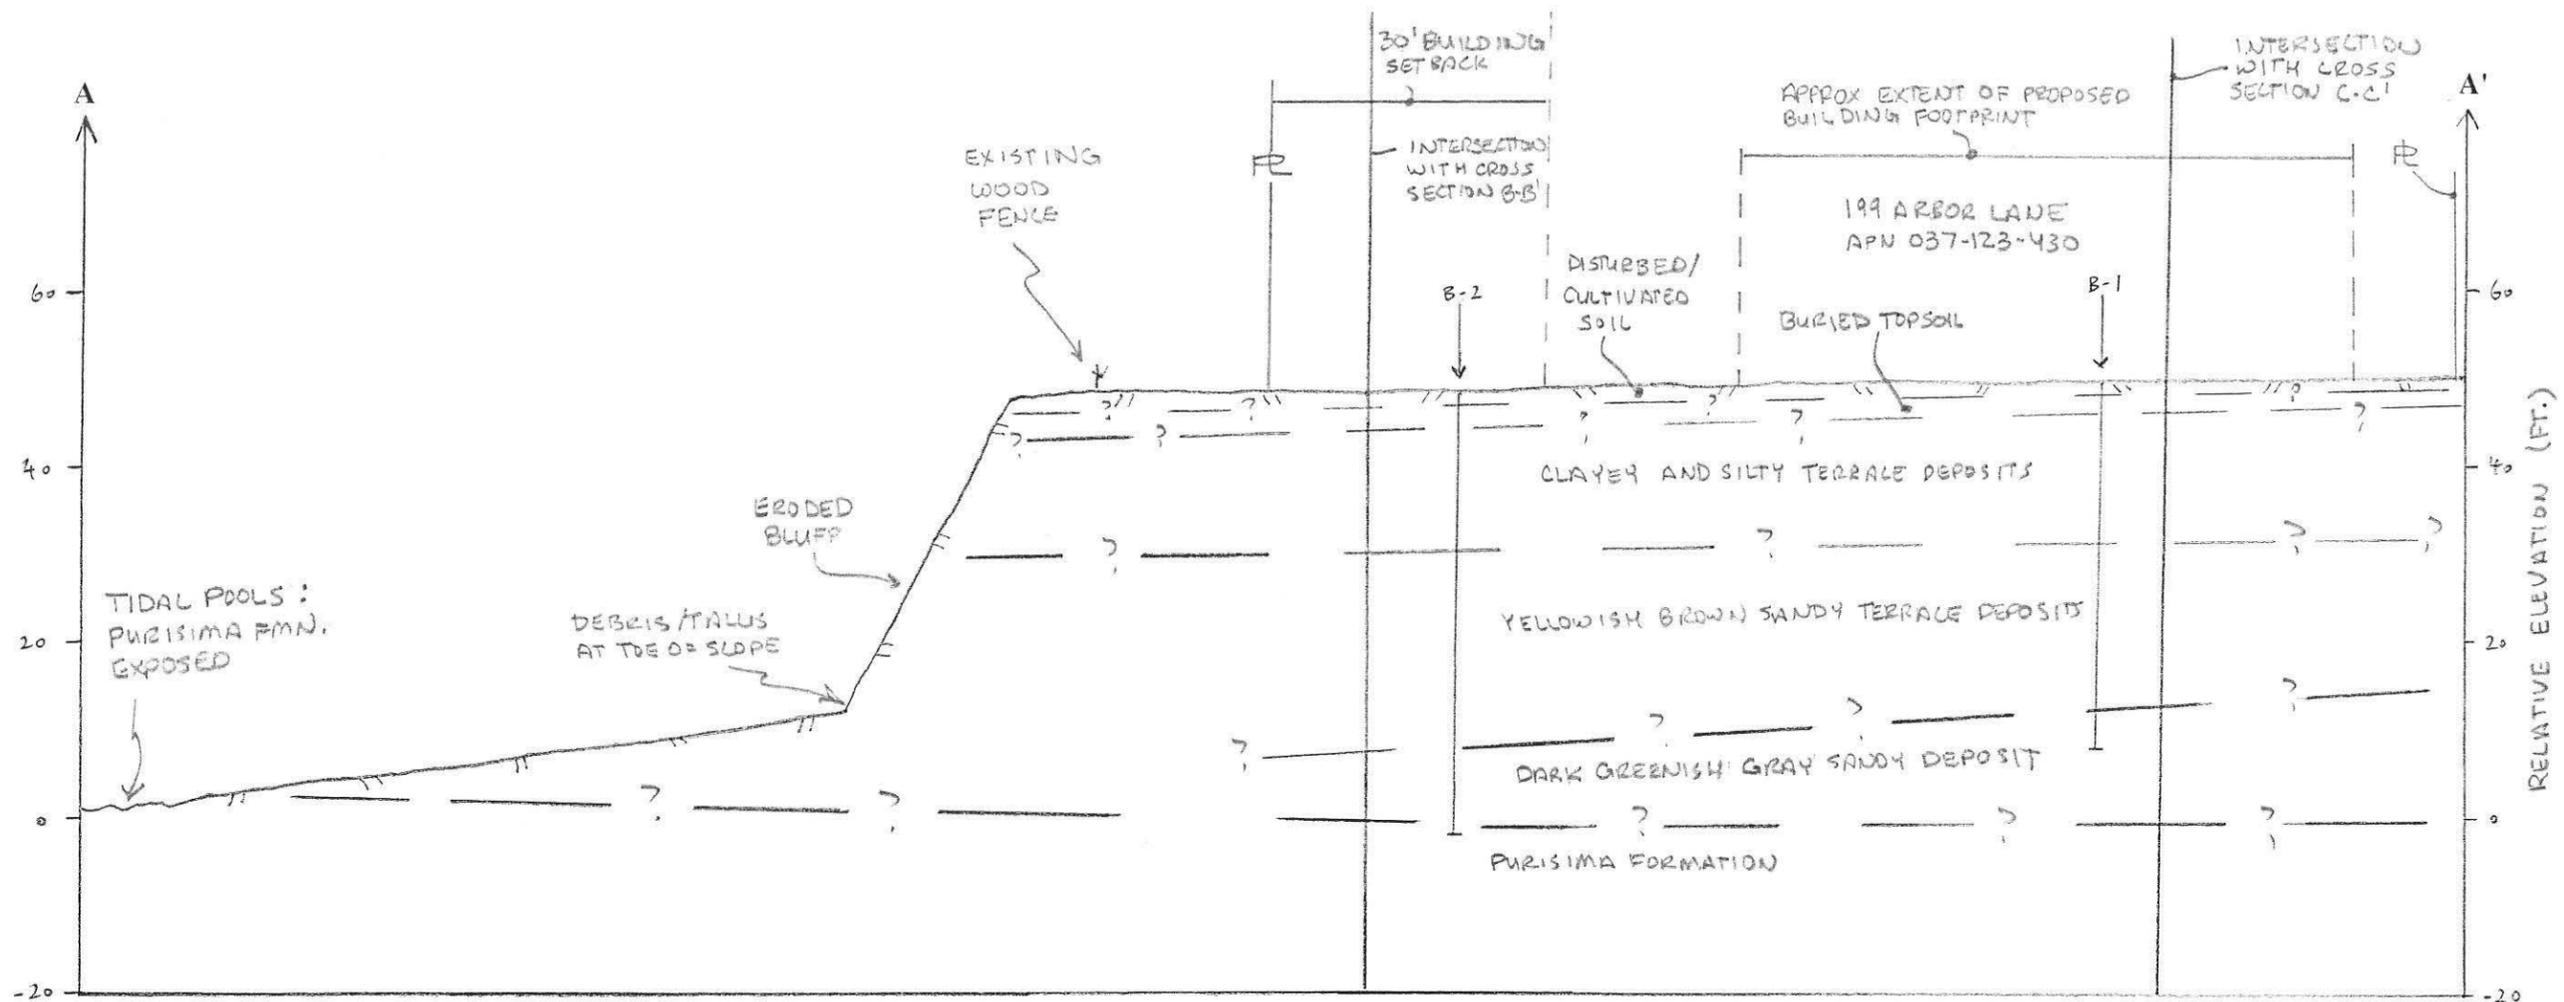
Michelucci & Associates, Inc.		
Job No. 16-4572		Figure 9

CROSS SECTION A-A'

SCALE: 1" = 20' ± (H. & V.)

* Existing topography based on topographic contours shown on a topographic survey of the site prepared by Lea & Braze Engineering, Inc., (Sheet SU1) titled, "199 Arbor Lane, Moss Beach, California," dated May 16, 2016.

An approximately 35 to 40 foot tall near-vertical bluff exists along the west side of the preserve, and the beach is at the base of the bluff. The slope at the ocean bluff is inclined at approximately 0.53 to 1.0 (feet to feet horizontal to vertical), equivalent to 189 percent at the location of Cross Section A-A' (Figure 9). The maximum ocean bluff slope is approximately 0.2 to 1.0 (feet to feet horizontal to vertical), equivalent to 490 percent. The southerly slope adjacent to the drainage is inclined at approximately 1.56 to 1.0 feet to feet (horizontal to vertical) at the location of Cross Section B-B' (Figure 10), equivalent to 64 percent; and 2.2 to 1.0 feet to feet, equivalent to 46 percent, at the location of Cross Section C-C' (Figure 11).

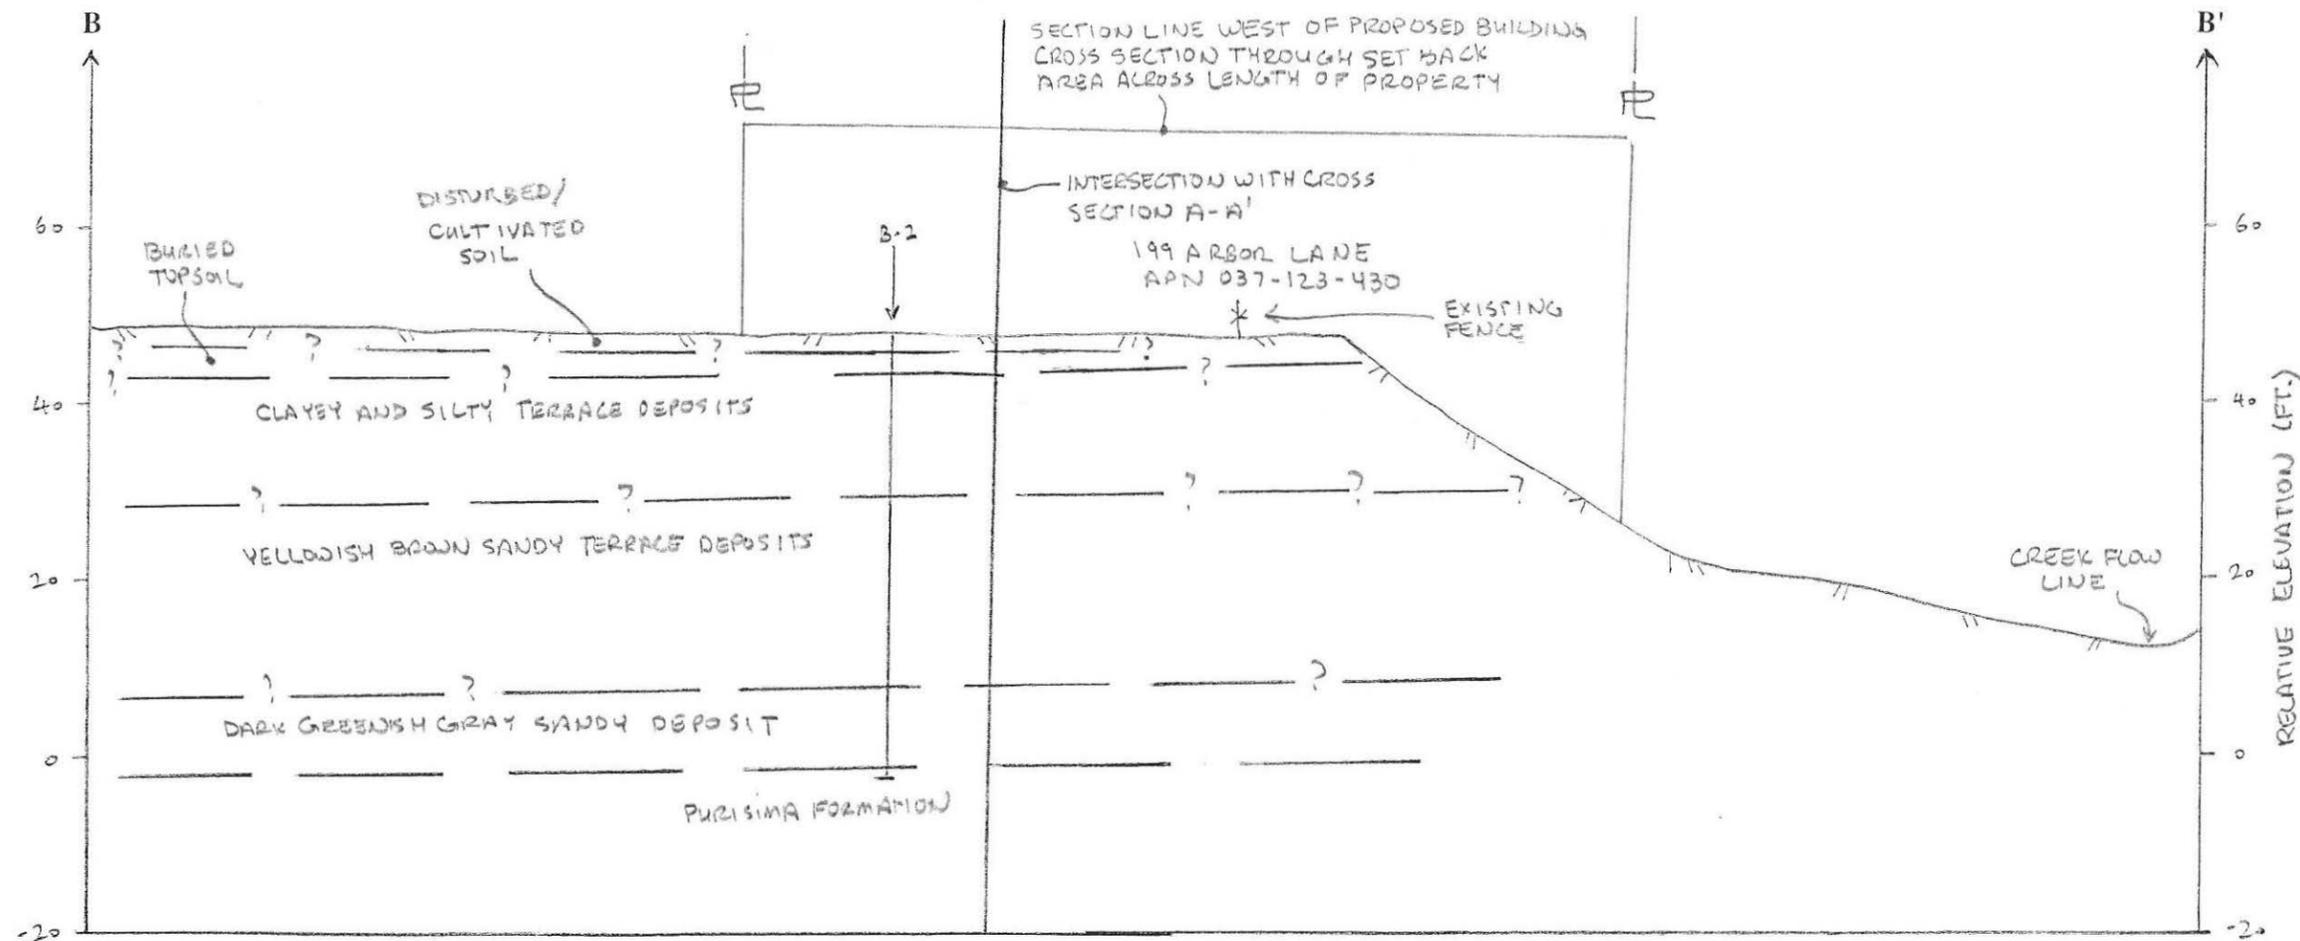
Michelucci & Associates, Inc.		
Job No. 16-4572		Figure 10

CROSS SECTION B-B'

SCALE: 1"=20'± (H. & V.)

* Existing topography based on topographic contours shown on a topographic survey of the site prepared by Lea & Braze Engineering, Inc., (Sheet SU1) titled, "199 Arbor Lane, Moss Beach, California," dated May 16, 2016.

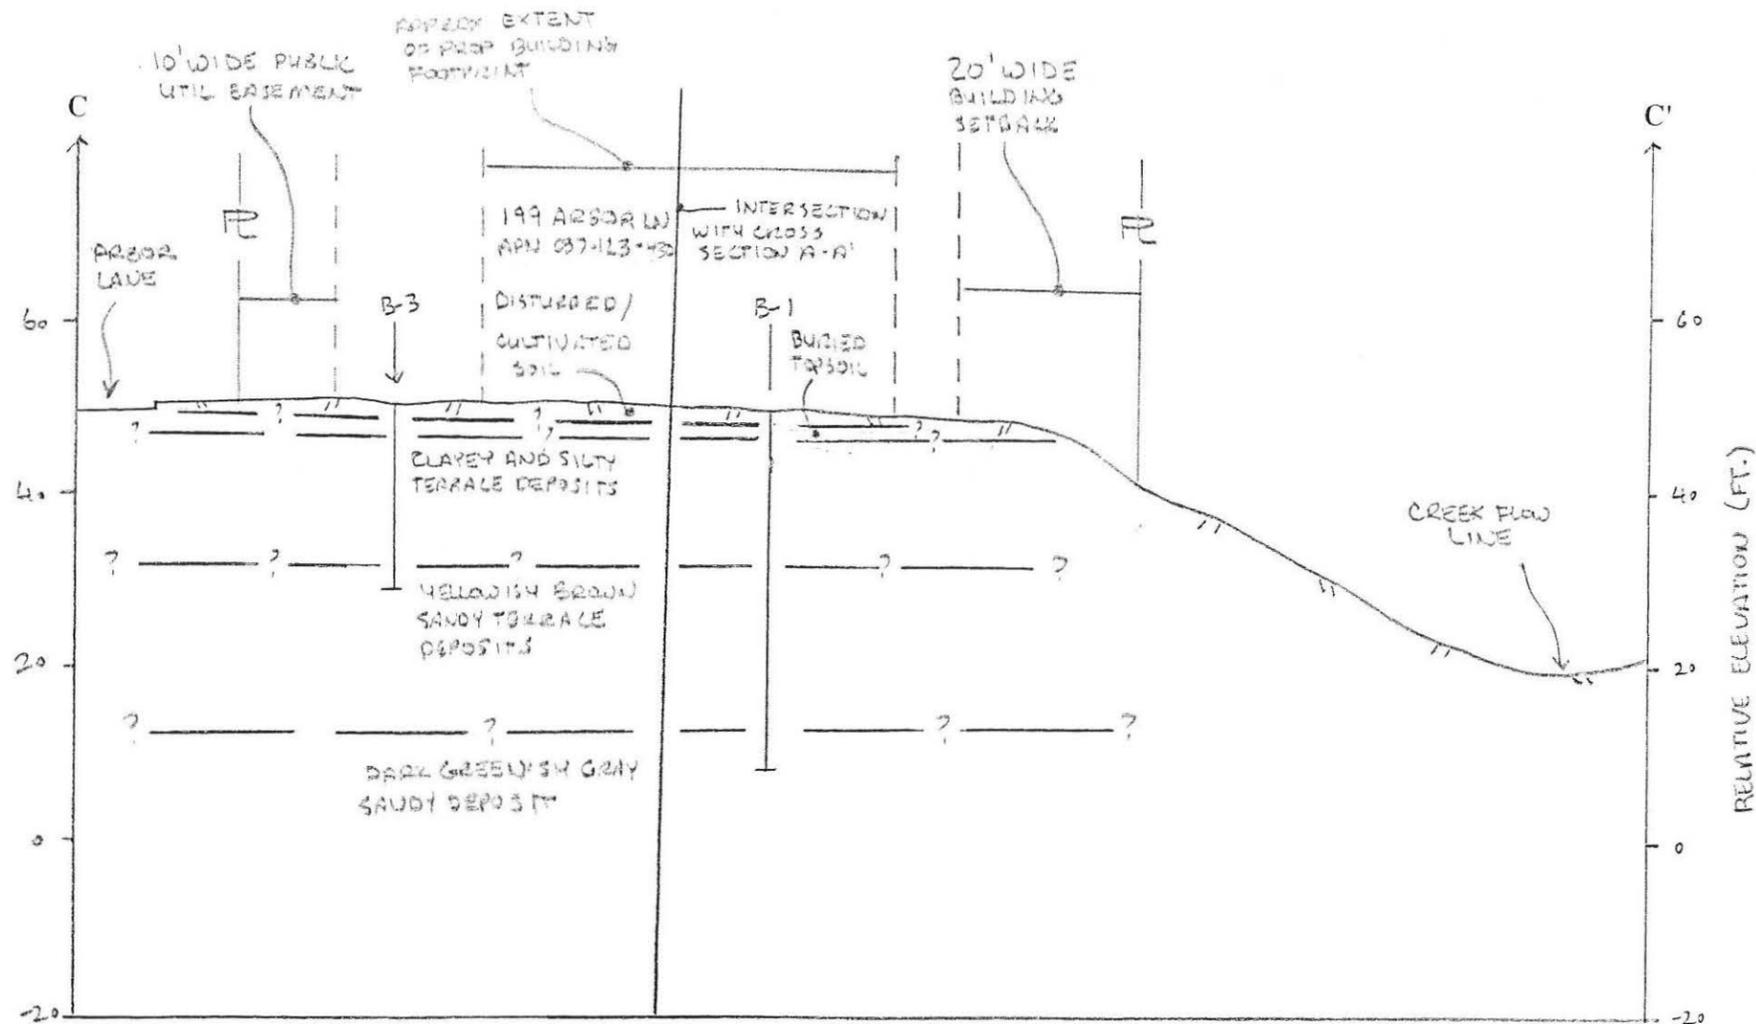
Michelucci & Associates, Inc.		
Job No. 16-4572		Figure 11

CROSS SECTION C-C'

SCALE: 1" = 20' ± (H. & V.)

* Existing topography based on topographic contours shown on a topographic survey of the site prepared by Lea & Braze Engineering, Inc., (Sheet SU1) titled, "199 Arbor Lane, Moss Beach, California," dated May 16, 2016.

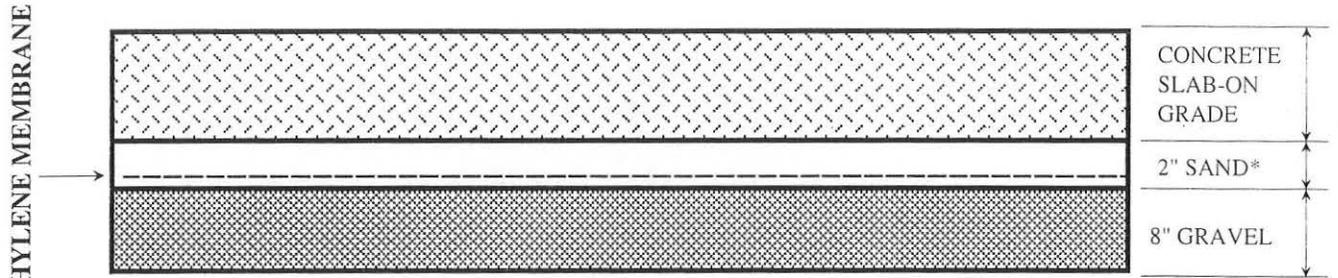
MOISTURE RETARDANT BENEATH CONCRETE SLABS TYPICAL SECTION

* or pea gravel
